**Remediation Closure Documentation**

**Gary Johnson Property**

**Moon A Tank Battery Lease**

**Lea County, New Mexico**

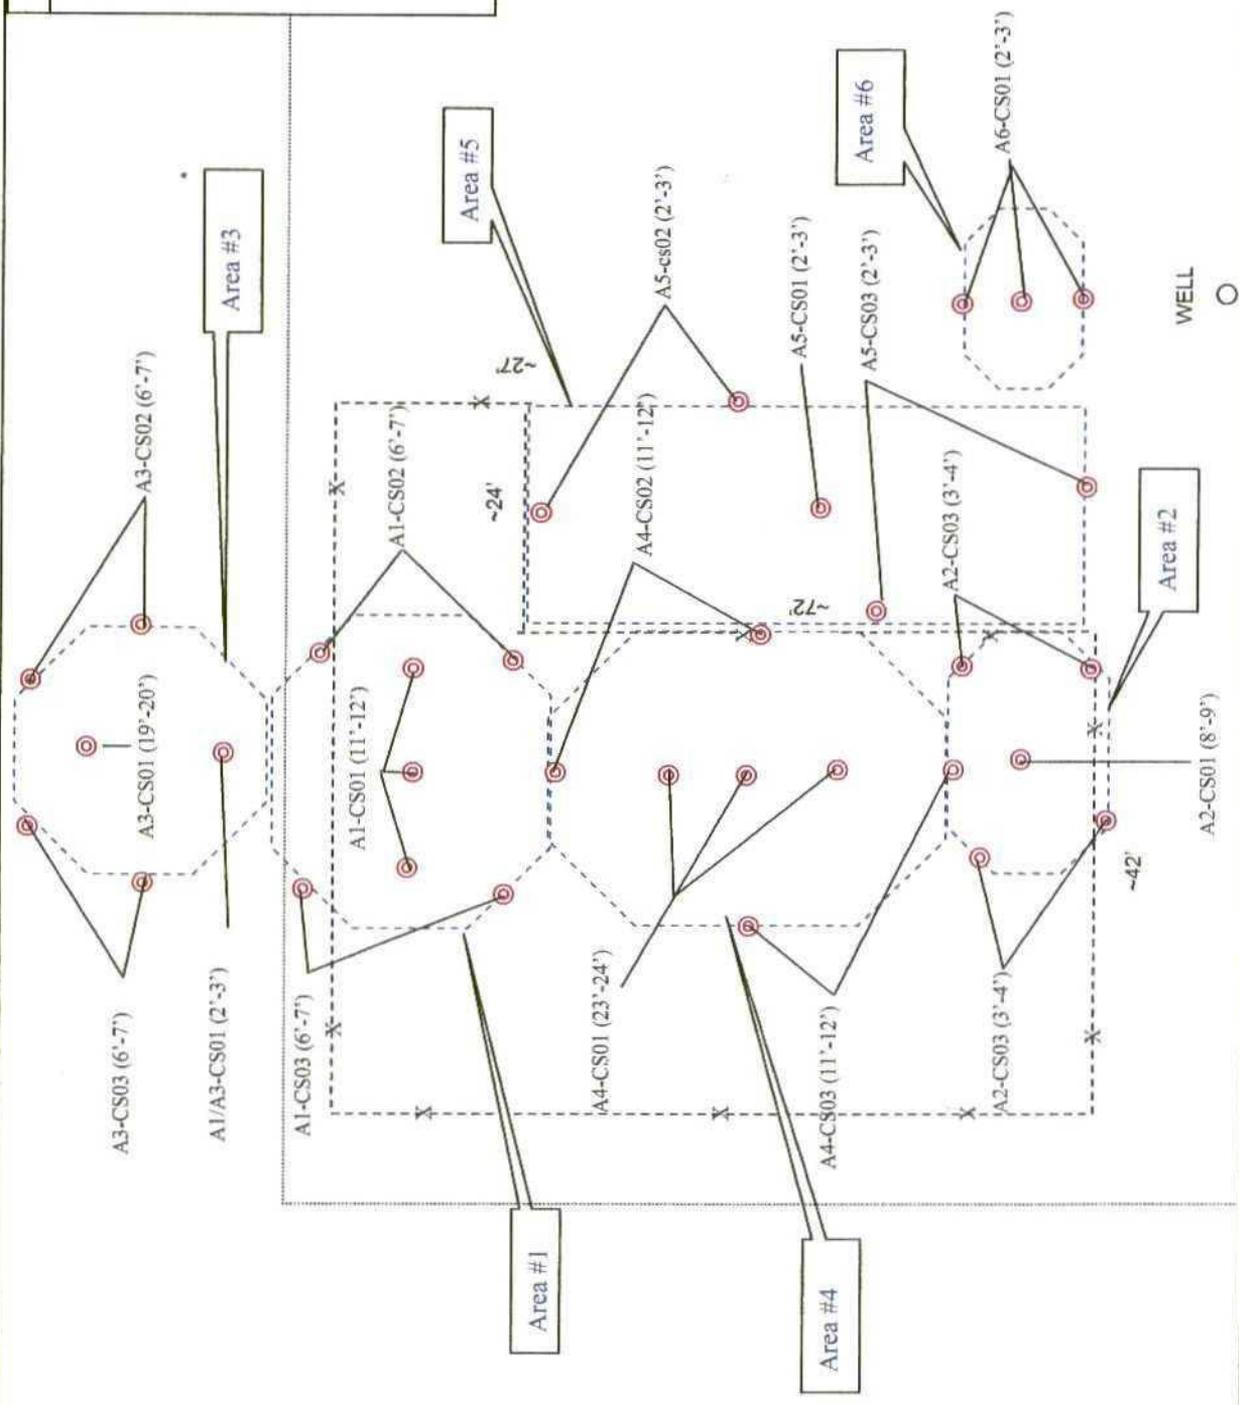
LINE LEGEND	
---X---	CYCLONE FENCE
-----	CATTLE FENCE
-----	EXCAVATION EXTENT
⊙	Confirmation Soil Sample Location

NOT TO SCALE	LEA COUNTY	SW/4 NE/4 SEC 28 T18S R38E	<b>Moon A Tank Battery Lease</b>	
		N 32° 43.227' W 100° 09.033'	HOBBS WEST QUADRANGLE	LEA COUNTY, New Mexico	
		NAD 27	09/20/05

A total of six (6) hydrocarbon impacted spill areas on the property were identified during the Phase II ESA and required remediation as outlined in the NEI approved Remediation Work Plan. Complete horizontal and vertical delineation with removal of hydrocarbon contaminated soils at each impacted spill area was completed as per NMOCD remediation guidelines and the approved Remediation Work Plan. A plot plan depicting impacted remedial areas is depicted in **Figure 2**.

A total of 20 confirmation soil samples were collected from the floor and side wall slope of each excavation area. The confirmation soil sample locations are presented on **Figure 2** and the analytical results are included on **Table 3**.

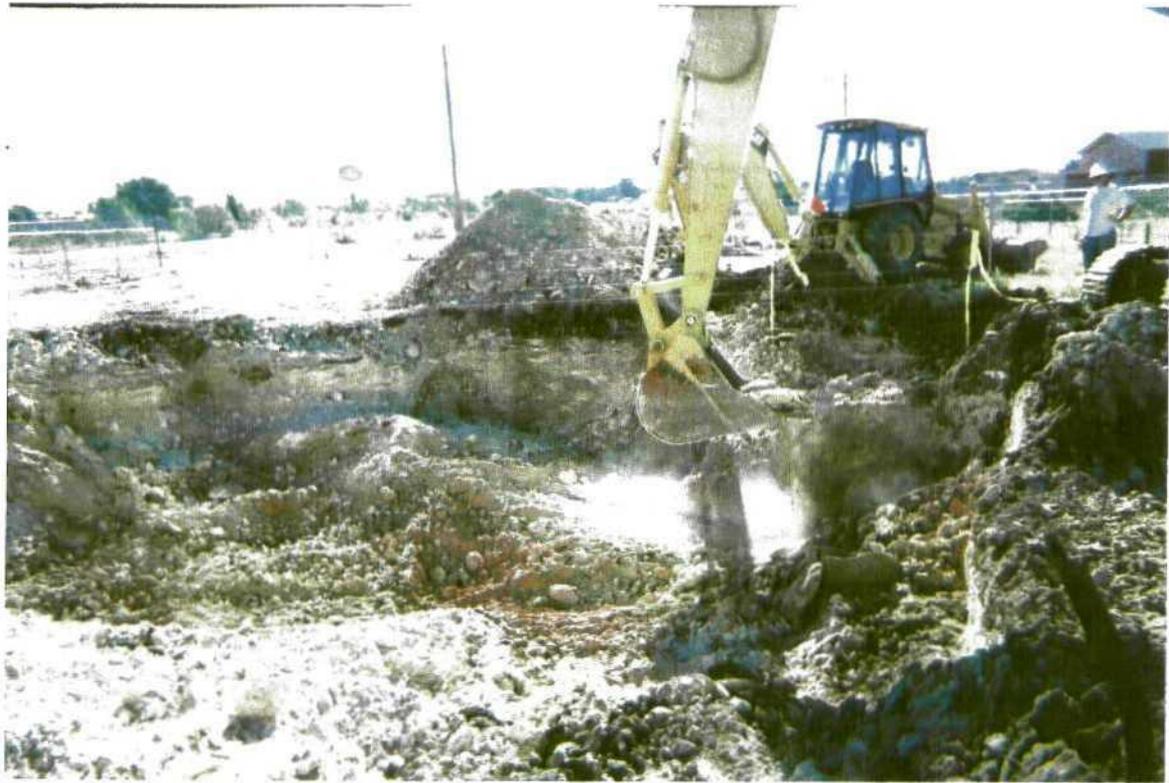
Impact Area 1 Facing Mobile Street (East) – Excavation Progress

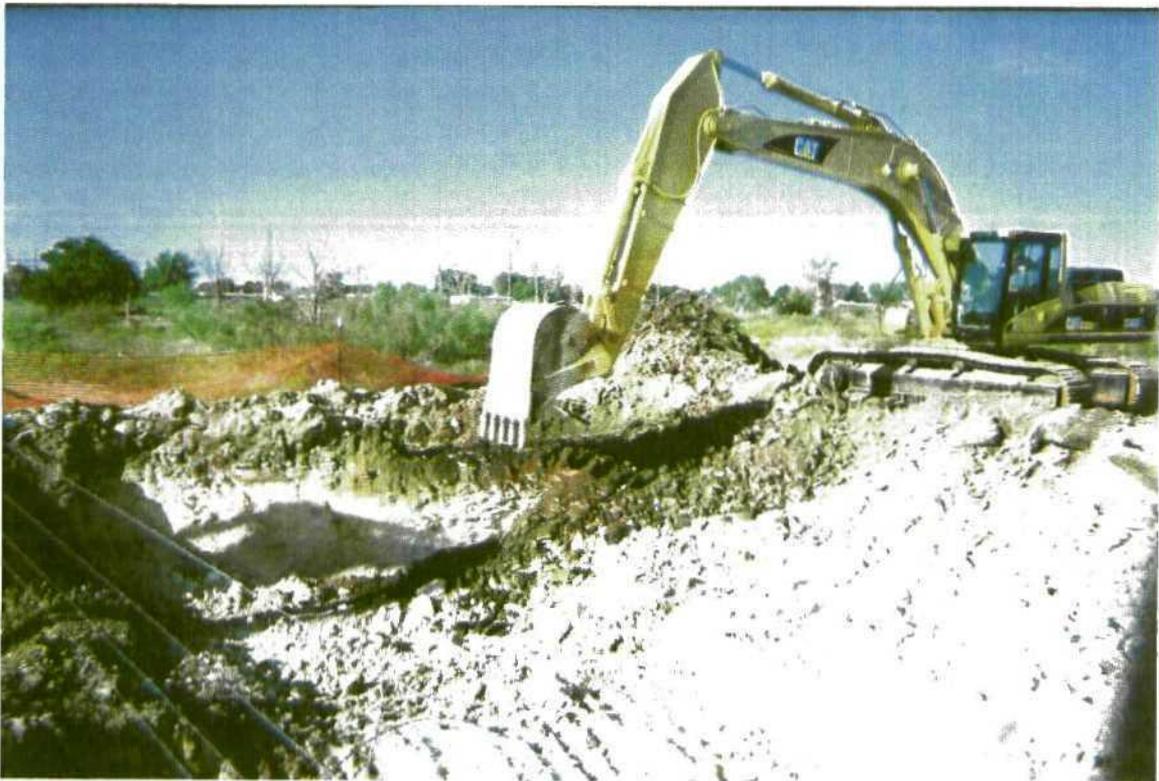
Impacted Area 1 Facing West-Southwest – Excavation in Progress

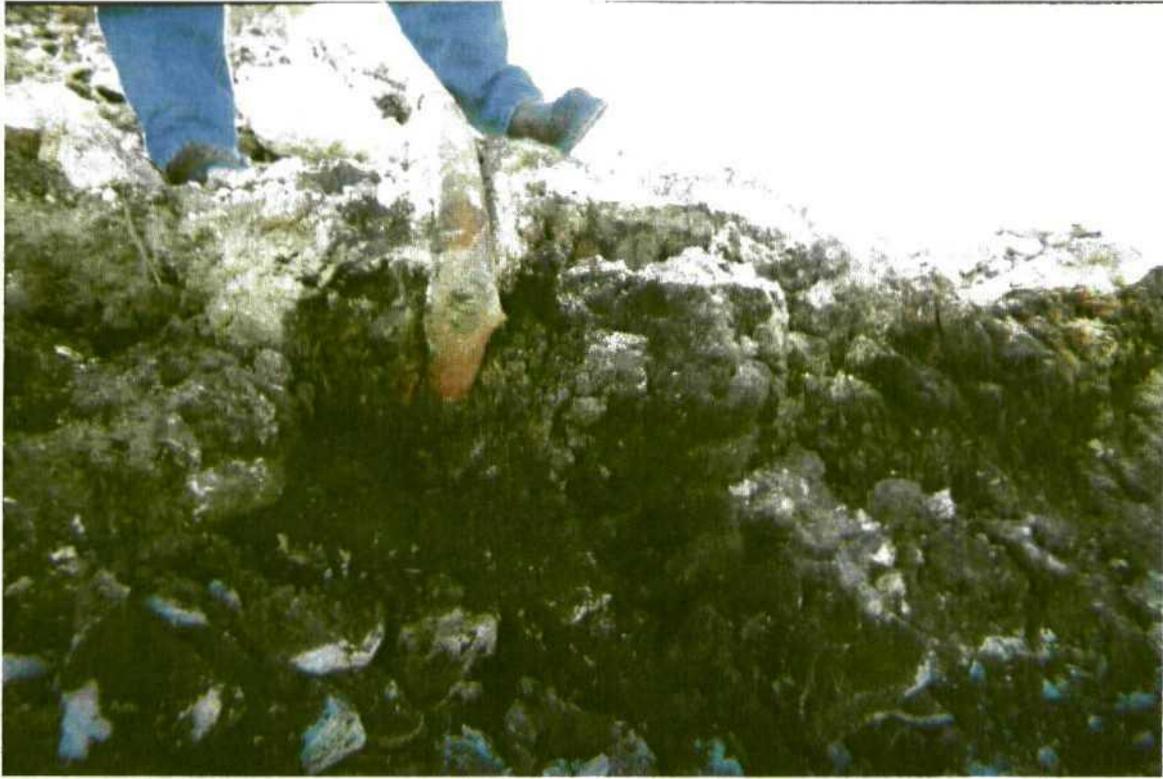
Impact Area 1 – Impacted soil around 2" flow line to be removed

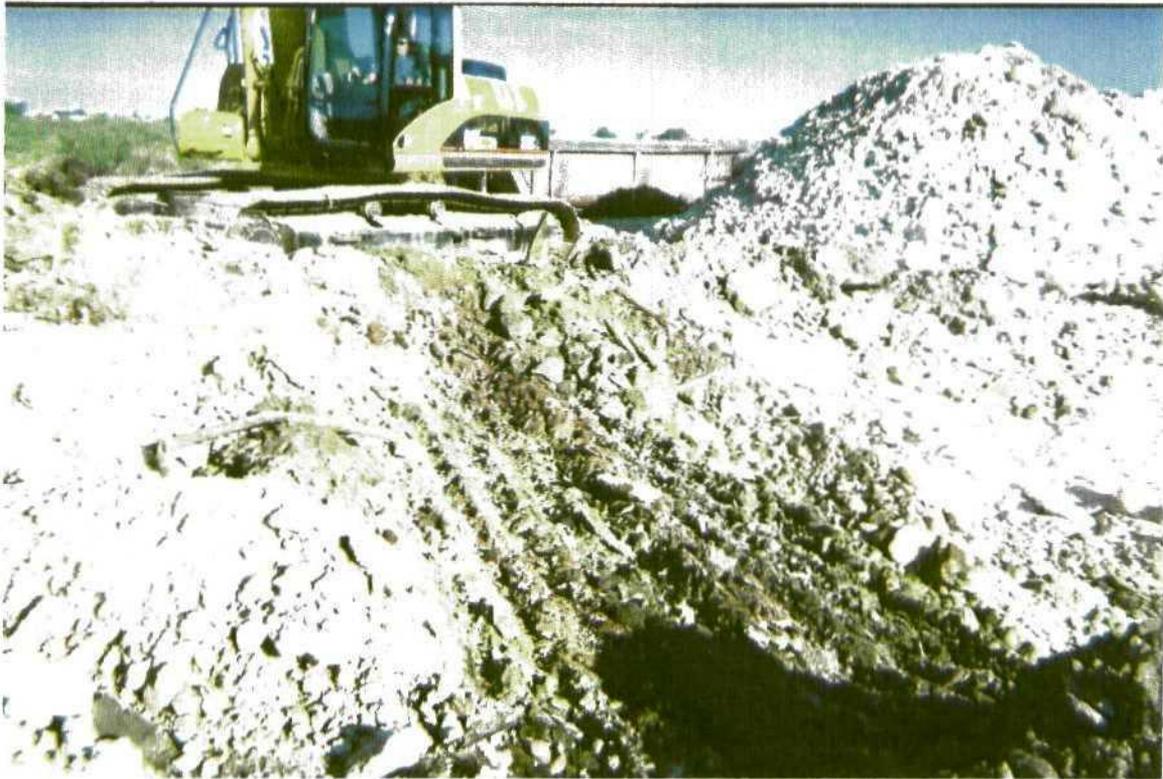
Impacted Area 1 Facing West-Southwest – Impacted soil and old flow line removal

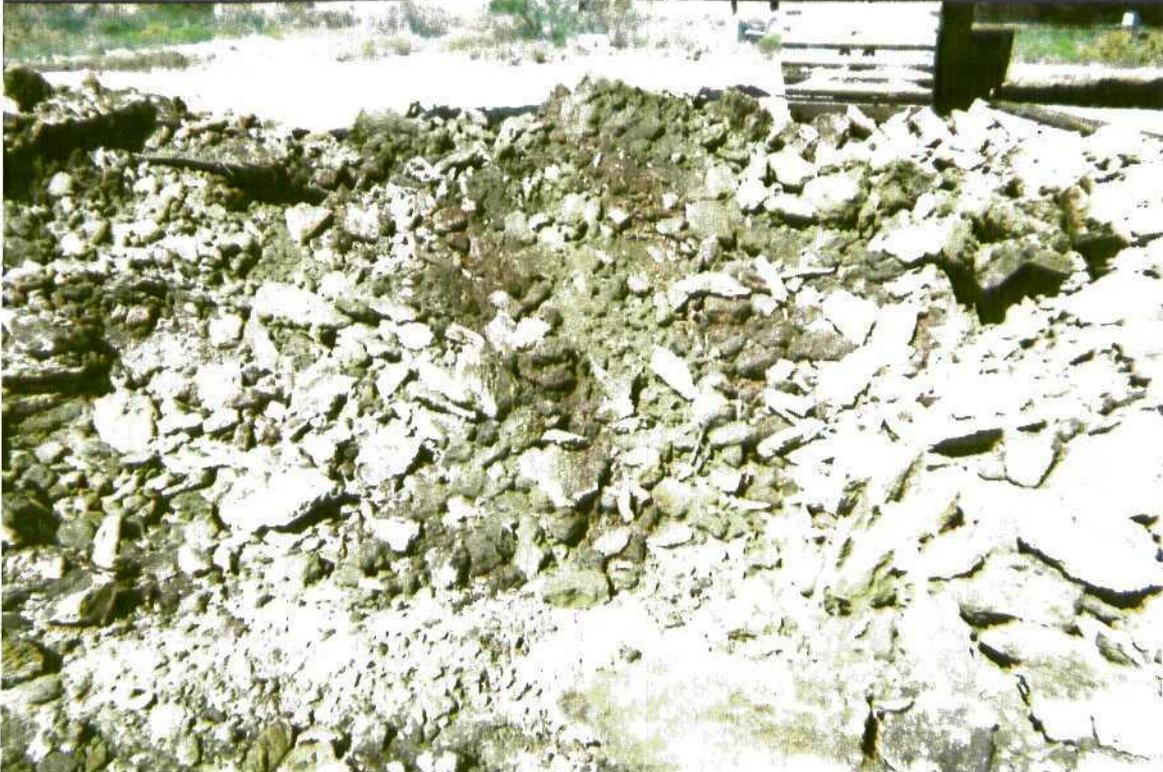
Impact Area 2 Facing Mobile Street (East) – Hydrocarbon contaminated soil

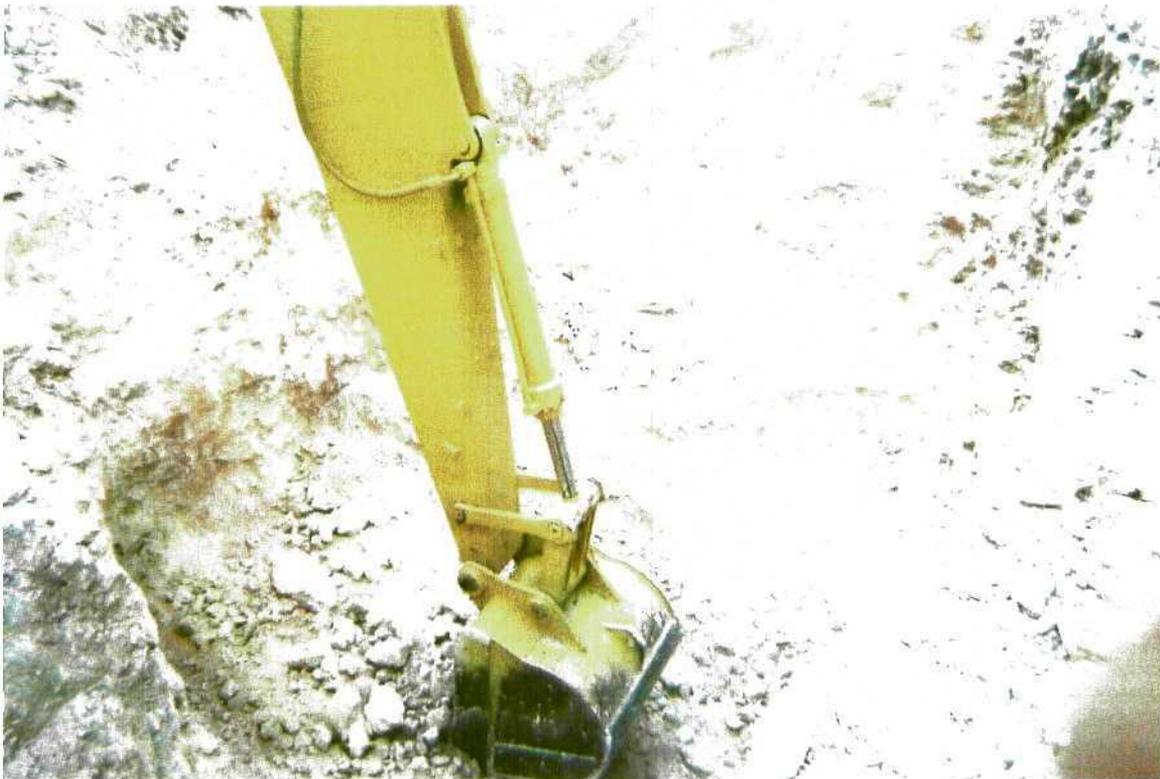
Impacted Area 4 – Excavation in Progress

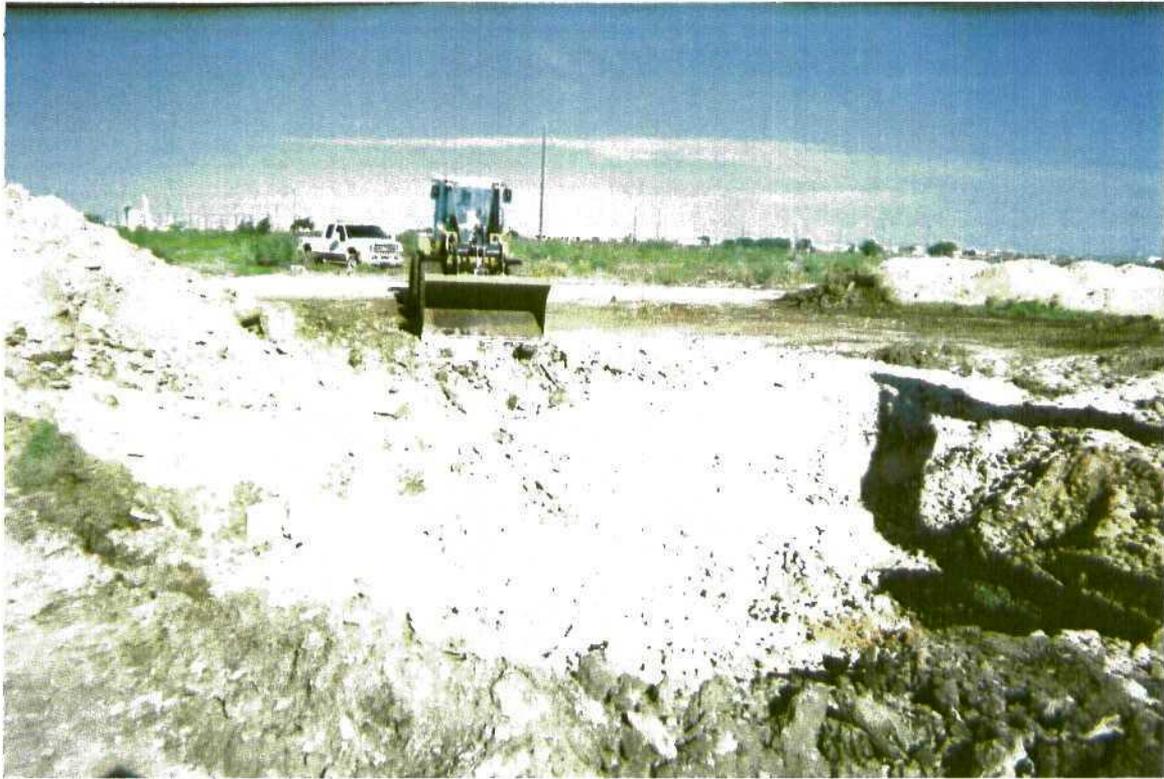
Impact Area 3 Facing West – Excavation Progress

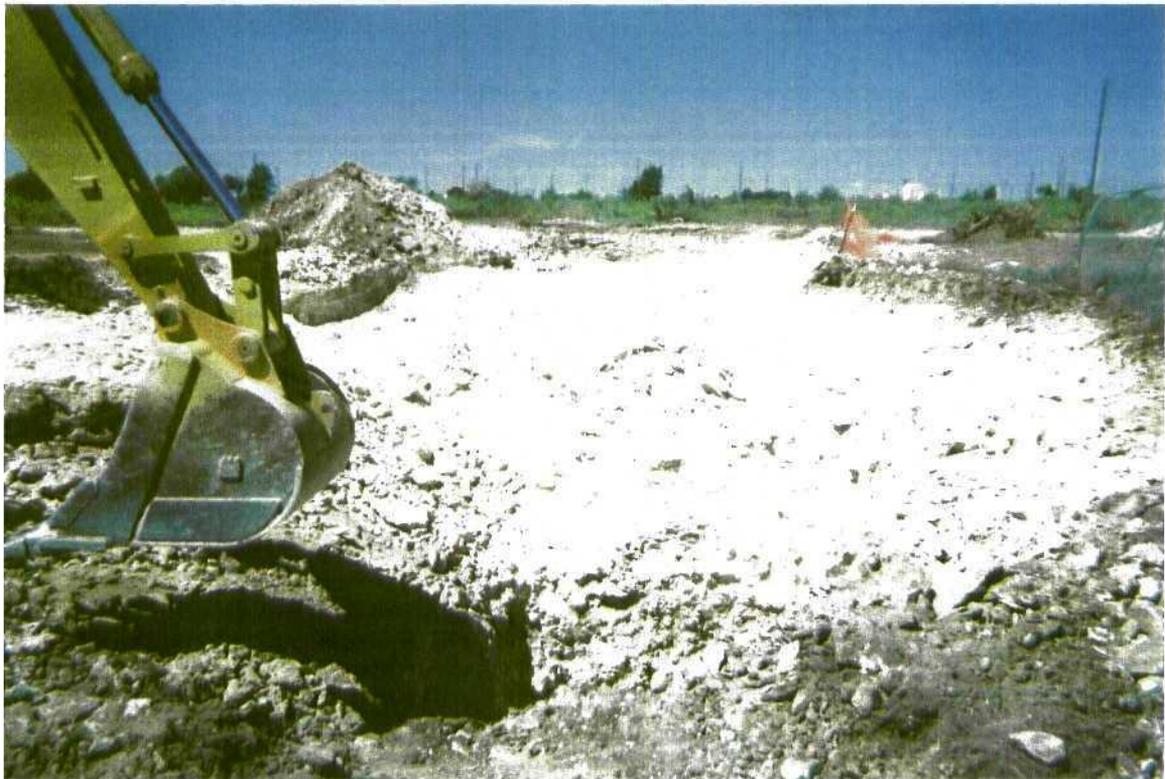
Impacted Area 4, 1 & 3 Facing West – Excavation on Area 4

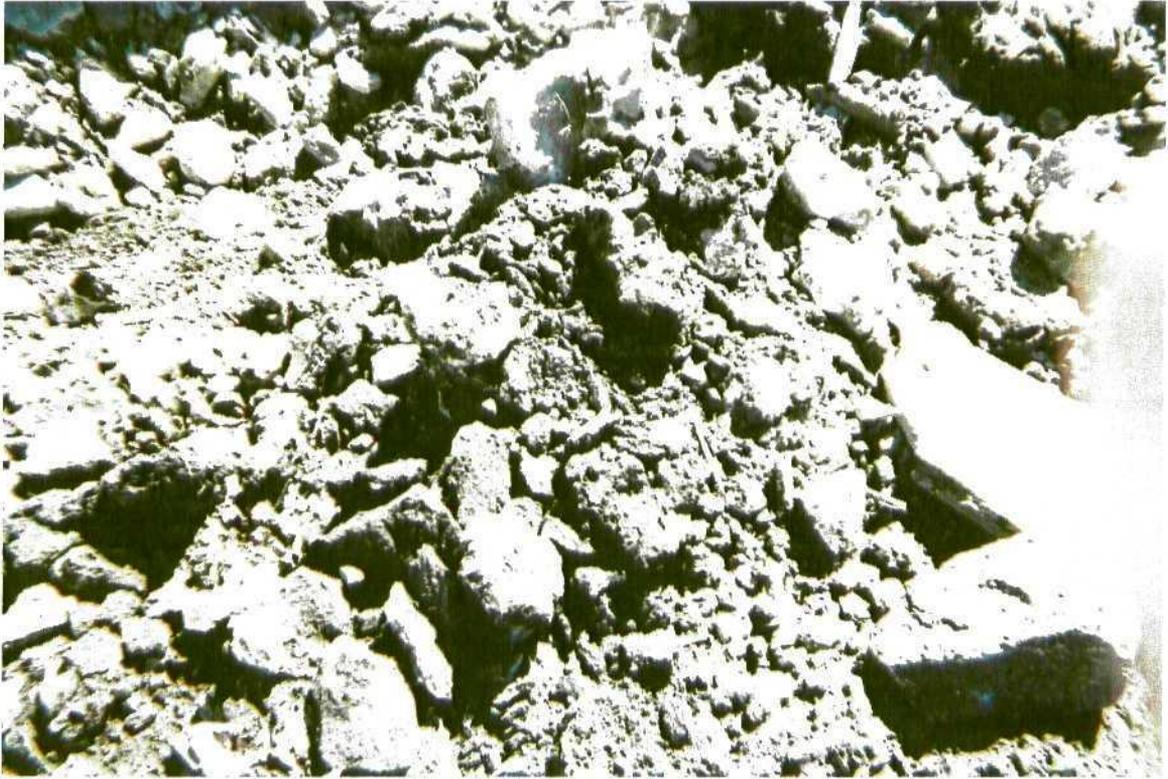
Impact Area 4 – Hydrocarbon contaminated soil excavated from 19 feet below land surface

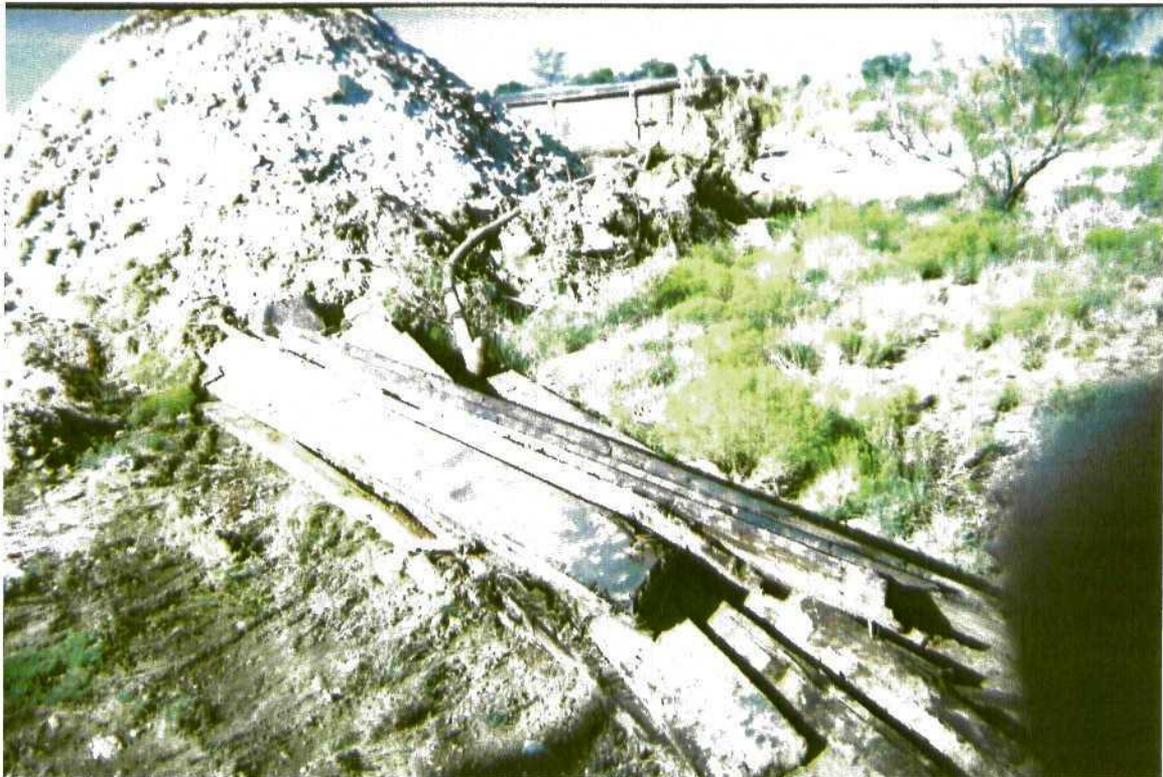
Excavated Redwood timbers and flow line from Impact Area 1

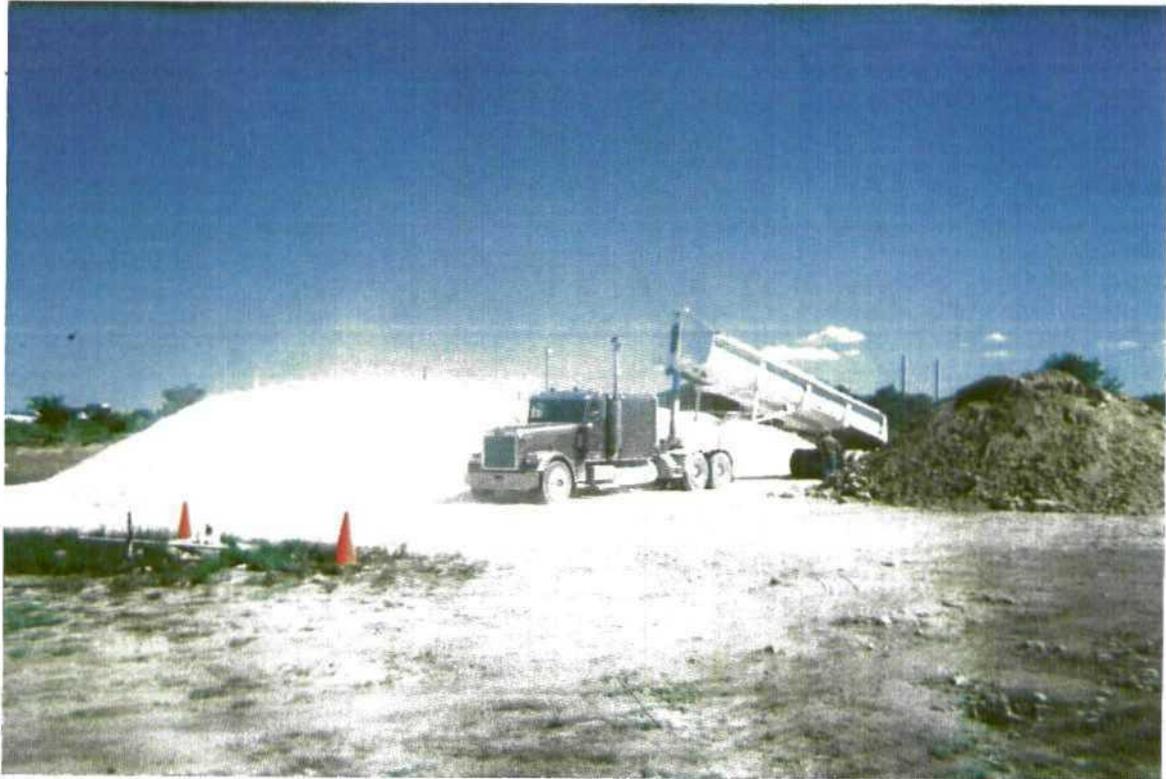
Clean Backfill staging area East of Impacted Area

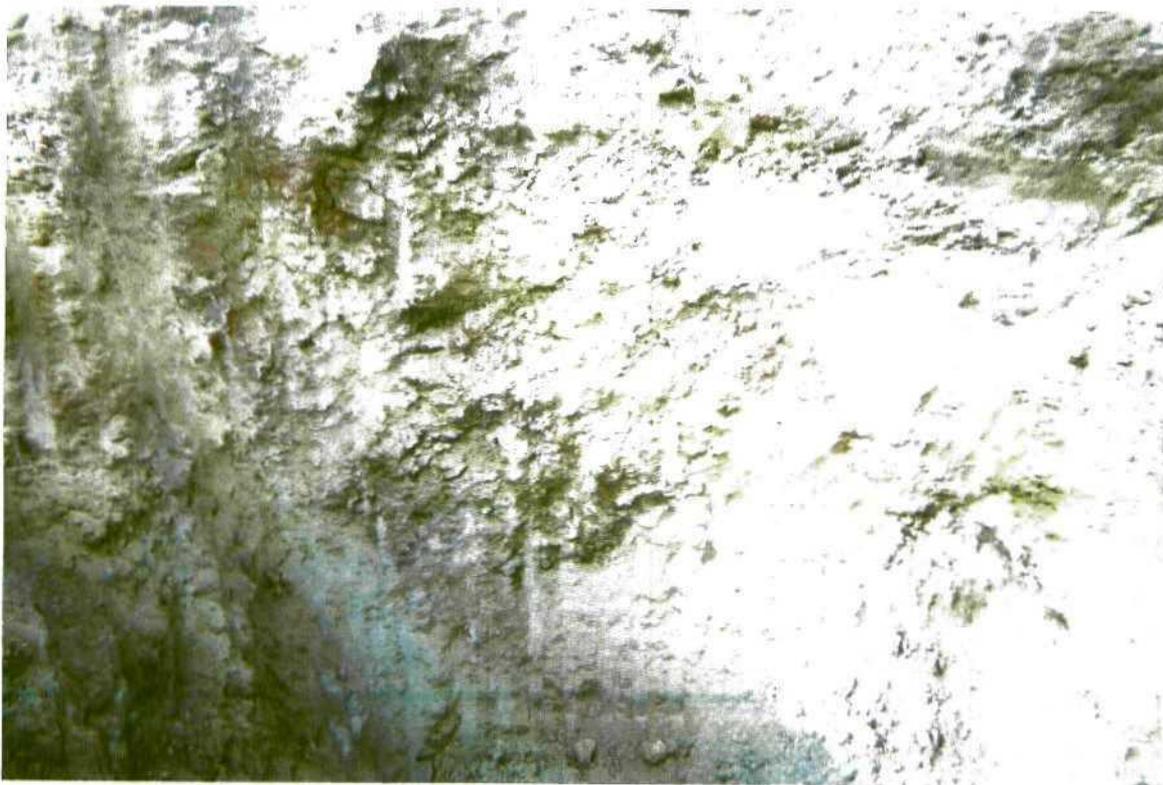
Impacted Area 1 hydrocarbon contaminated soil sidewall – Excavation in Progress

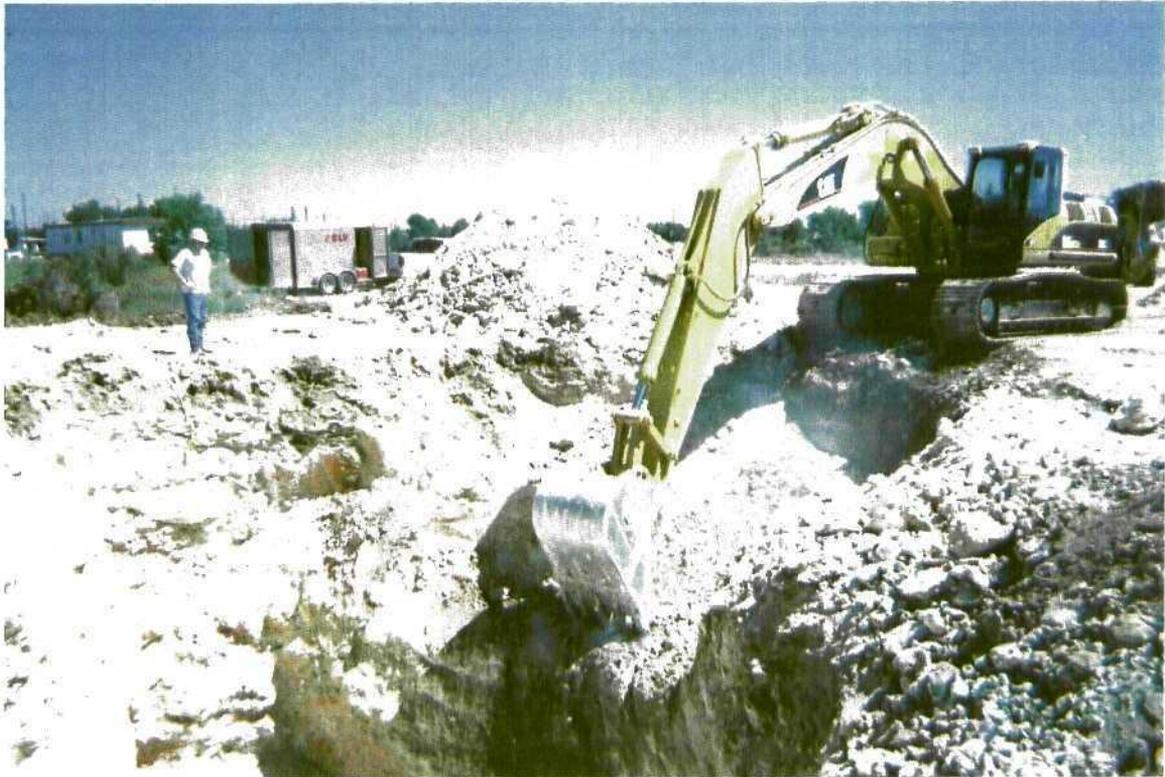
Impact Area 2 Facing Mobile Street (East) – Excavation Progress

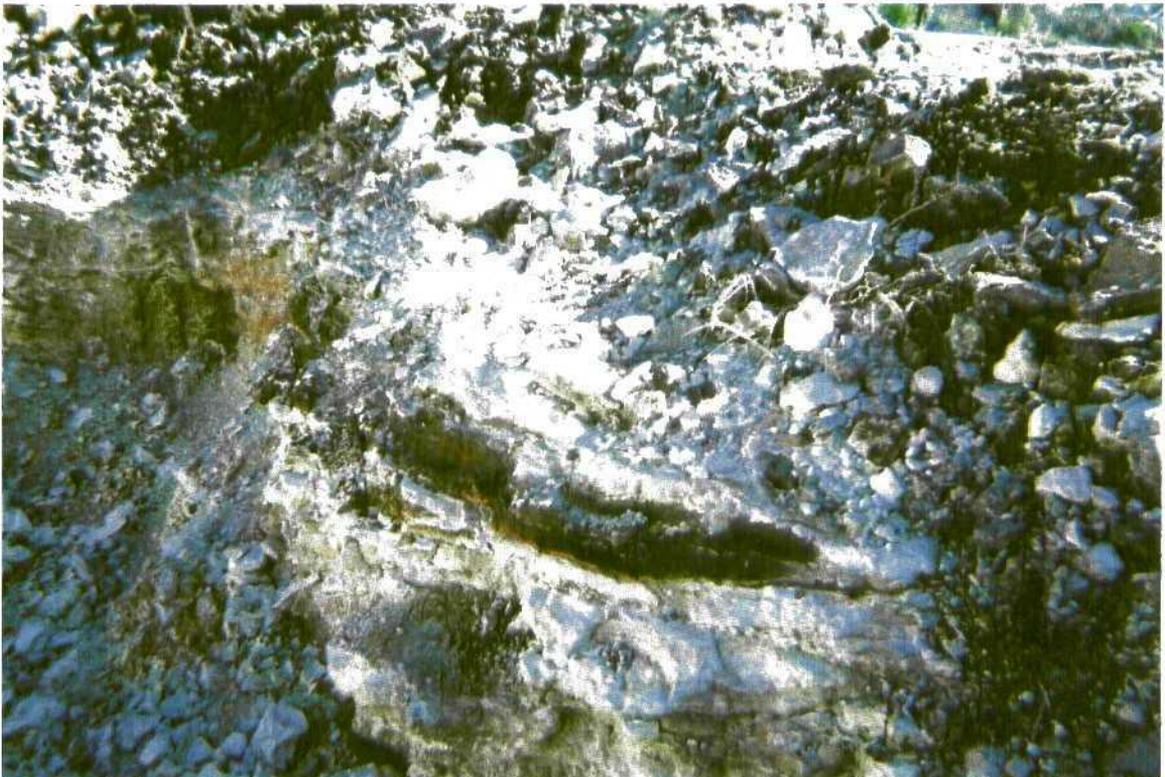
Impacted Area 4 - Excavation in Progress

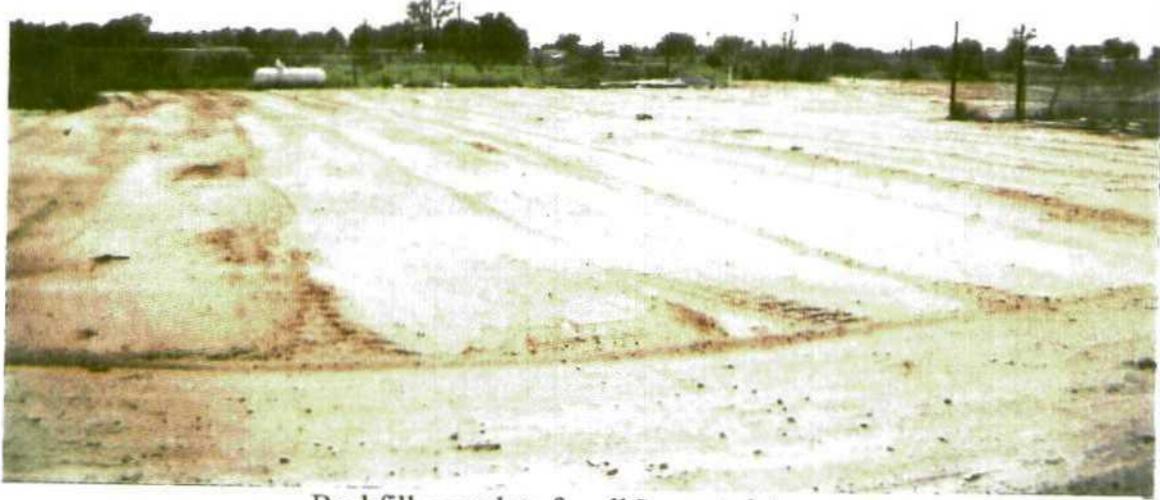
Backfill complete for all Impacted Areas

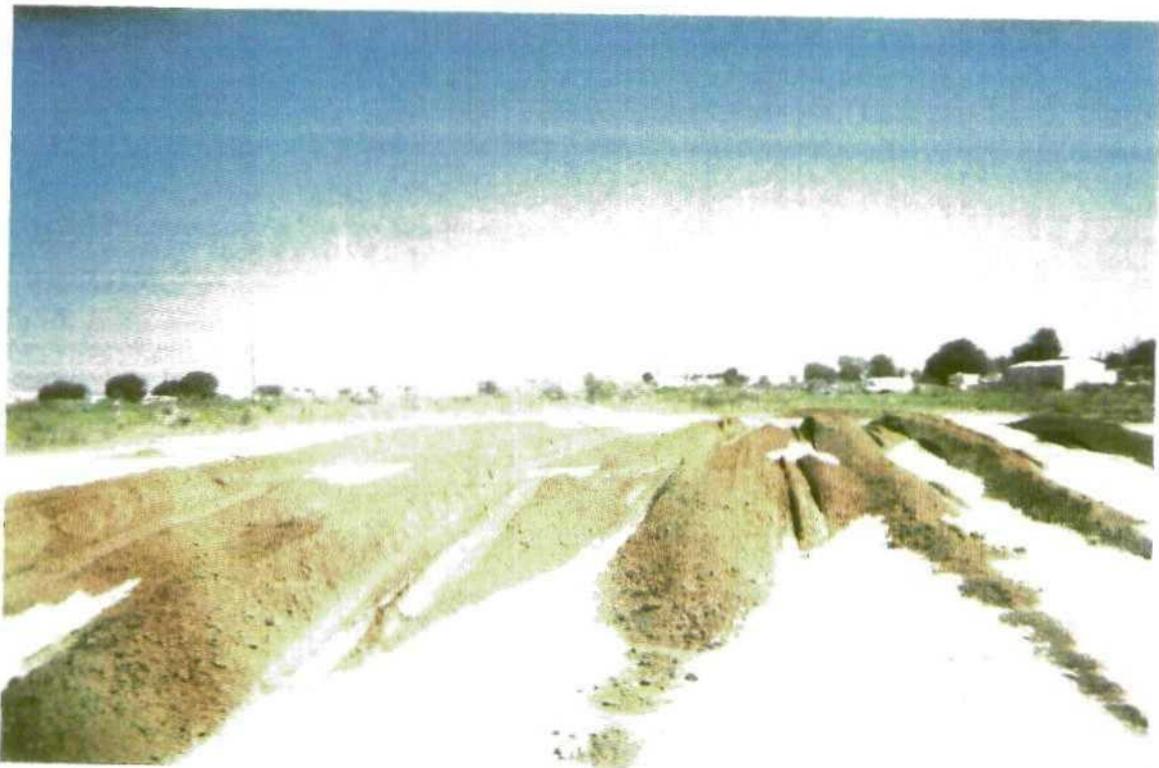
Top soil placement over backfill

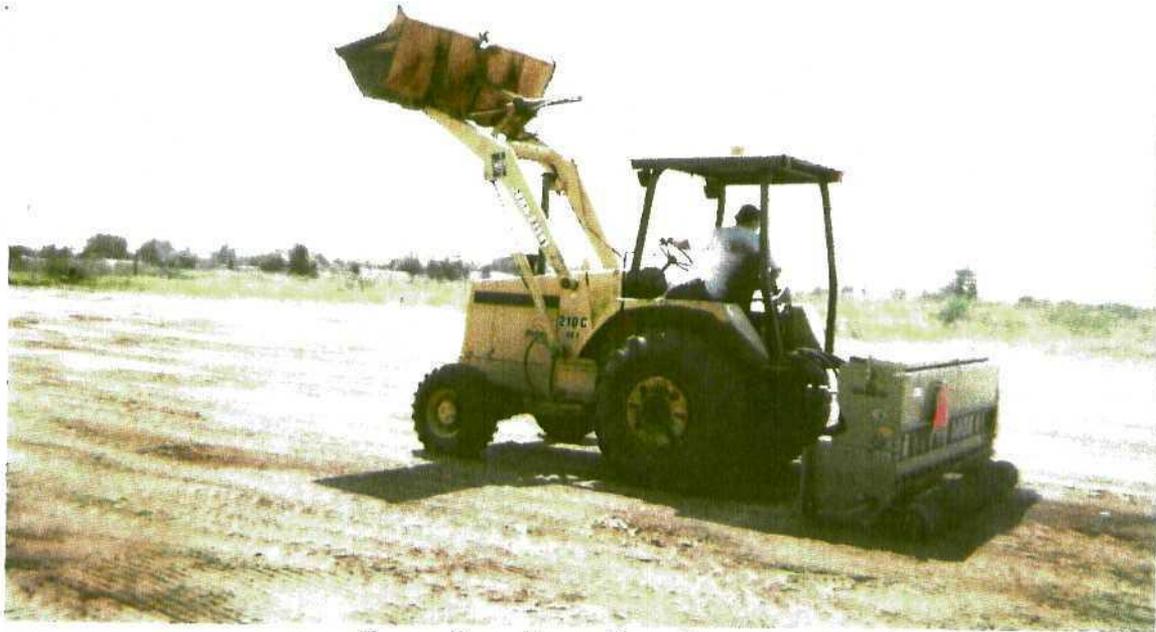
Top soil seeding with native grass

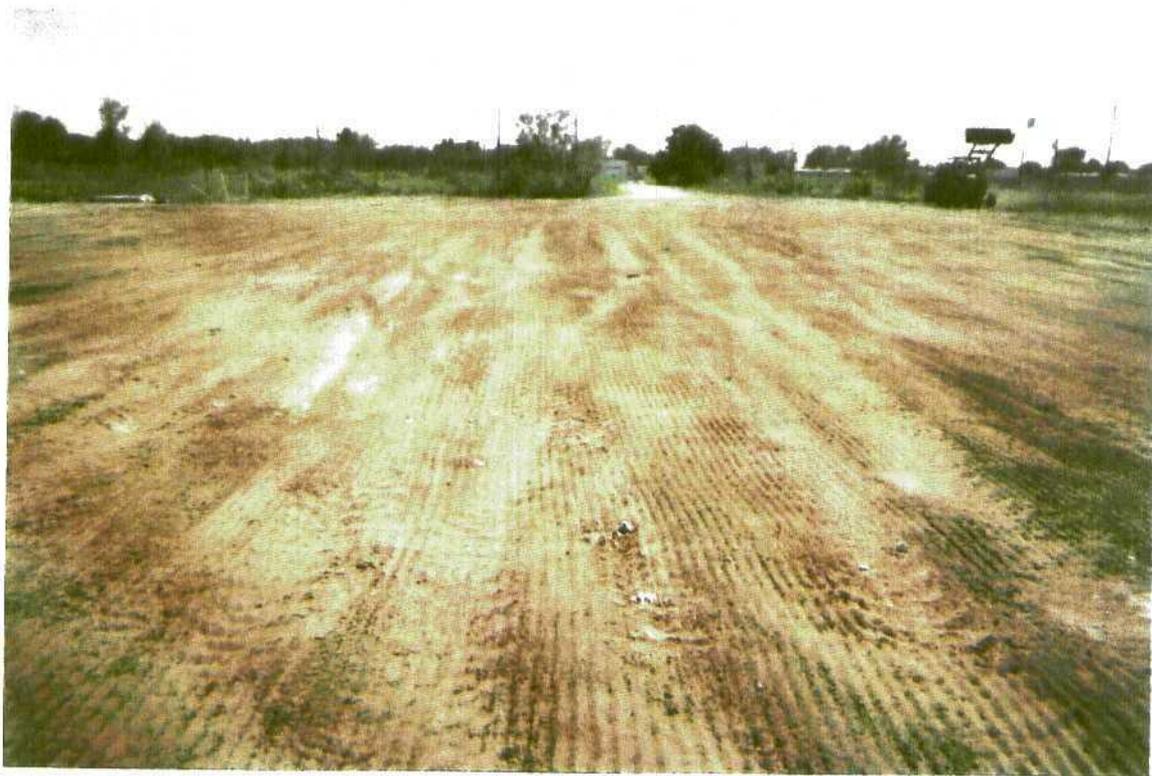
Site restoration complete
