1R - 293

**Re: Soil Sample Results, Former M<sup>c</sup>Kinley Lease Production Facility, UL A,  
Section 30, Township 18 South, Range 38 East, Lea County, New Mexico**

**Table 1: Summary of Headspace and Laboratory Analysis of Soil Samples**  
**Texaco Exploration and Production Inc., McKinley Lease**  
**NE/4, NE/4, Section 30, Township 18 South, Range 38 East**  
**Lea County, New Mexico**

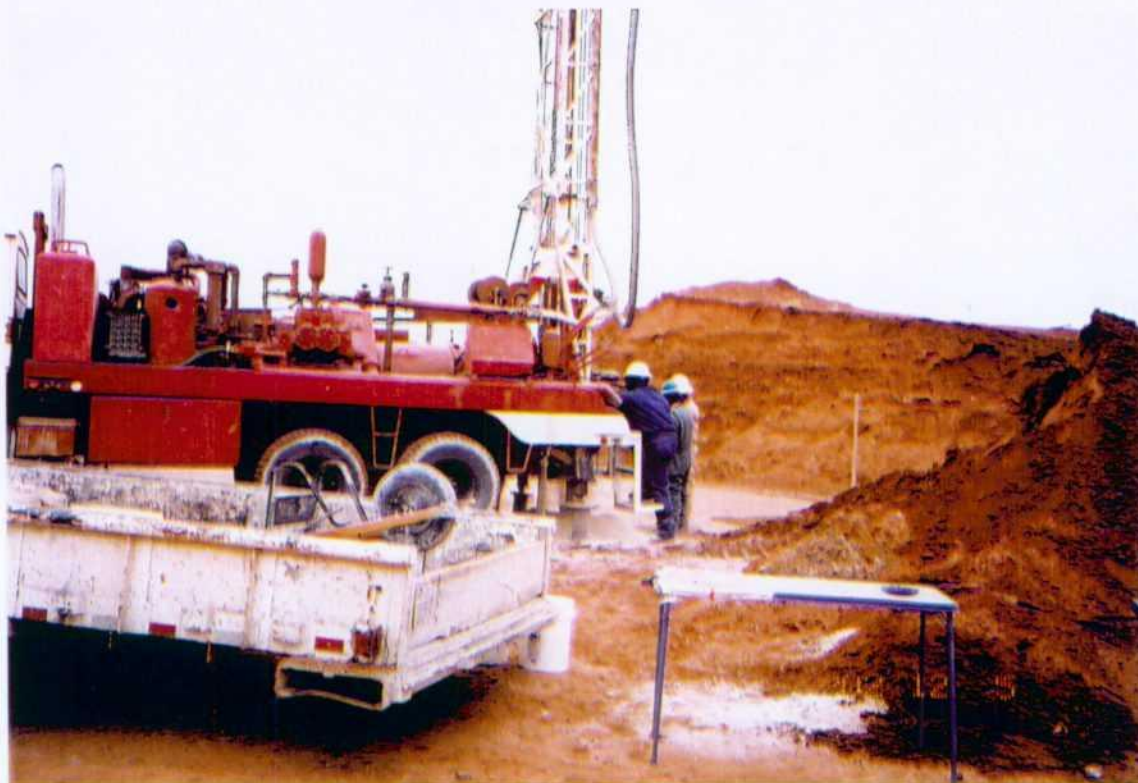
1. View to north. Installation of soil boring BH-13. Stockpiled soil to right in photo.

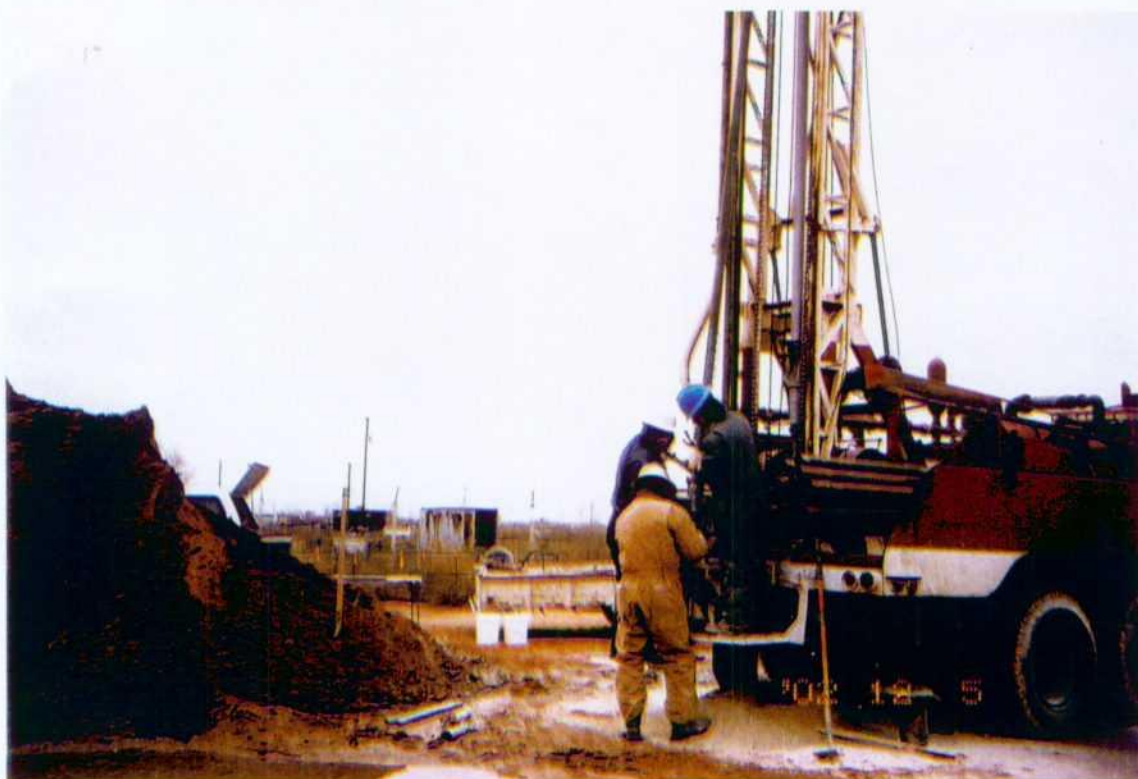
2. View to south. Installation of soil boring BH-13. Stockpiled soil to left in photo.

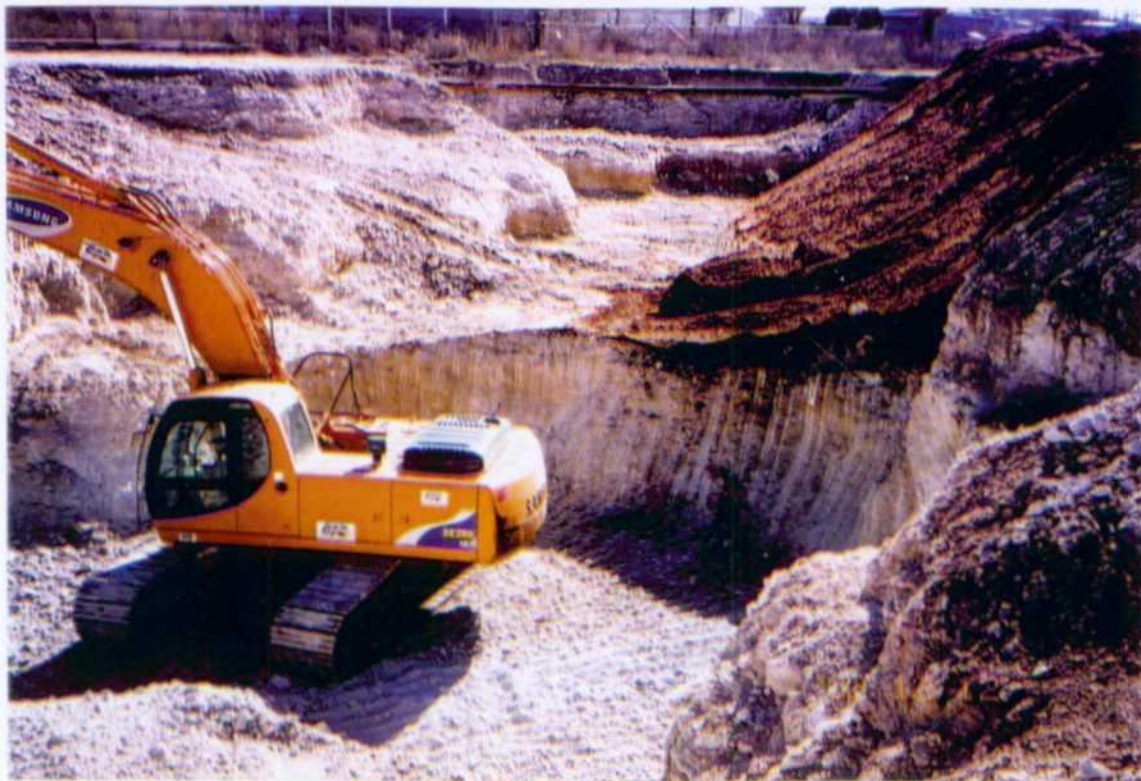
3. View to south of excavation immediately north of Hole #2.

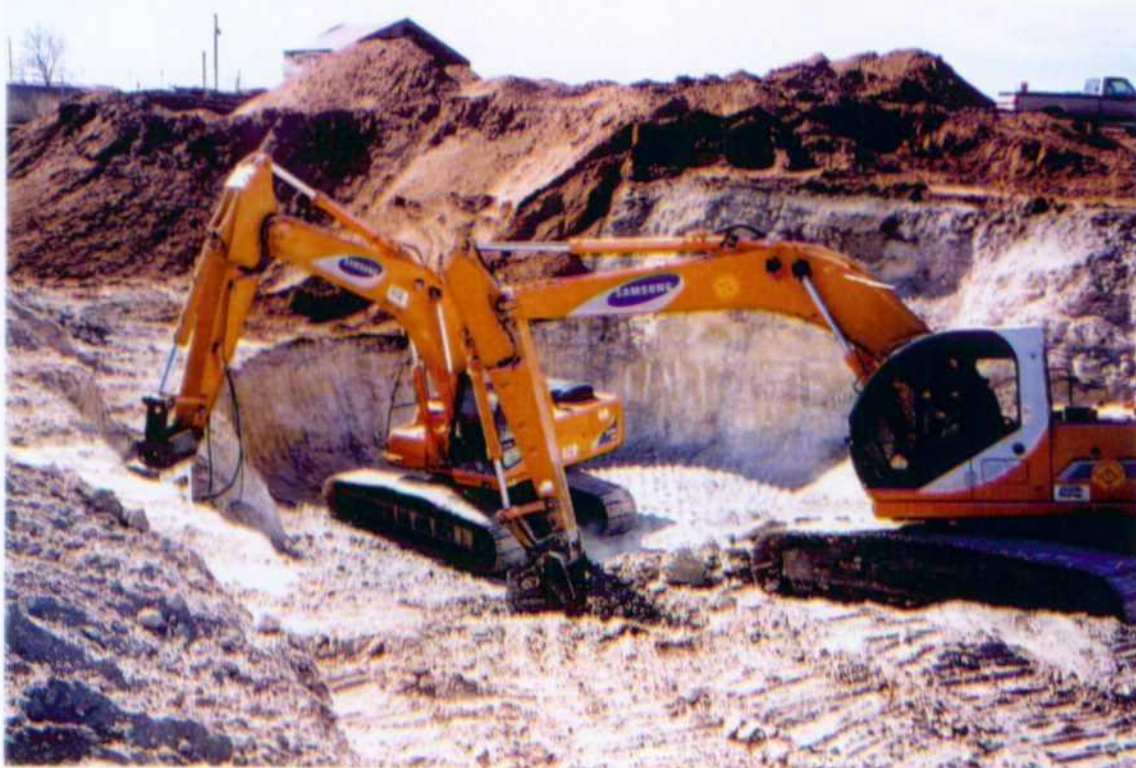
4. View to southwest of excavation immediately north of Hole #2.

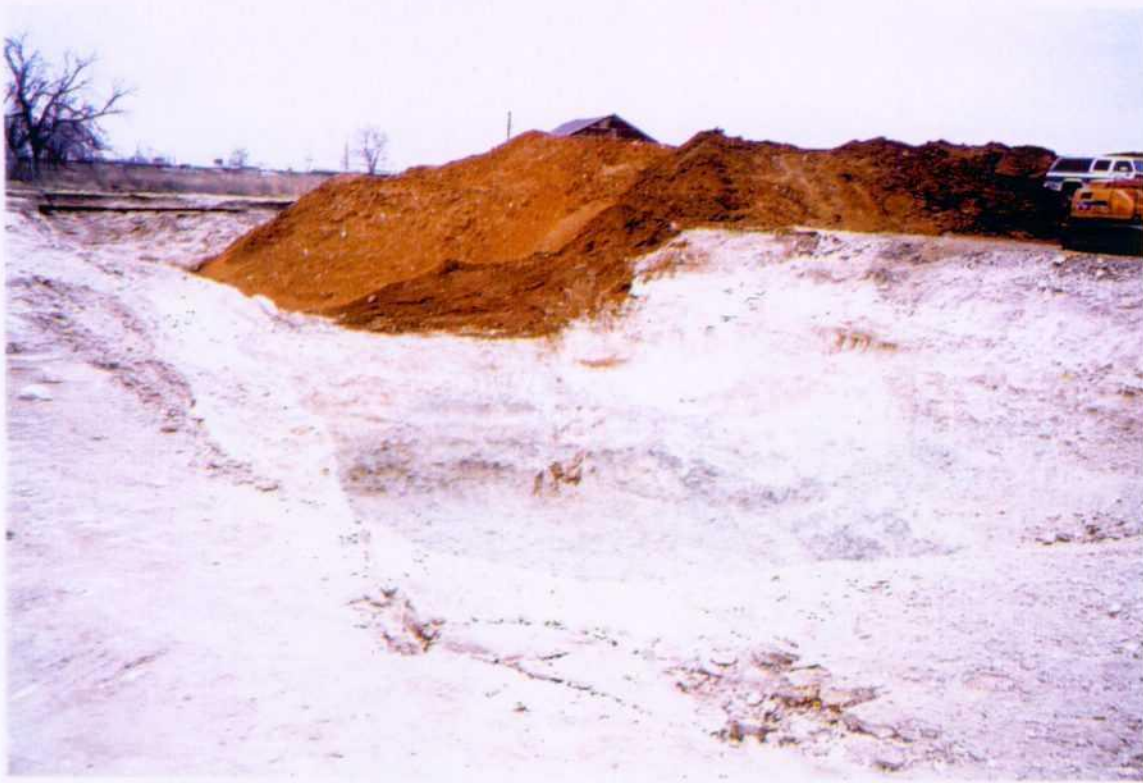
5. View to southwest of excavation immediately north of Hole #2.

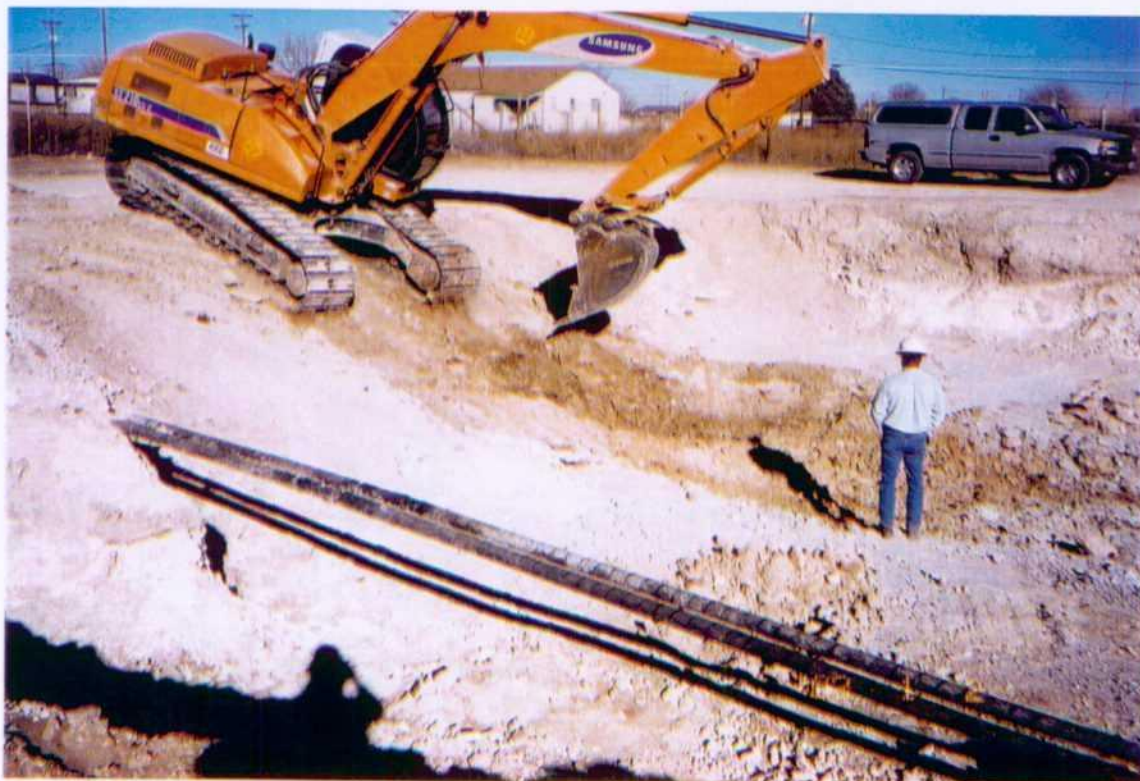
6. View to northeast of north end of excavation.

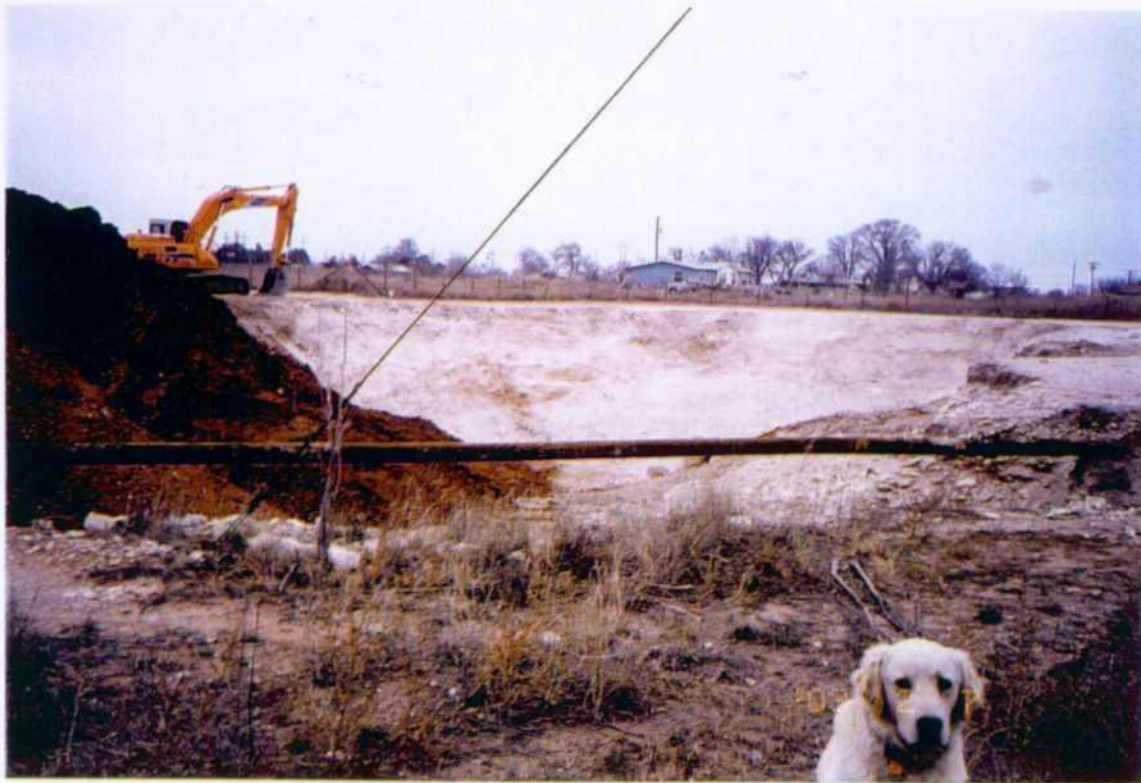
7. View to north of Hole #1 and Hole #2 extended to the north.

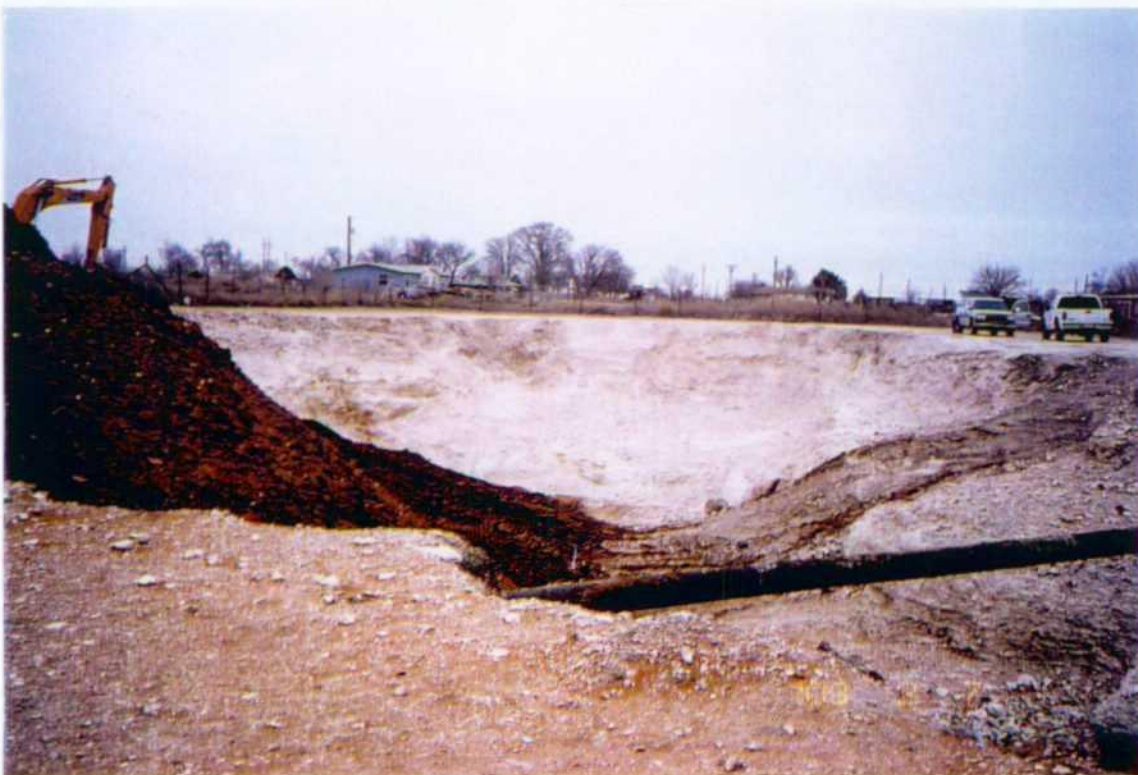
8. View to north of Hole #1 and Hole #2 extended to the north.
