**Chevron USA
Coleman/Grimes Site Investigation
Lea County, New Mexico**

August 27, 2001

**Chevron USA
P.O. Box 1949
Eunice, New Mexico 88231**

***Safety & Environmental Solutions, Inc.
703 E. Clinton, Suite 102
Hobbs, New Mexico 88240
(505) 397-0510***

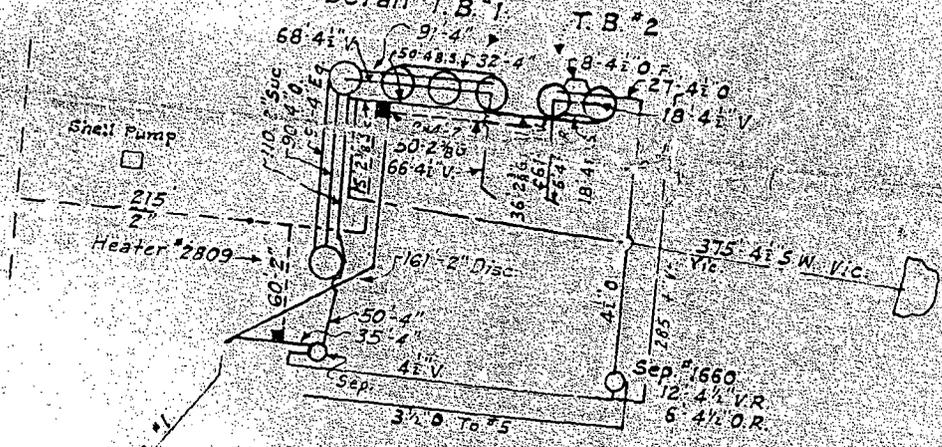
Figure 2.
Site Diagram 1948

Six storage tanks and associated vessels and piping were previously located on the subject area according to the facility site diagram dated 11-17-1848. (Figure 2) The aerial photograph taken for the City of Hobbs by Wilson & Company, Engineers on March 26, 1964, confirms this fact. (Figure 3) The aerial photograph date March 9, 1978 shows that all equipment had been removed from the subject site. (Figure 4) The equipment was removed from the subject site in the early 1970's according to the C-140 filed on December 17, 1971 and correspondence between Gulf Oil Company and Shell Pipeline Corporation in 1971 and 1972. (Appendix A)

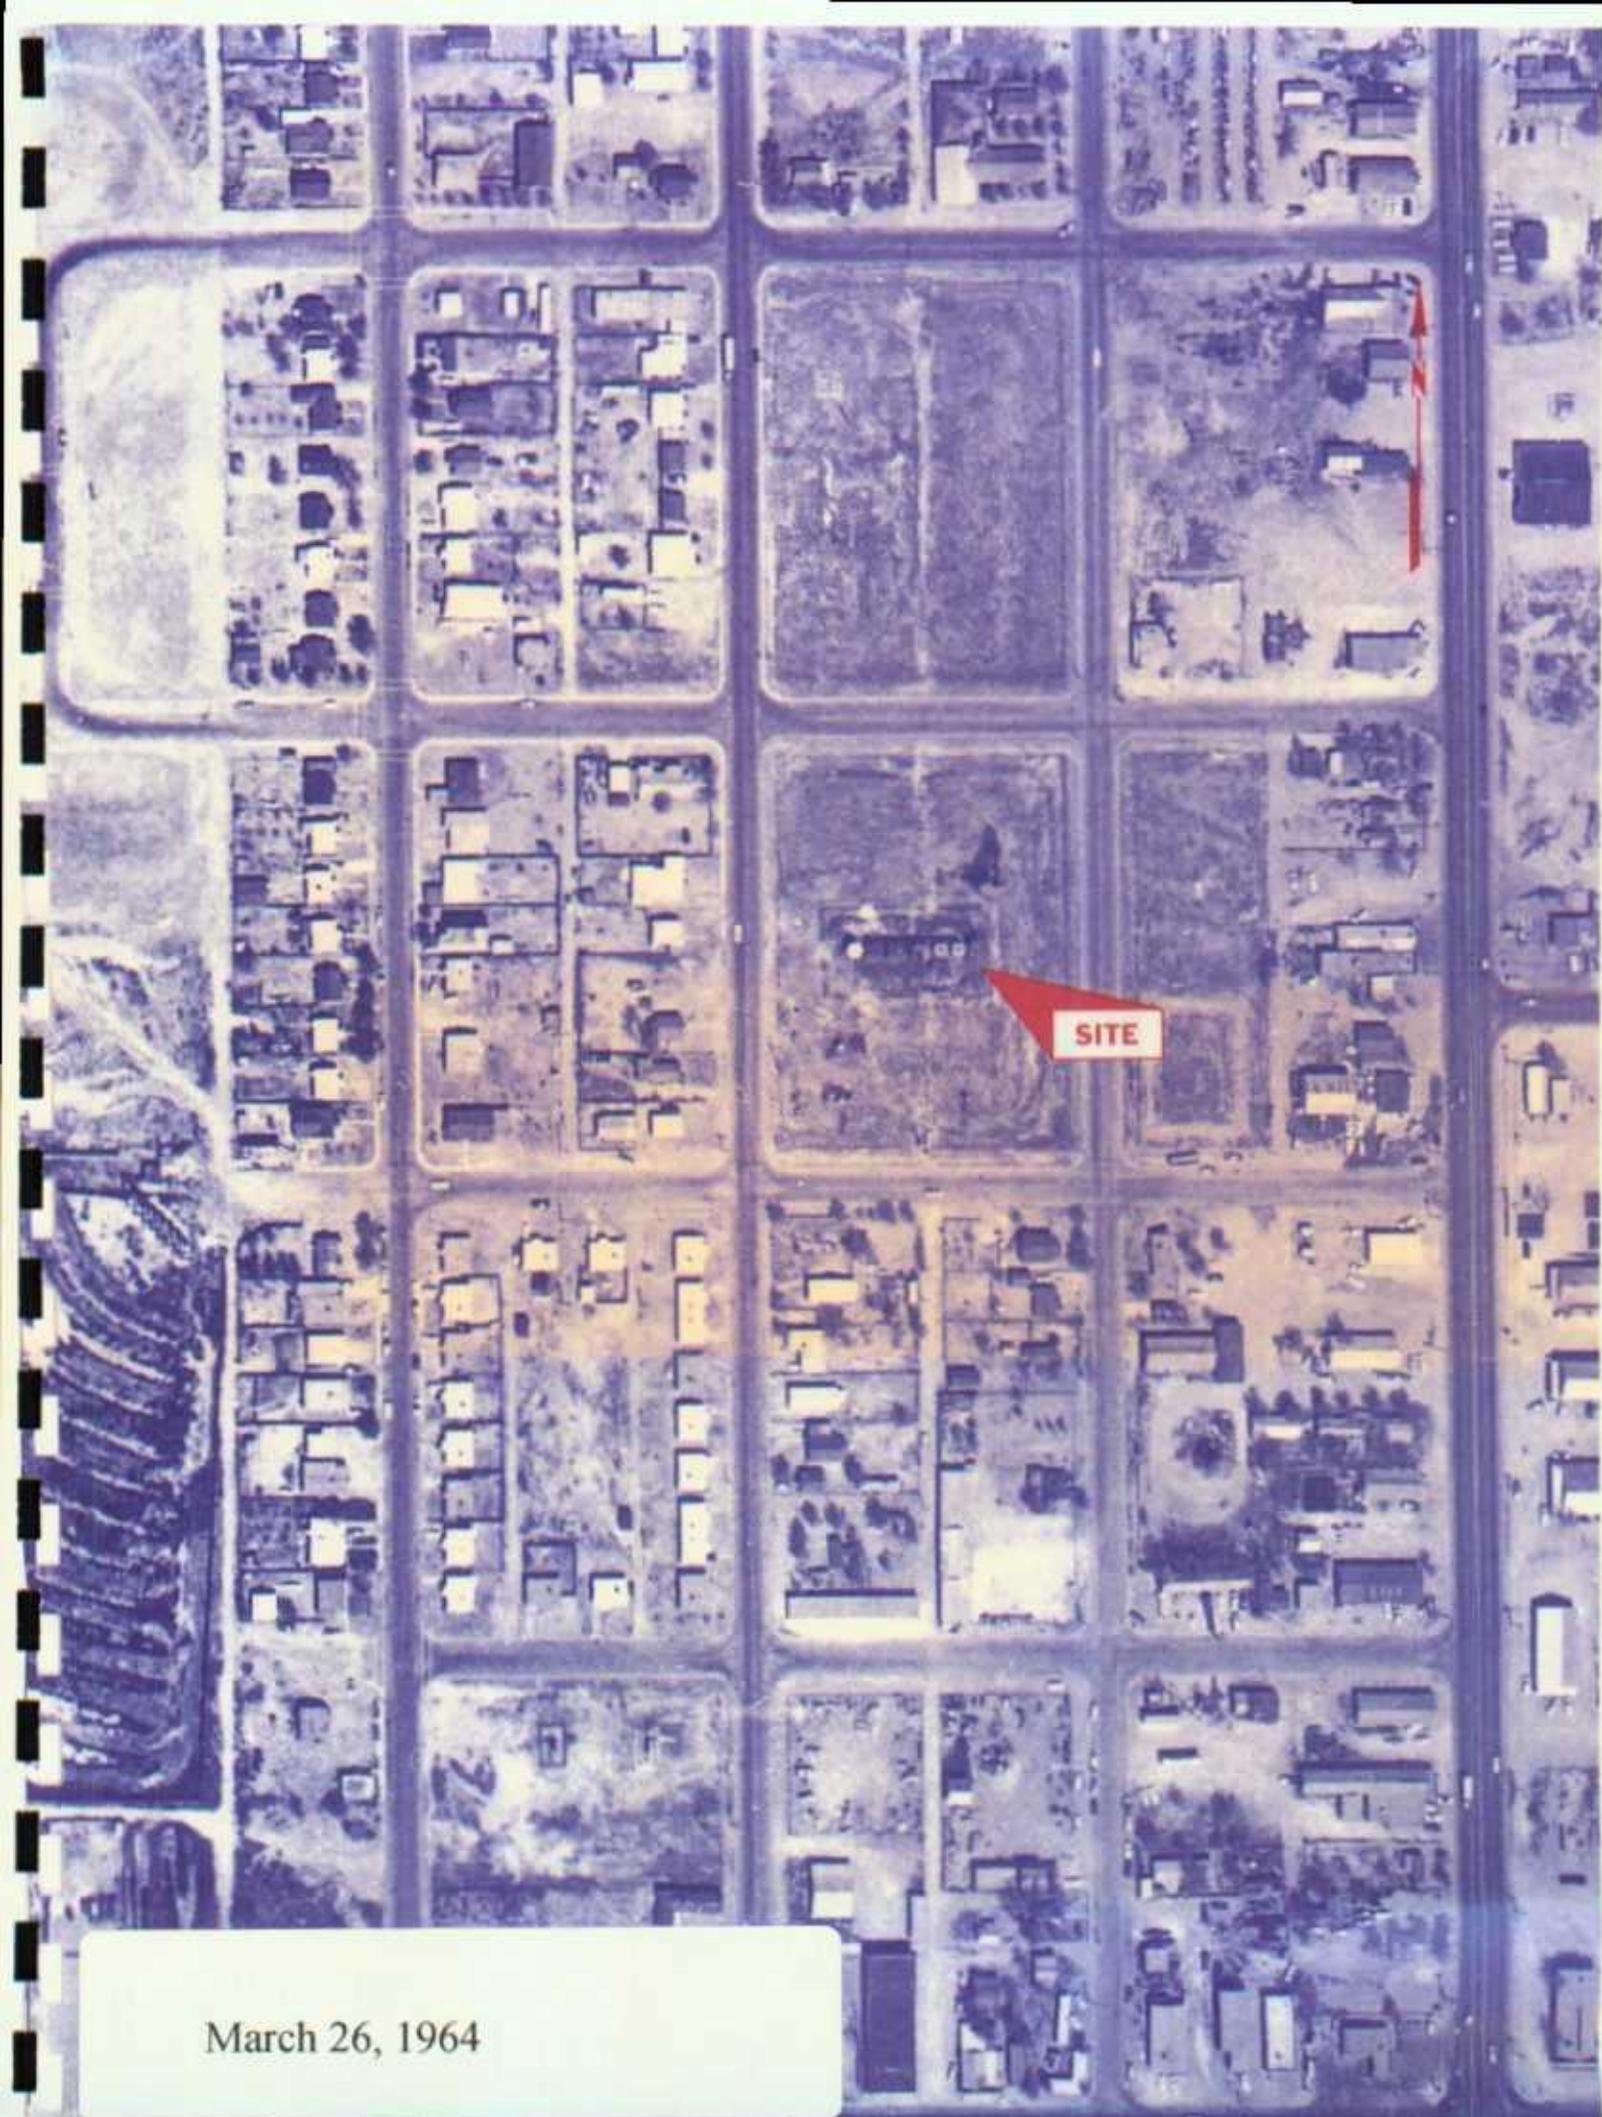
Figure 3.
Aerial Photo 1964

SITE

March 26, 1964

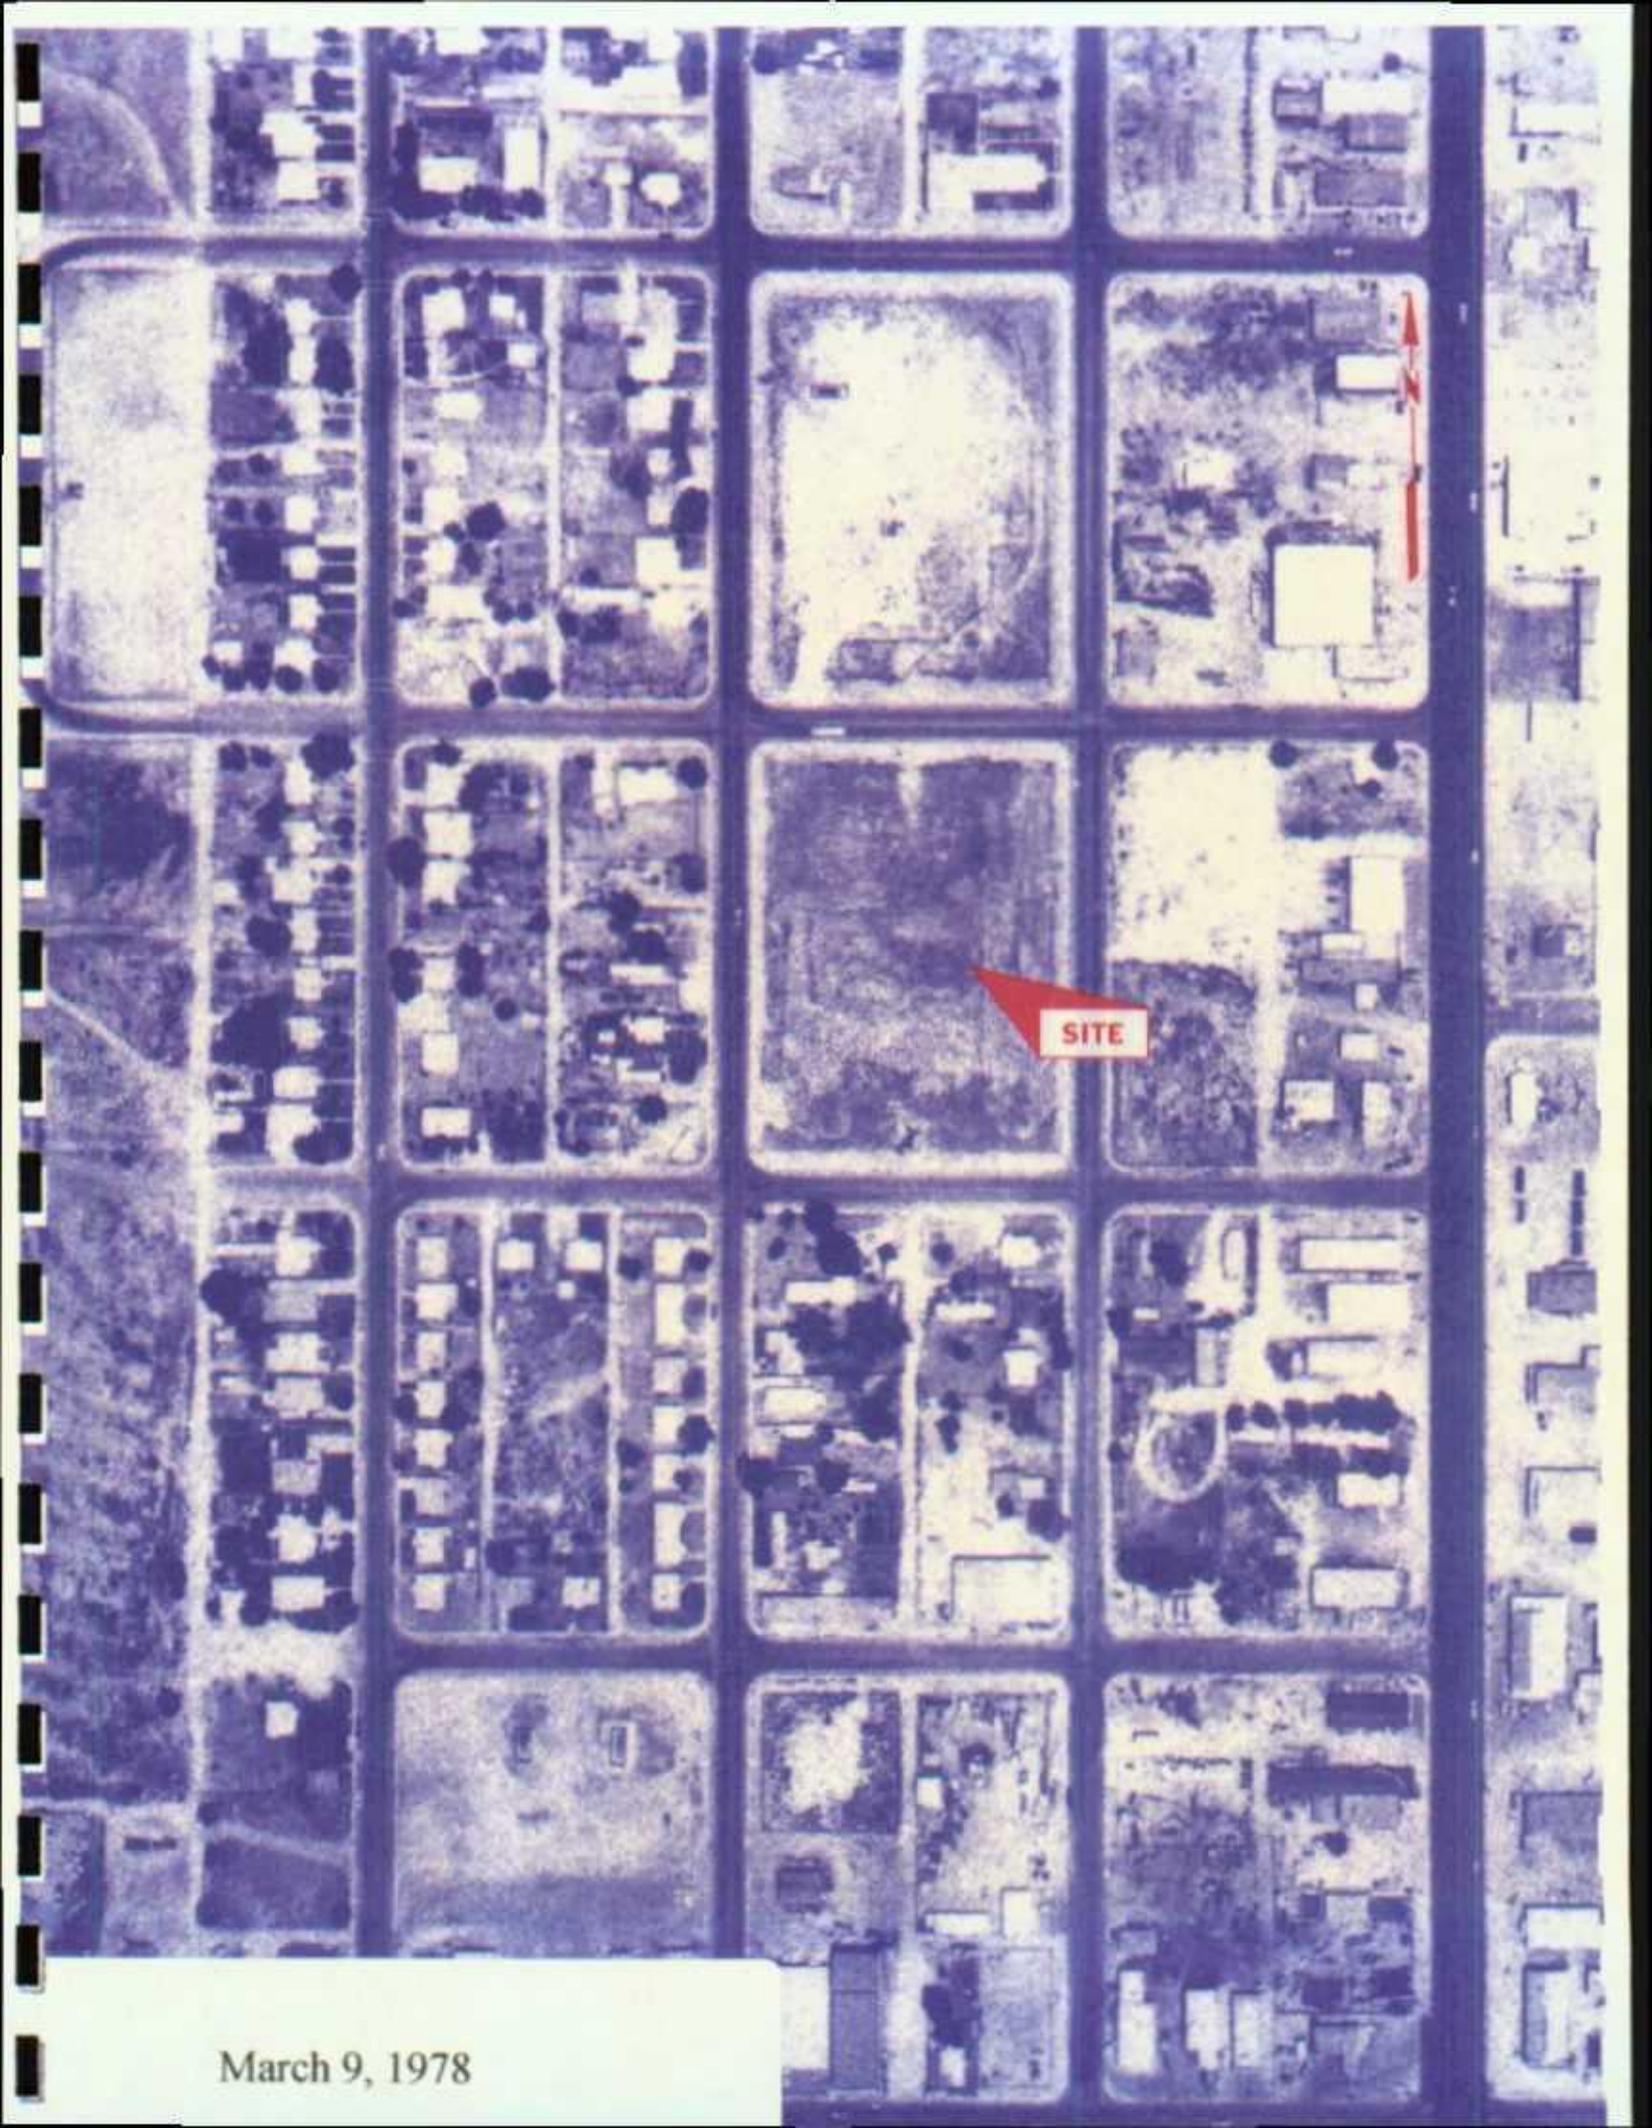
Figure 4
Aerial Photo 1978

SITE

March 9, 1978

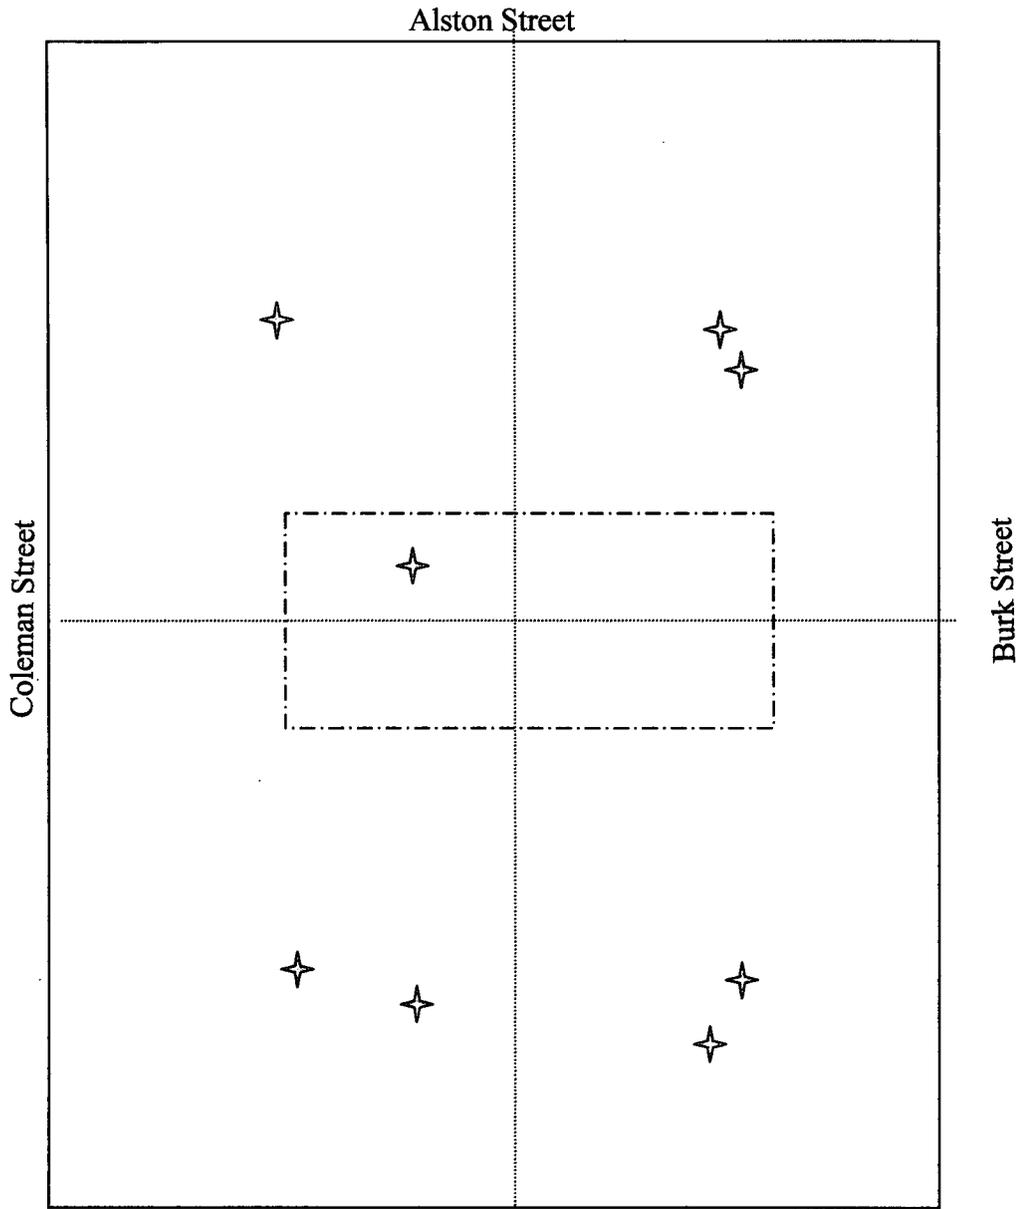
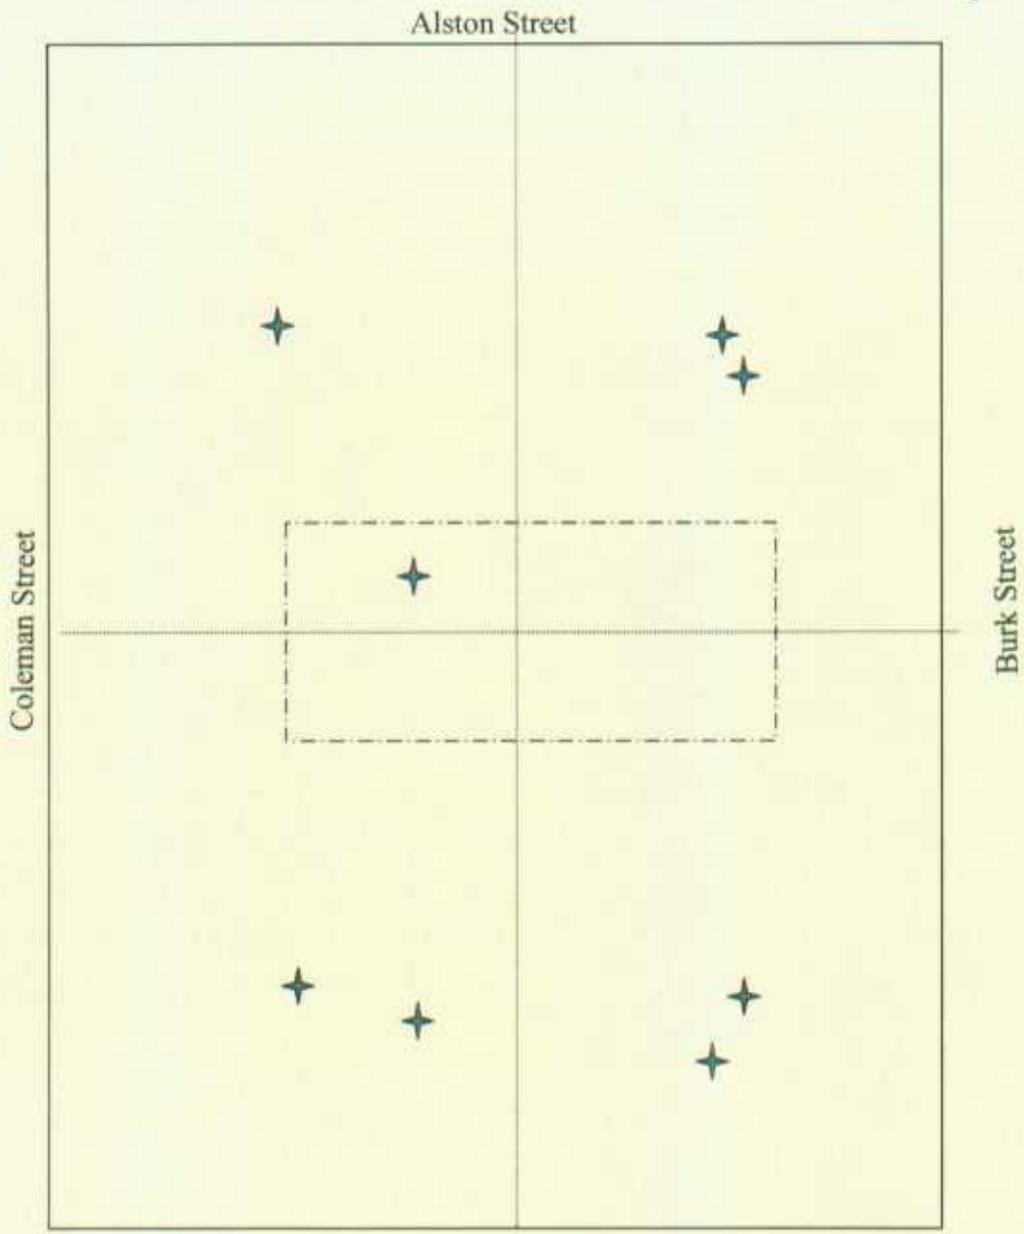
Figure 5.
Site Plan – Surface Samples

The NMOCD requested surface, 0"-6", soil samples be taken from the center of each quadrant of the site as well as surface soil samples from the most visually contaminated areas in each quadrant. The NMOCD requested the samples be analyzed for Total Petroleum Hydrocarbons (EPA Method SW 846 8015), BTEX (EPA Method SW-846-8260) and Total RCRA Metals. (Figure 5)

On August 2 and 3, 2001, the subject site, a full city block, was quartered and sampled using SOPs found in Environmental Protection Agency, 1984, Characterization of Hazardous Waste Site - A Methods Manual: Vol. II. per the NMOCD request. In addition, SESI personnel identified the most visually stained areas in each quadrant, which were also sampled. (Figure 5)

**Coleman Street
Site Plan
Surface Sample Locations**

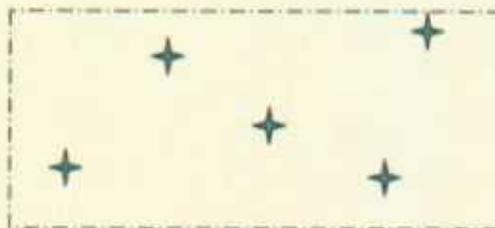
Figure 6.
Site Plan Borehole Location

Five (5) borehole locations were staked within the perimeter of the old battery site. (Figure 6)

✦ Test Hole Locations

**Coleman Street
Site Plan
Borehole Locations**
