1R - 396

Re: Emergency Pit Excavation and Closure Report, Texaco Exploration and Production Inc., V.M. Henderson Tank Battery, Unit Letter H, (SE/4, NE/4), Section 30, Township 21 South, Range 37 East, Lea County, New Mexico

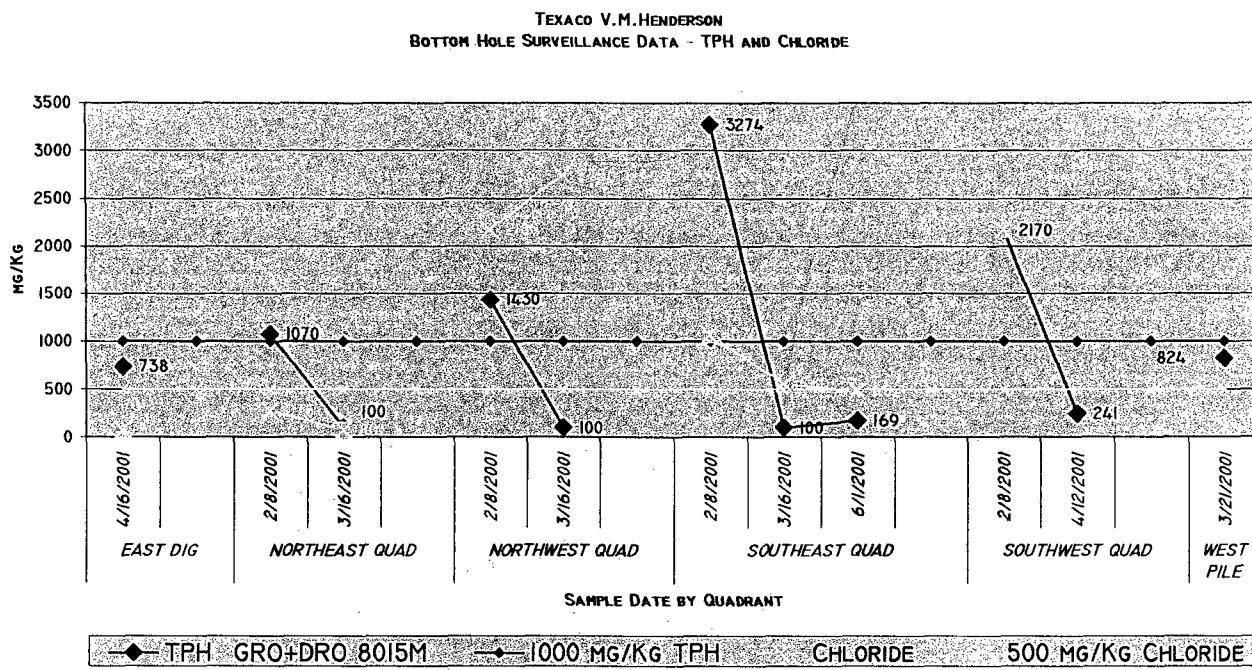
The site was divided into the NE, NW, SE, and SW quadrants to ensure that the composite bottom hole samples were representative and collected within reasonably sized and definable boundaries. During the course of the remediation, composite samples were collected at successive excavation depths to determine achievement of the remedial goals. These data are summarized on the chart below.

Note that for each quadrant, the most recent bottom hole TPH sample results are <1000 mg/Kg and are thus within acceptable limits. The Chloride values obtained at the current excavation bottom hole interval in the Northwest and Southwest quadrants indicate elevated levels.

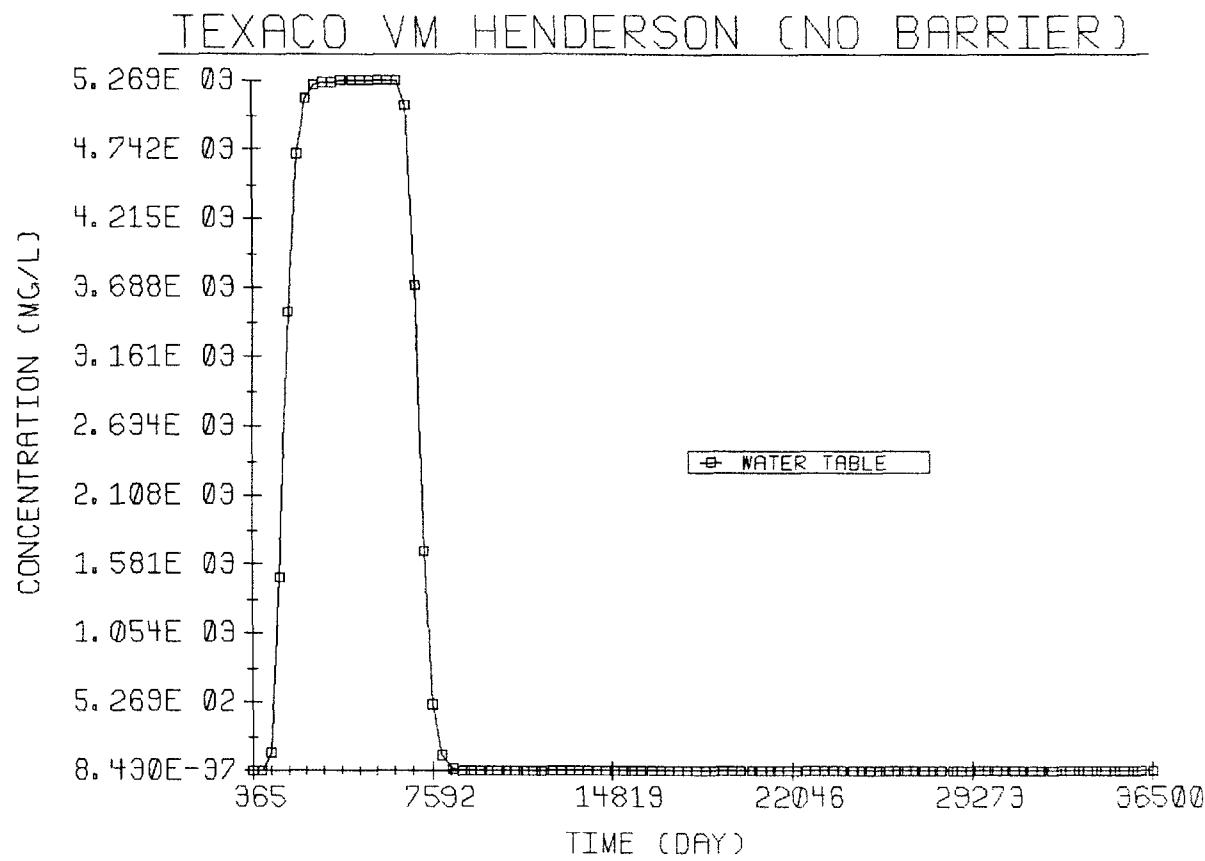
3.4.1 Simulation w/o impermeable barrier

This simulation indicates that the residual chloride will impact ground water in approximately 7 years at an unacceptable level of 5,269 mg/L Chloride.

Clearly, installation of an impermeable barrier will prevent future contamination of the ground water resource at the site. Also, the natural topography of the site dips to the south and will not allow retention of sufficient quantities of water to promote infiltration and may be reason to reduce the inputted infiltration rate.

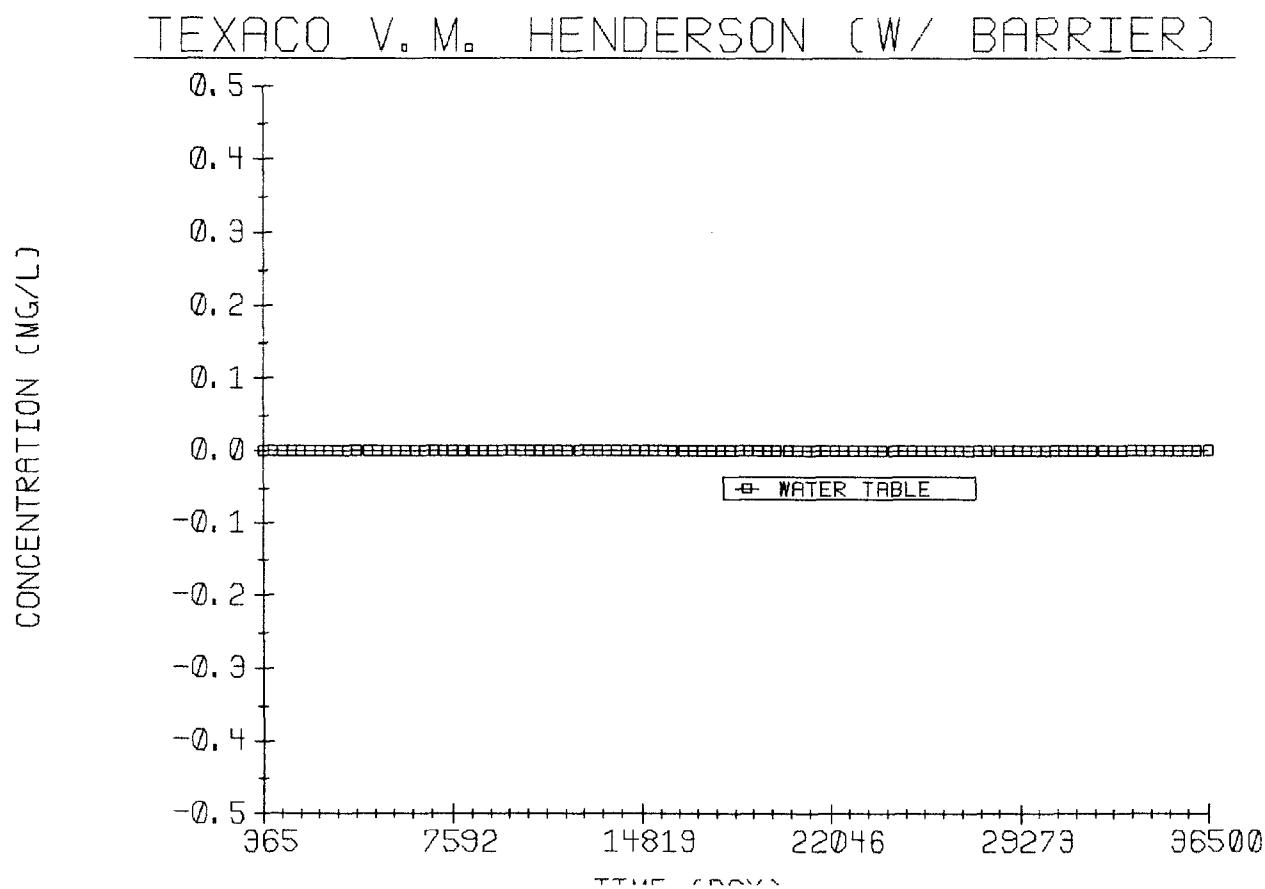
3.4.2 Simulation with impermeable barrier

The installation of an impermeable barrier will interrupt the chloride transport sufficiently enough to eliminate future ground water impact.

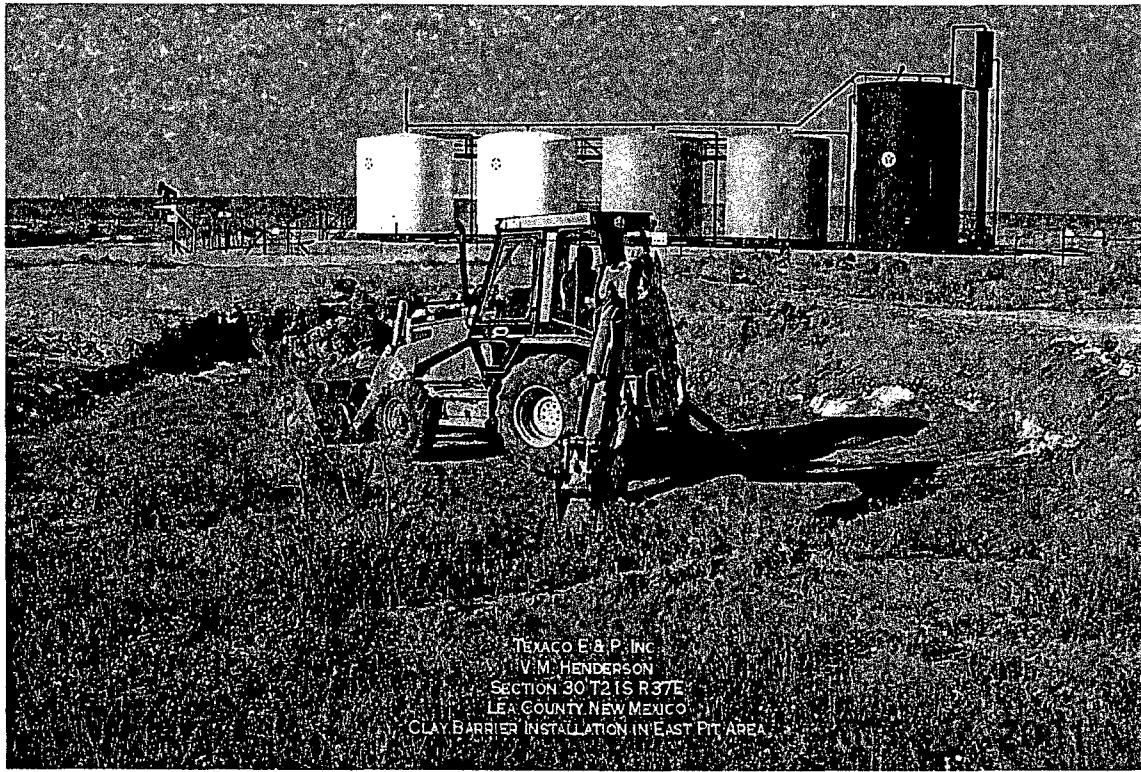
TEXACO E&P INC
V.M. HENDERSON
SECTION 30 T21S R37E
LEA COUNTY, NEW MEXICO
CLAY BARRIER INSTALLATION IN EAST PIT AREA
