# **SITE CHARACTERIZATION AND SOIL CLOSURE PROPOSAL**

**LIVINGSTON RIDGE TO HUGH – P. SIMS  
PLAINS REF: 2001-11005  
(COMPANY # 231735)**

**UL-J (NW¼ OF THE SE¼) OF SECTION 3, T21S, R37E**

**JUNE 2006**

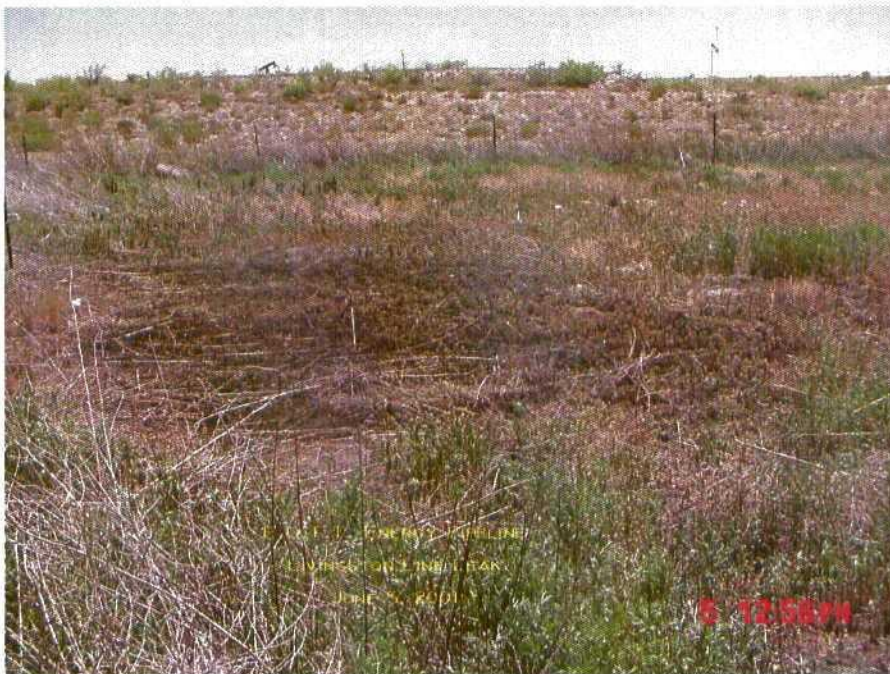
**Photograph #1 – Looking northerly at initial release area.**

**Describe Cause of Problem and Remedial Action Taken.\*** Internal corrosion of 4-inch steel pipeline. Release area comprised approximately 1,214-ft<sup>2</sup> (~20'x50'). Crude oil saturated soil was excavated and stockpiled until a remediation plan was developed.

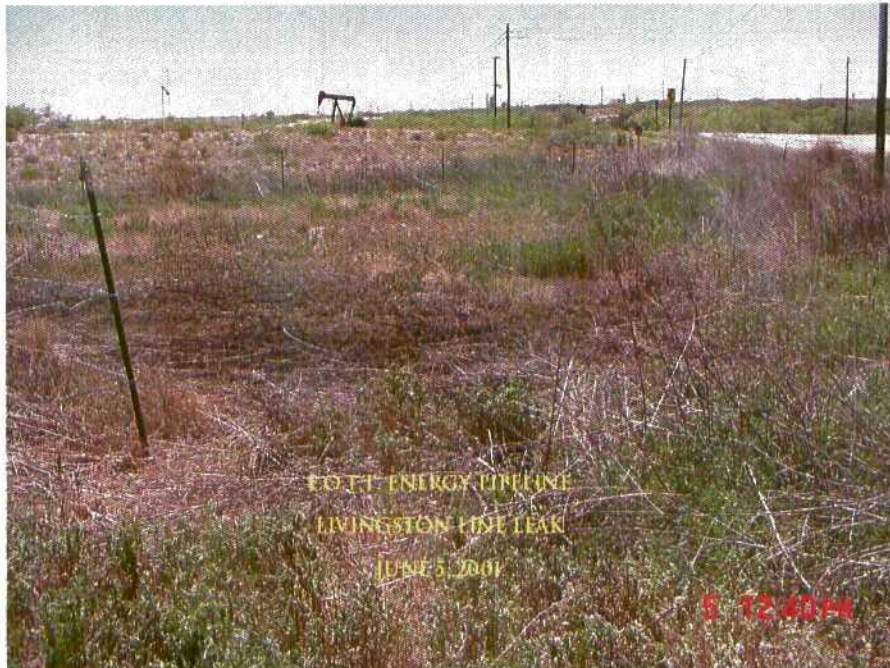
**Photograph #2 – Looking westerly at initial release area.**

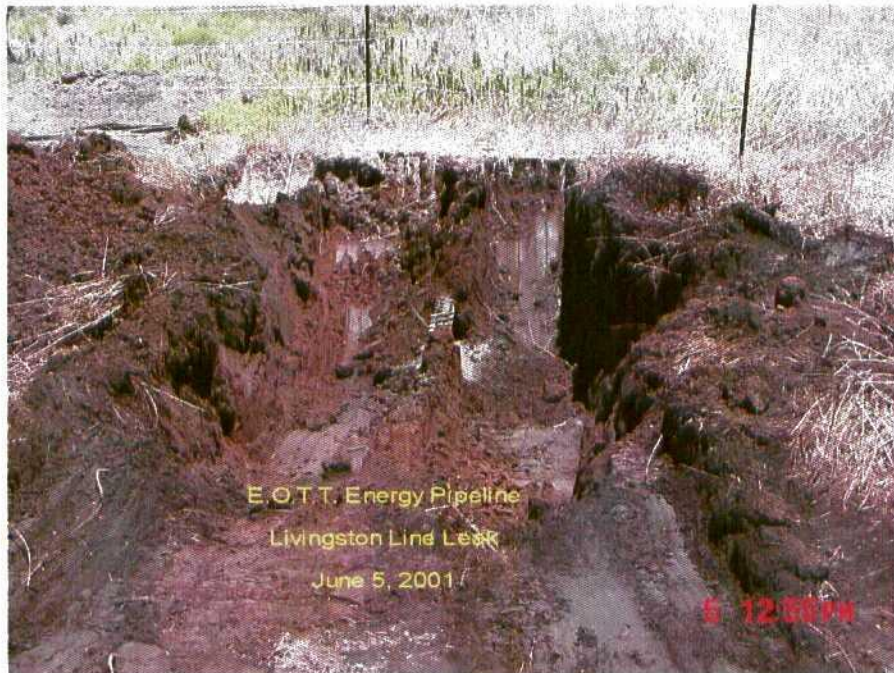
**Photograph #3 – Looking westerly at initial excavation.**

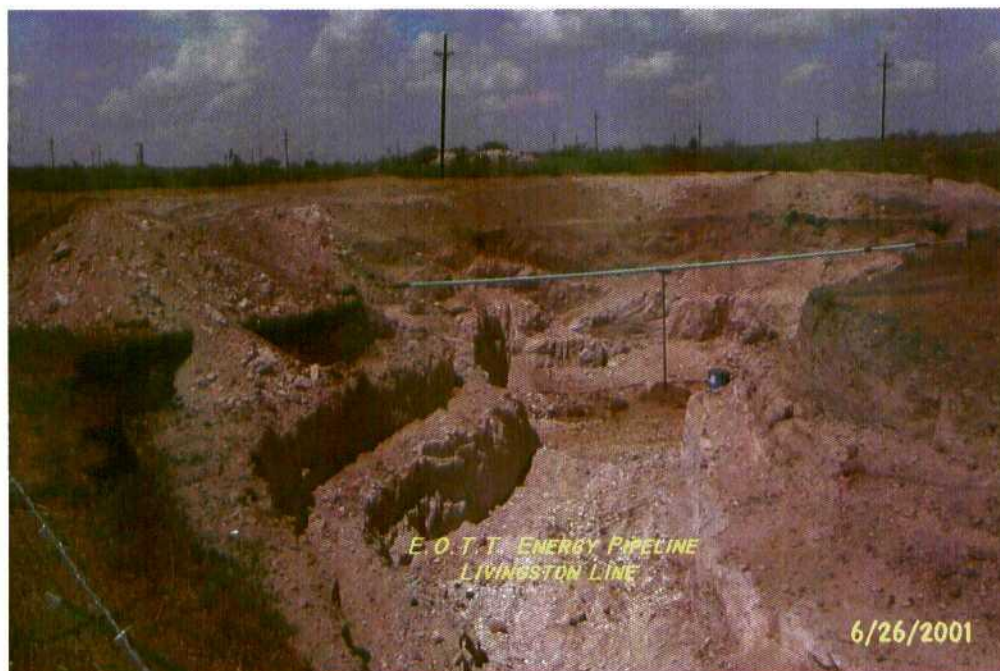
**Photograph #3 – Looking northerly at excavation.**
