# DISCLOSURE REPORT

**RICE OPERATING COMPANY  
JUNCTION BOX DISCLOSURE\* REPORT**

## BD O-17-1 Vent

March – August 2003

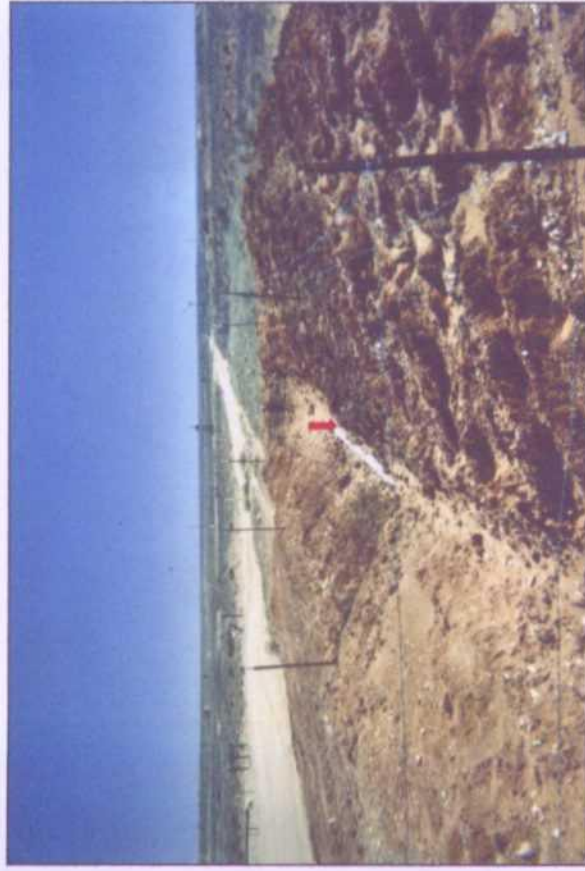
Looking East: Site of Old Vent (red arrow) After Line Replacement and Box Removed

General Description of Remedial Action: This junction box once contained a vent but the junction has been eliminated and the site re-plumbed straight through with new poly pipeline. The 30 x 18 x 12 ft deep excavation yielded TPH impact to at least 12 ft deep. Vertically, the 8 ft and 12 ft samples were field-tested for chlorides, yielding 1000 and 400 ppm respectively. However, there was not a lateral decline in chloride concentrations on the excavation walls. The color change in the titration of the chloride test was difficult to detect due to the TPH concentration and the color of the soil sample, which may account for the discrepancy with the lab results. The excavation has been backfilled and the location identified for further consideration at a later date.

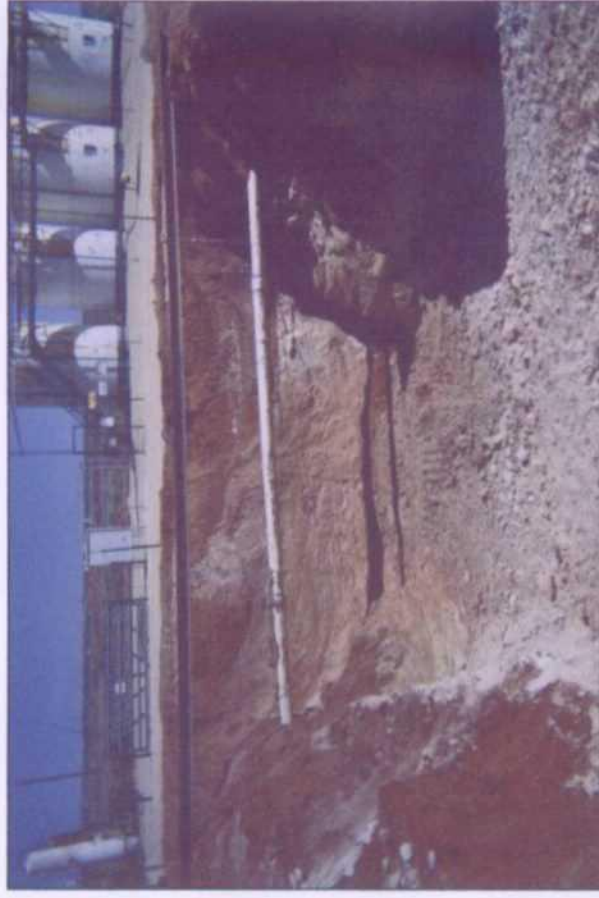
Looking North: Final Excavation 30 x 18 x 12 ft deep

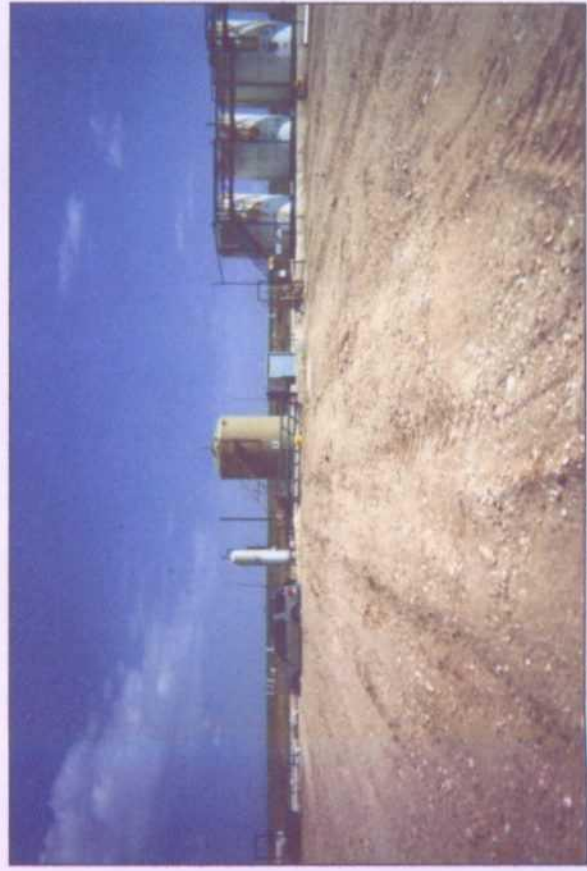
Looking North: Backfilled (battery is across the road.)
