# DISCLOSURE REPORT

**RICE OPERATING COMPANY  
JUNCTION BOX DISCLOSURE\* REPORT**

# BD Matern 5 EOL

## BD Mattern 5 EOL

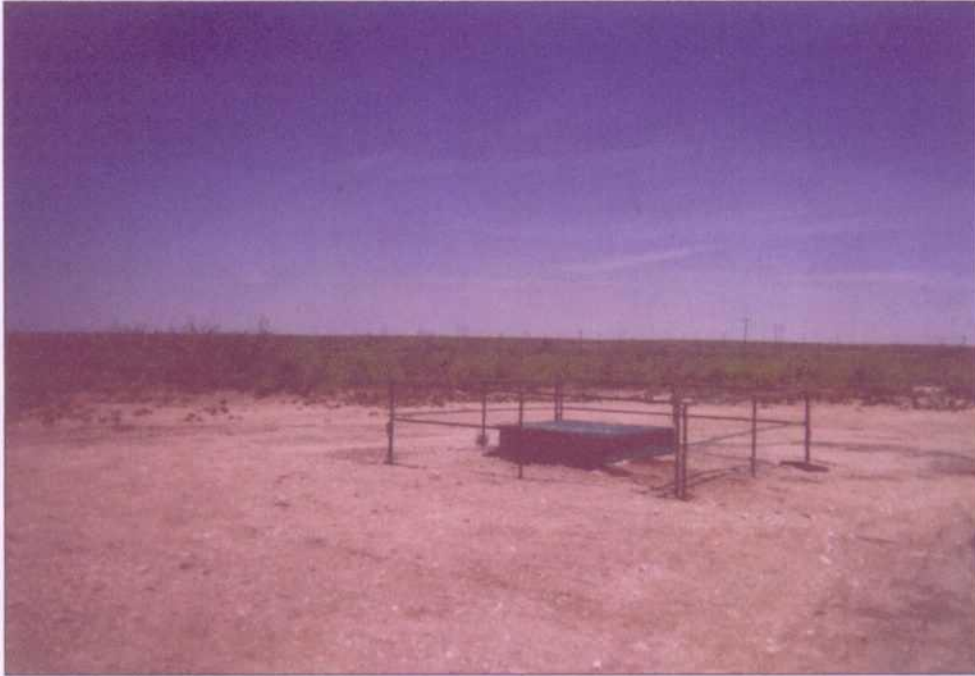
6/6/2003 Old Jct. Box Before NORM Removal

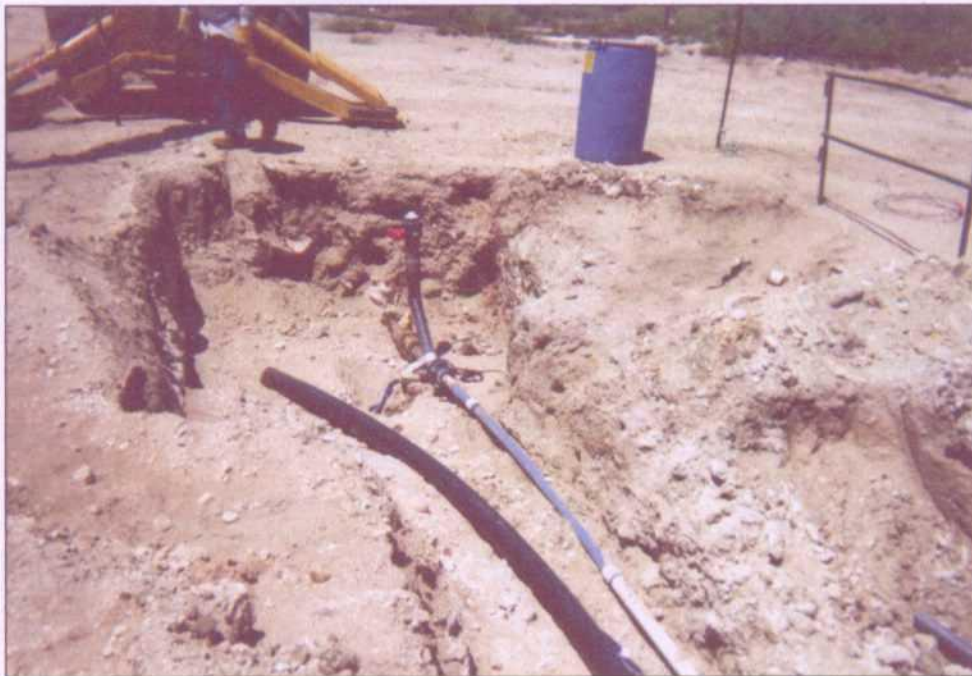
After NORM Removal; Before Impact Delineation & Excavation

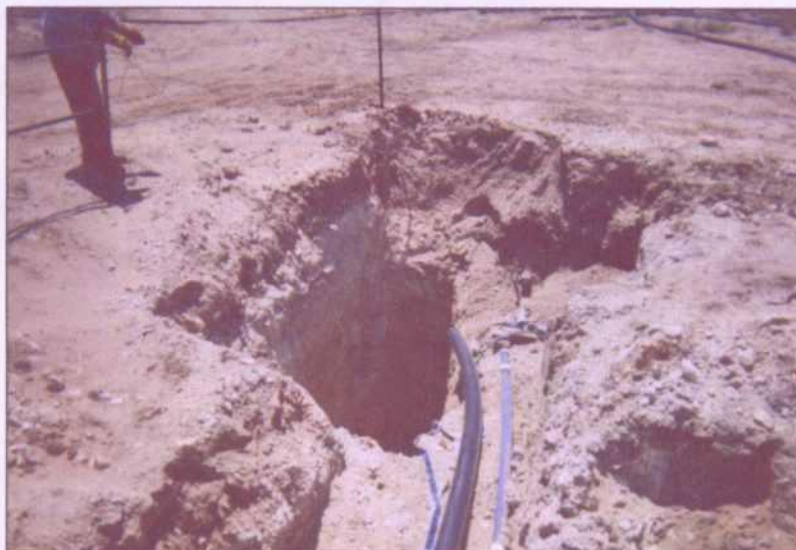
General Description of Remedial Action: During vertical delineation, it was

apparent that neither chloride nor TPH concentrations declined sufficiently with depth.

Although there was no evidence of surface impact, NMOCD TPH guidelines were not met.

7/14/2003 Vertical Delineation at Old Jct.

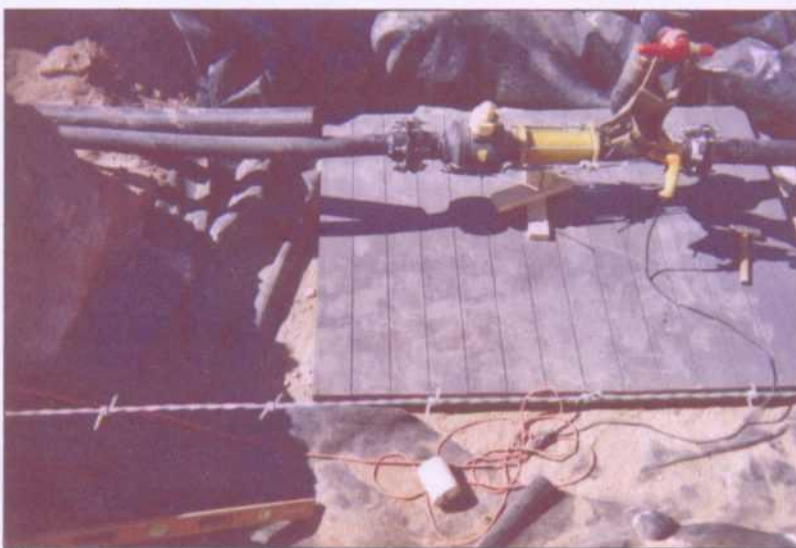
Floor Construction of New Plastic Box with Poly Liner (130 ft East)

A new watertight junction box has been built 130 ft east of this site.

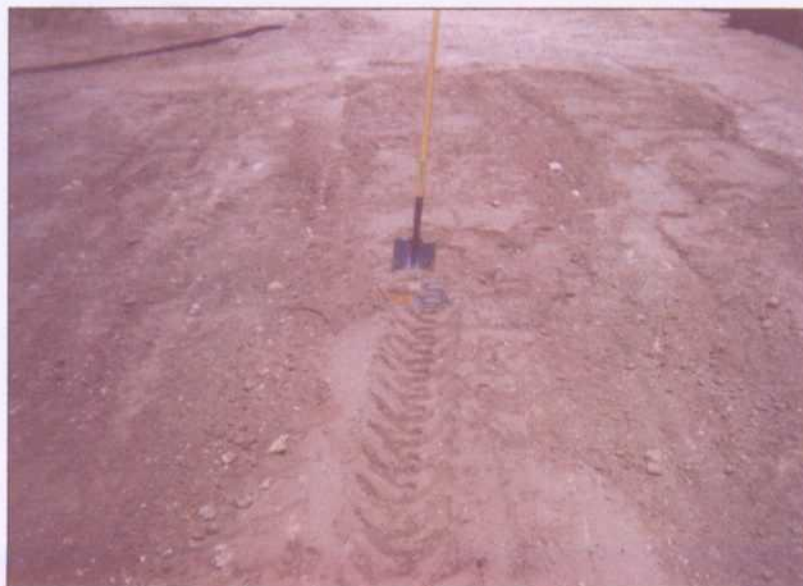
Old Jct. Site: Backfilled with ID Plate

The hole was backfilled and the location identified for further consideration at a later date.
