EME I-12

**FINAL  
REPORT**

**RICE OPERATING COMPANY  
JUNCTION BOX FINAL REPORT**

T21S, R35E

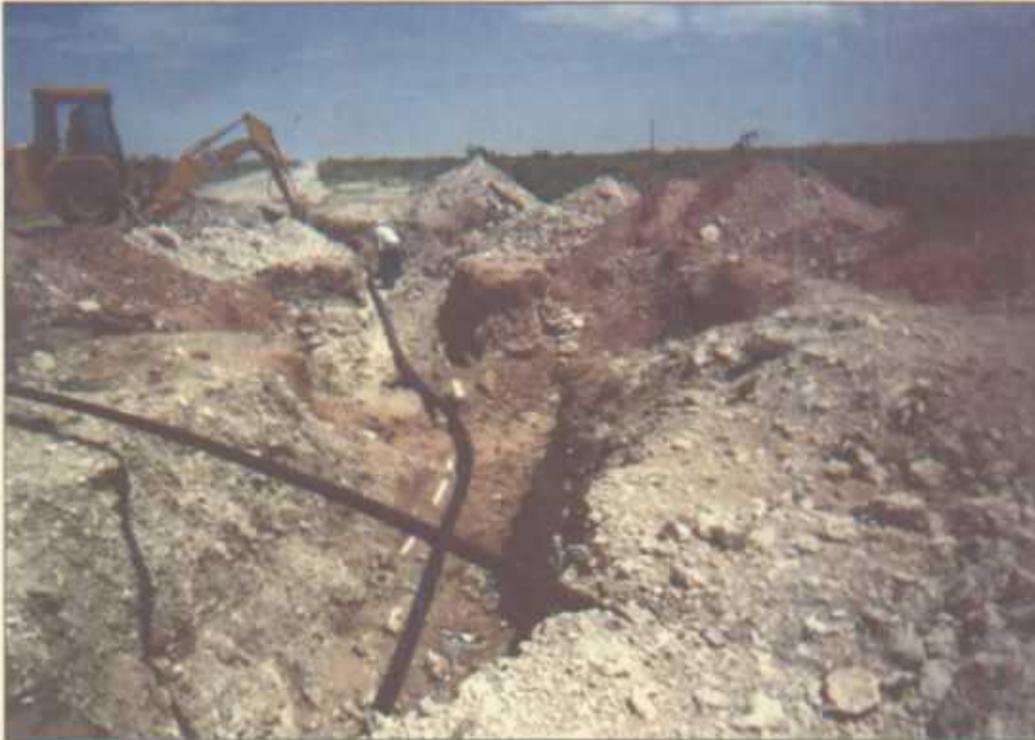
Old junction site in foreground; new junction 30 ft north in background (backhoe) 8/5/2003

General Description of Remedial Action: Vertical delineation with a backhoe at the old junction box site did not yield a sufficient decline in chloride concentrations. PID readings indicated minimal VOC's. The site was drilled and delineated for chloride impact. The bores indicated a conclusive decline in chloride concentrations well before groundwater was encountered (see graphs). A compacted clay barrier was installed at 6 ft bgs and the hole was backfilled with the excavated soil that was landfarmed on-site. The surface was leveled and contoured to the surrounding terrain. On 12/12/2003, the site was re-seeded with a seed blend of native vegetation and will be monitored for growth. This junction has been moved 30 ft north and a water-tight box has been built over it.

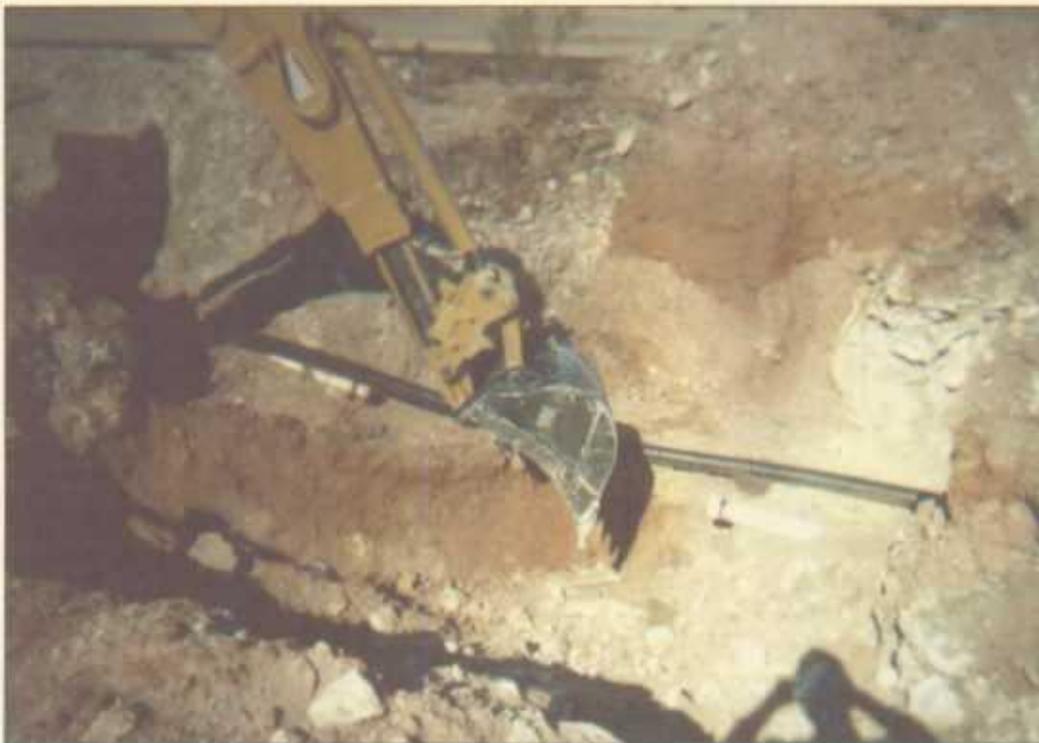
Beginning excavation & delineation at old junction box site 8/14/2003

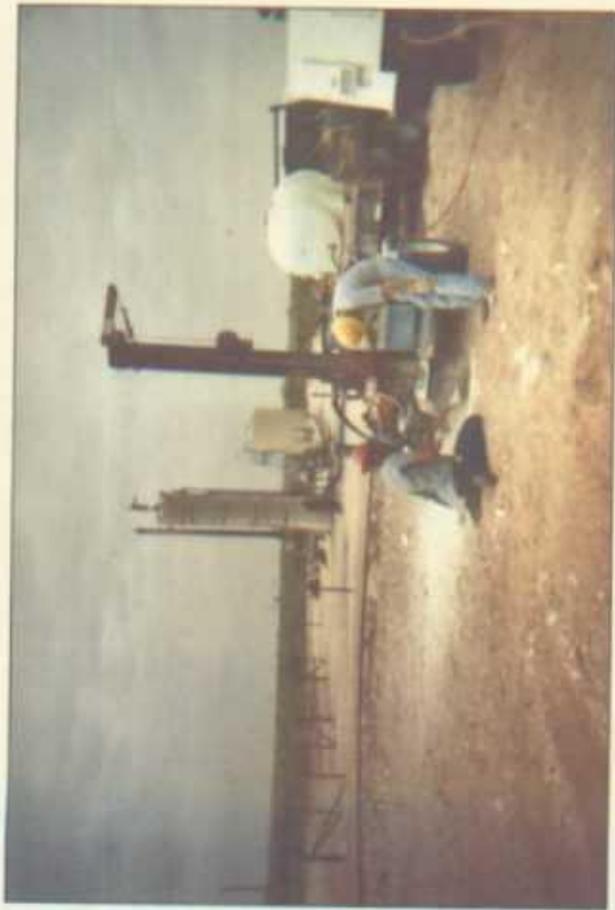
Soil bore for chloride delineation 9/18/2003

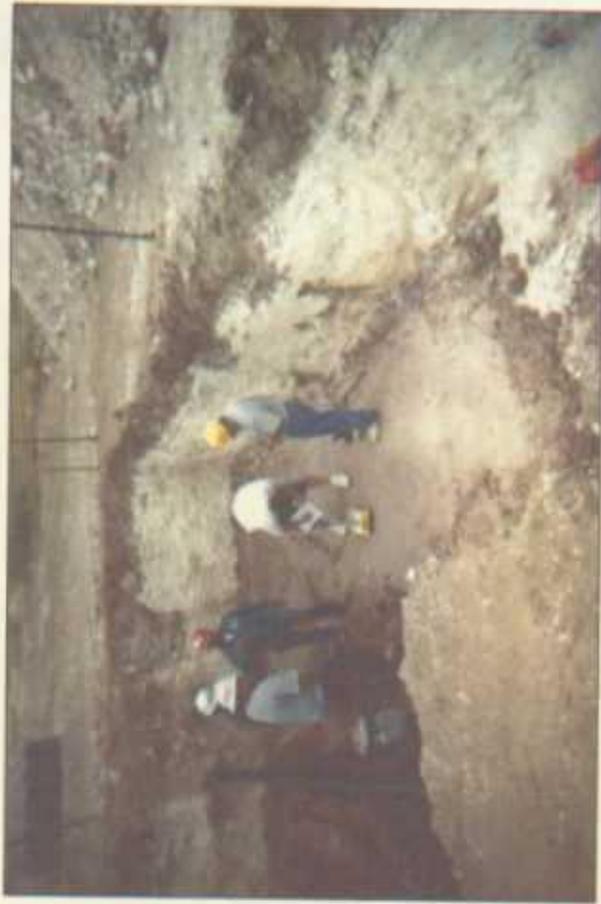
Compaction & density test of clay barrier at 6 ft 10/2/2003

Test No.	Location	Dry Density % Maximum	% Moisture	Depth
SG-1	Pit - 10' N. & 5' W. of the SE Corner	103.0	18.4

Control Density: 104.2  
ASTM: D 698

Required Compaction: 95%

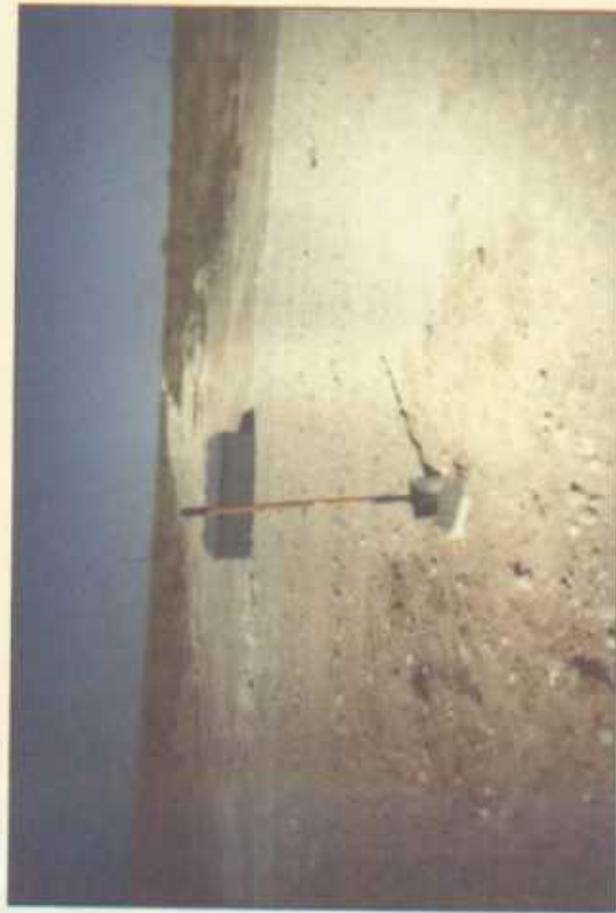
Identification plate marking clay barrier

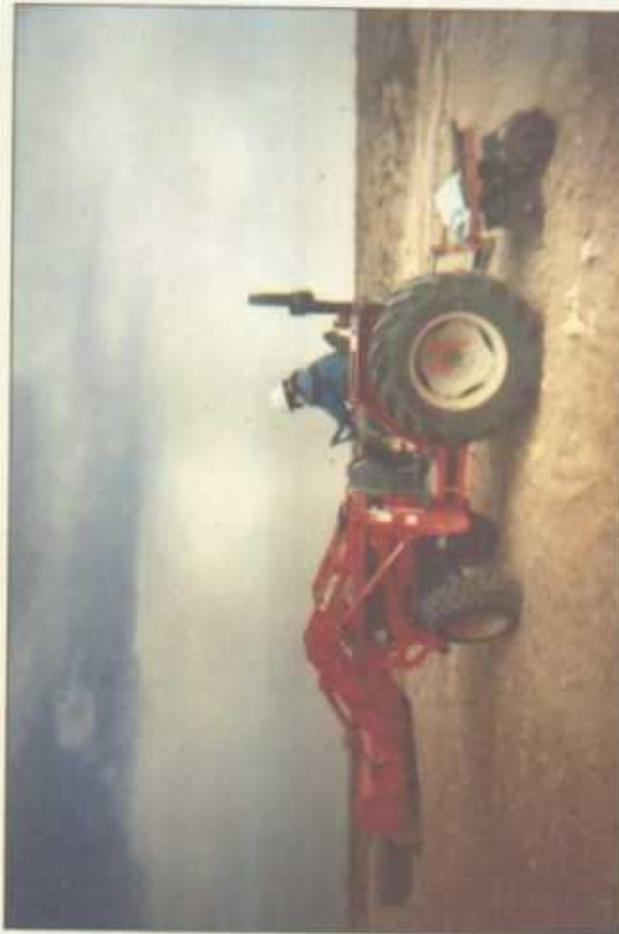
Seeding disturbed surface 12/12/2003

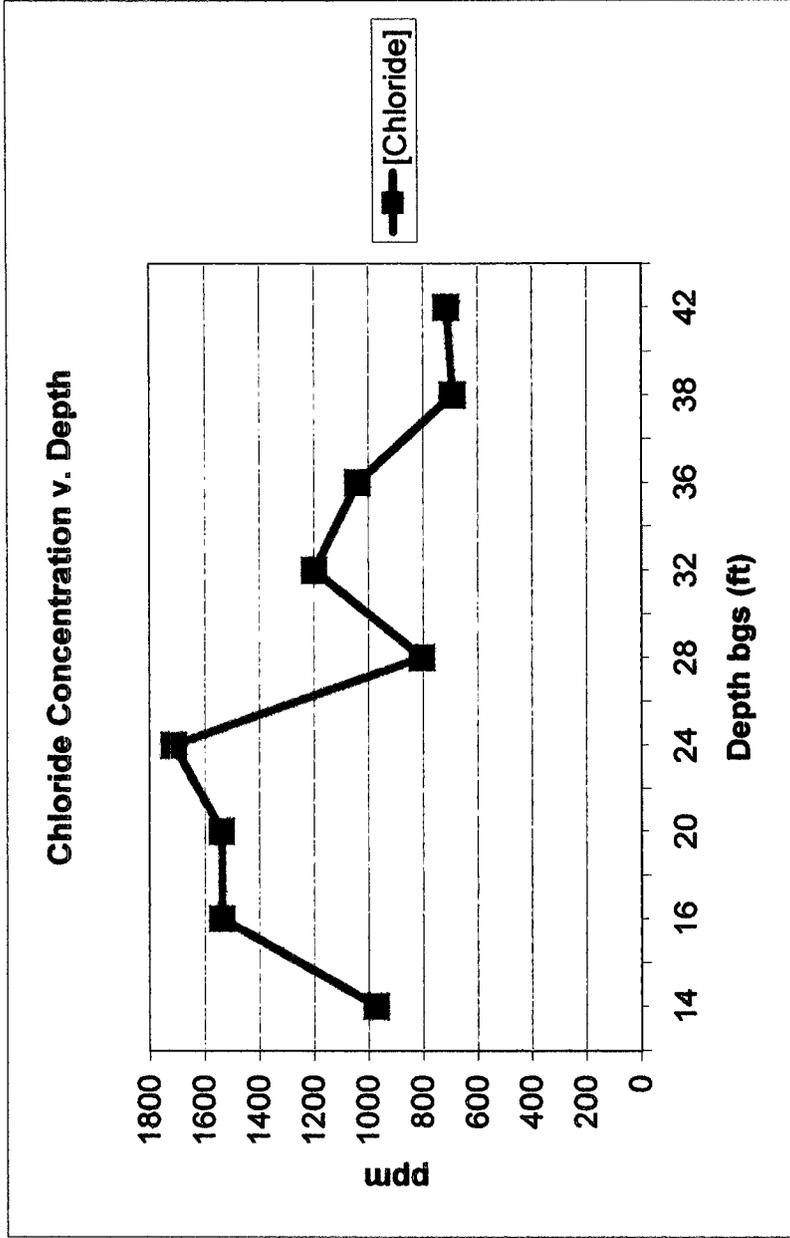
10 ft East of Junction

Depth bgs (ft)	[Cl <sup>-</sup> ] ppm
14	972
16	1536
20	1538
24	1713
28	803
32	1199
36	1039
38	691
42	713

Groundwater = 133 ft

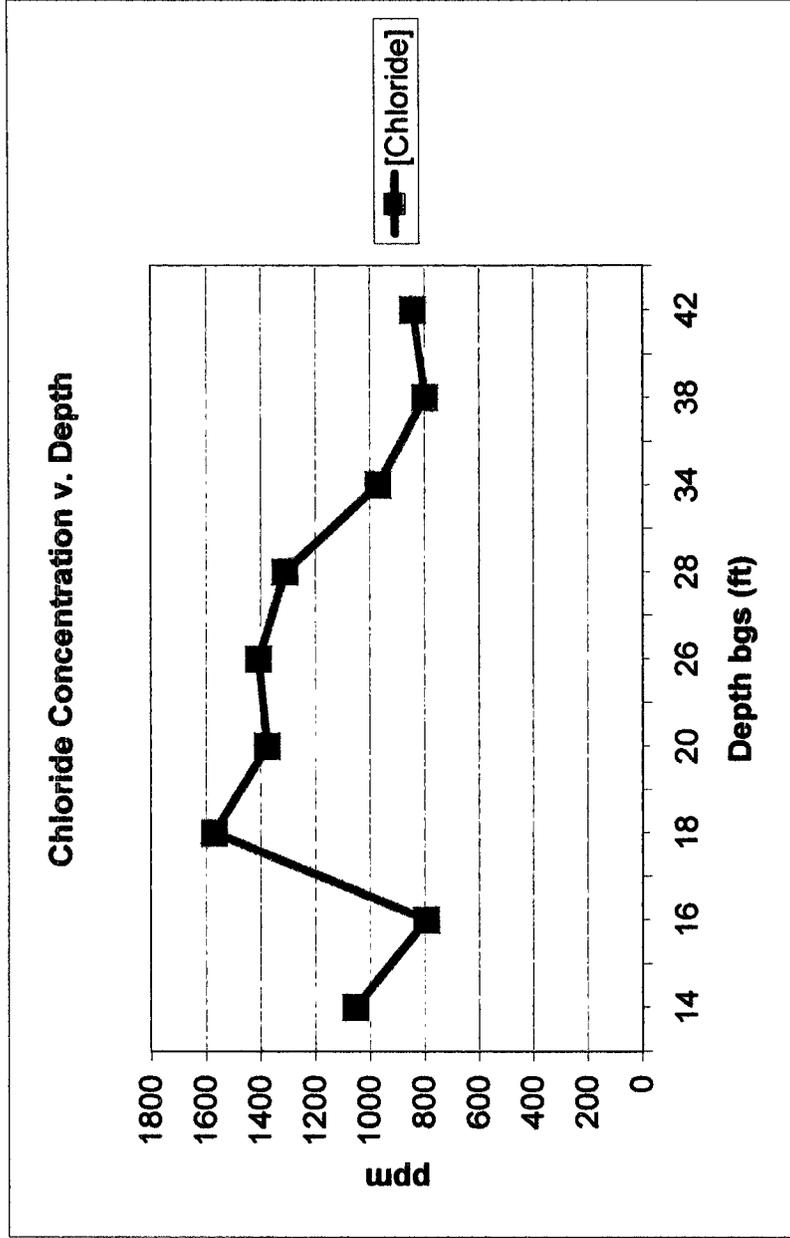
14 ft South of Junction

Depth bgs (ft)	[Cl <sup>-</sup> ] ppm
14	1053
16	793
18	1569
20	1376
26	1407
28	1309
34	969
38	797
42	842

Groundwater = 133 ft

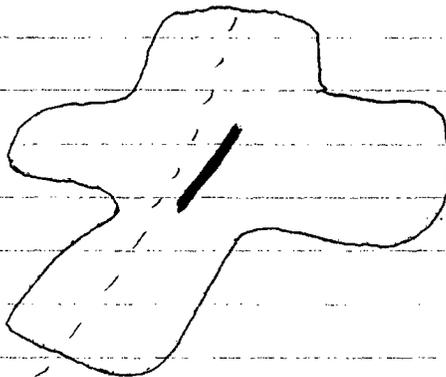
7'	651 ppm	Red clay
8'	862 ppm	Red clay Grey Sand
9'	908 ppm	Grey Sand
10'	1192 ppm	Grey Sand
11'	858 ppm	Grey Sand
12'	1194 ppm	Grey Sand
13'	1191 ppm	Grey Sand
14'	879 ppm	PID 43.4 Grey Sand

← New Jet Box

4" poly line →

30'

Vertical dig 14'  
~~center~~ center  
point
