**RICE OPERATING COMPANY  
JUNCTION BOX FINAL REPORT**

**BOX LOCATION**

| SWD SYSTEM | JUNCTION | UNIT | SECTION | TOWNSHIP | RANGE | COUNTY | BOX DIMENSIONS - FEET | | |
|---|---|---|---|---|---|---|---|---|---|
| EME | L-19-2 | L | 19 | 20S | 37E | LEA | Length<br>12 | Width<br>10 | Depth<br>5 |

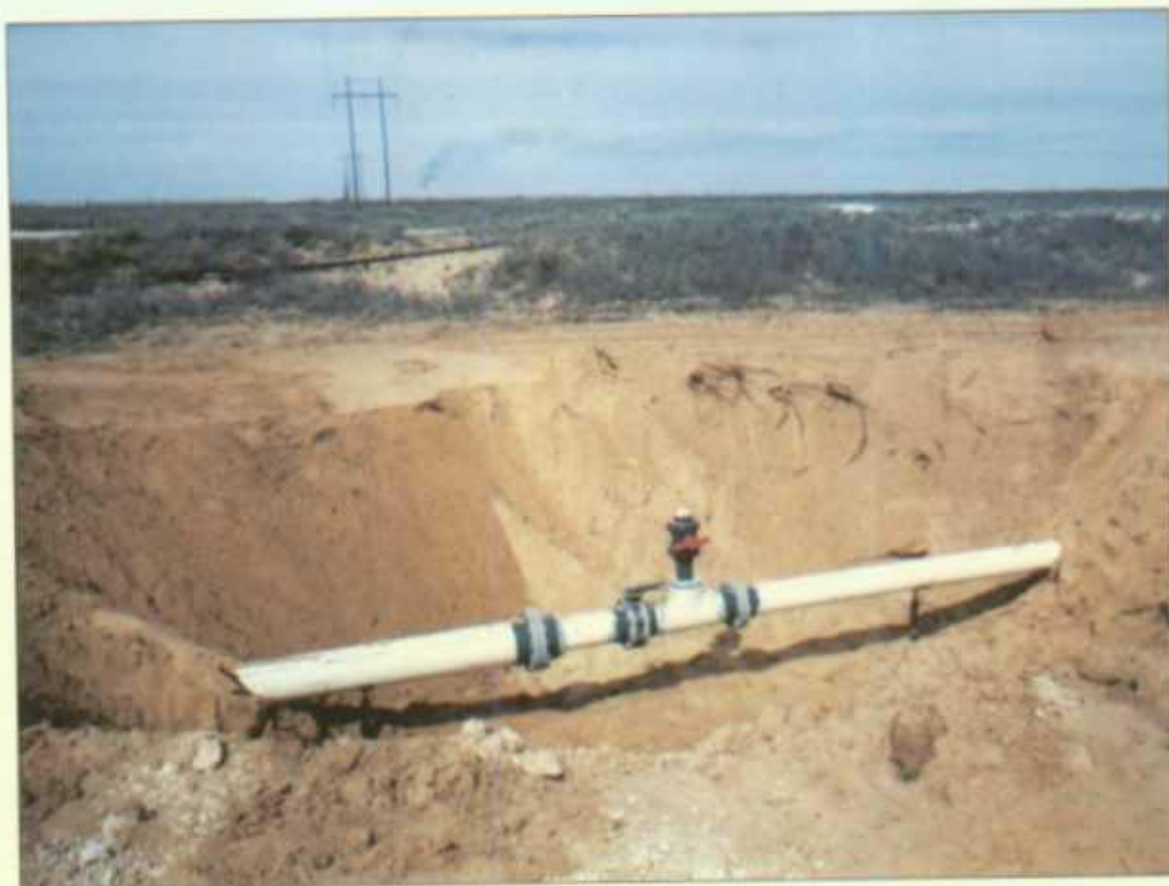
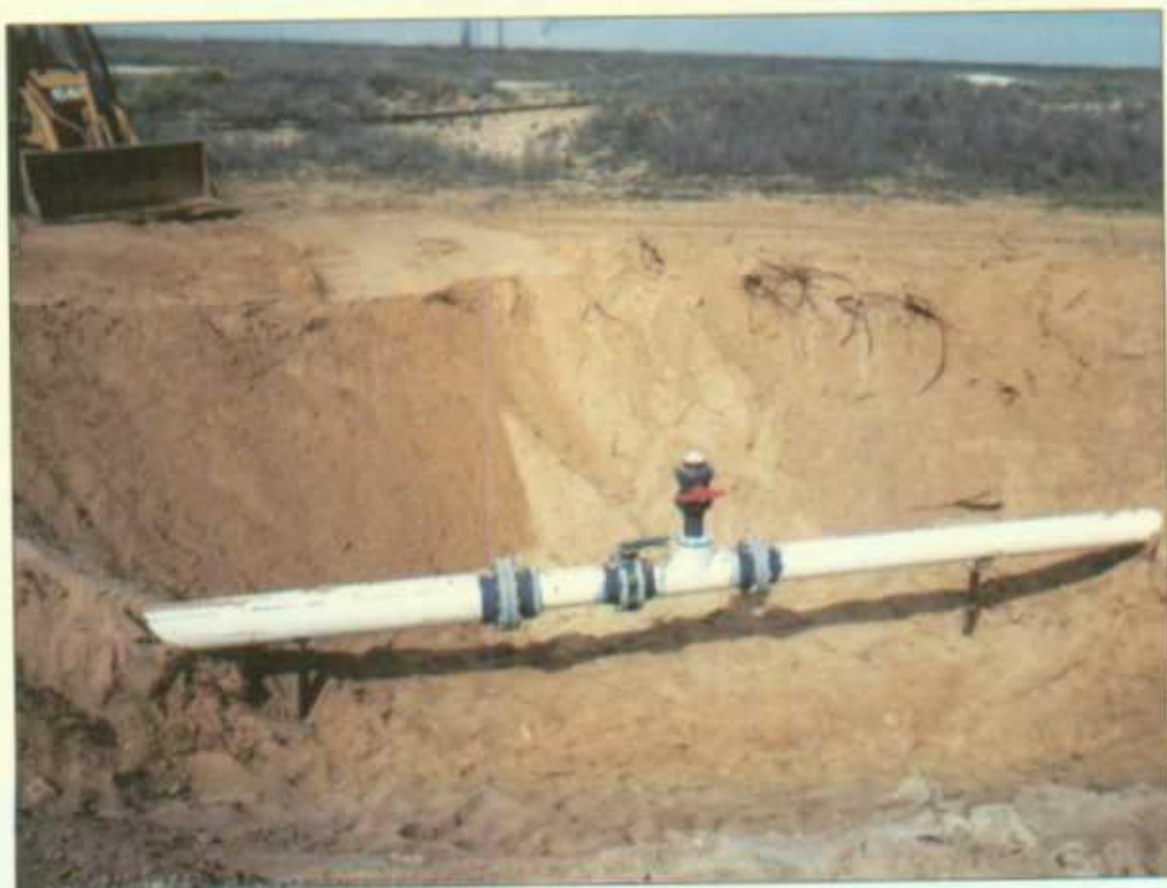
## EME L-19-2 Junction Box Upgrade

Remediation with New Plumbing

Found impact below NMOCD guidelines. Installed a compact clay barrier and water tight junction box. High impact soil was hauled to a permitted disposal facility. Backfilled with blended soil.
