# DISCLOSURE REPORT

**RICE OPERATING COMPANY  
JUNCTION BOX DISCLOSURE REPORT**

| SWD SYSTEM | JUNCTION | UNIT | SECTION | TOWNSHIP | RANGE | COUNTY | BOX DIMENSIONS - FEET | | |
|---|---|---|---|---|---|---|---|---|---|
| Blinebry-Drinkard | M-26-1 | M | 26 | 21 S | 37 E | Lea | No Box | | |

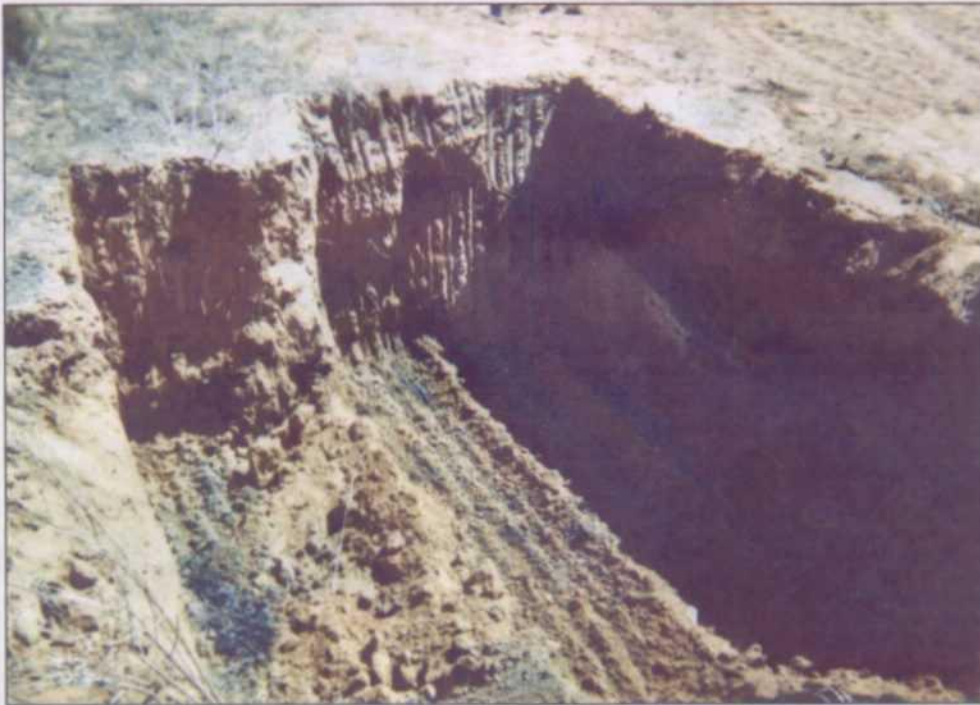
Excavation

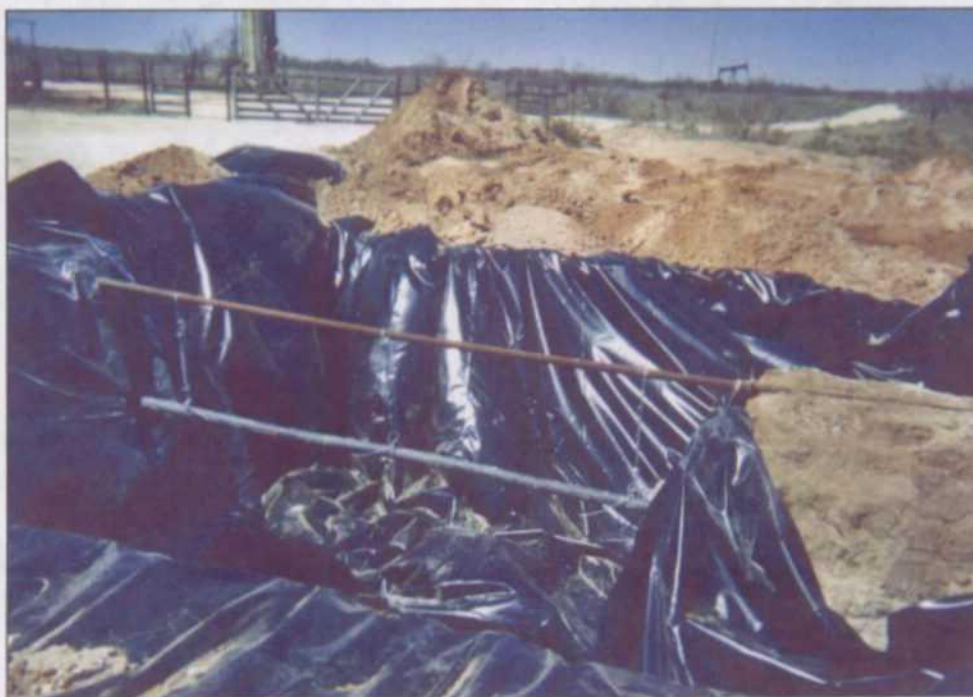
Poly Liner Installed

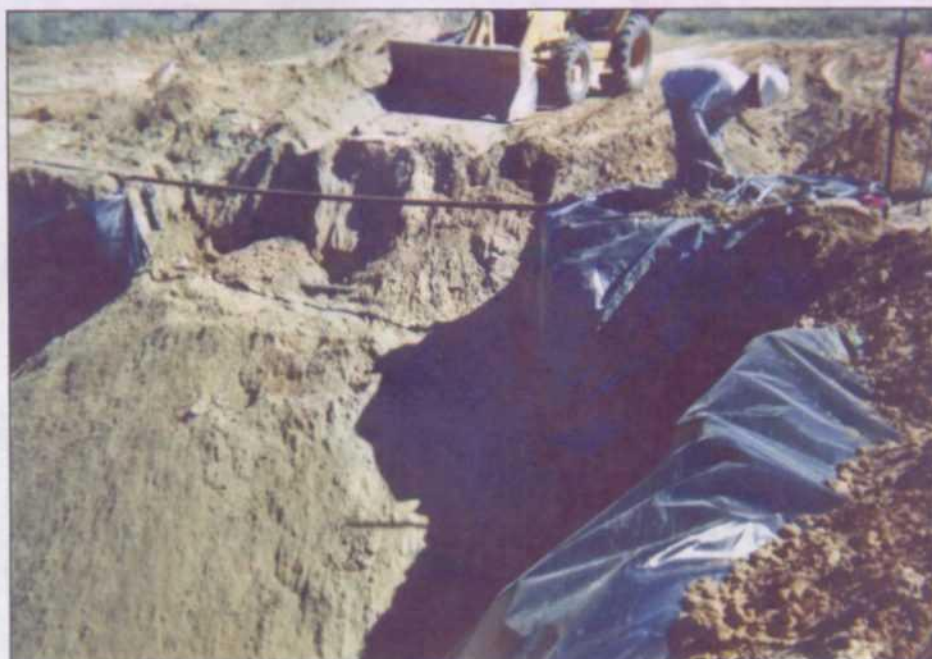
Backfilling Into Liner

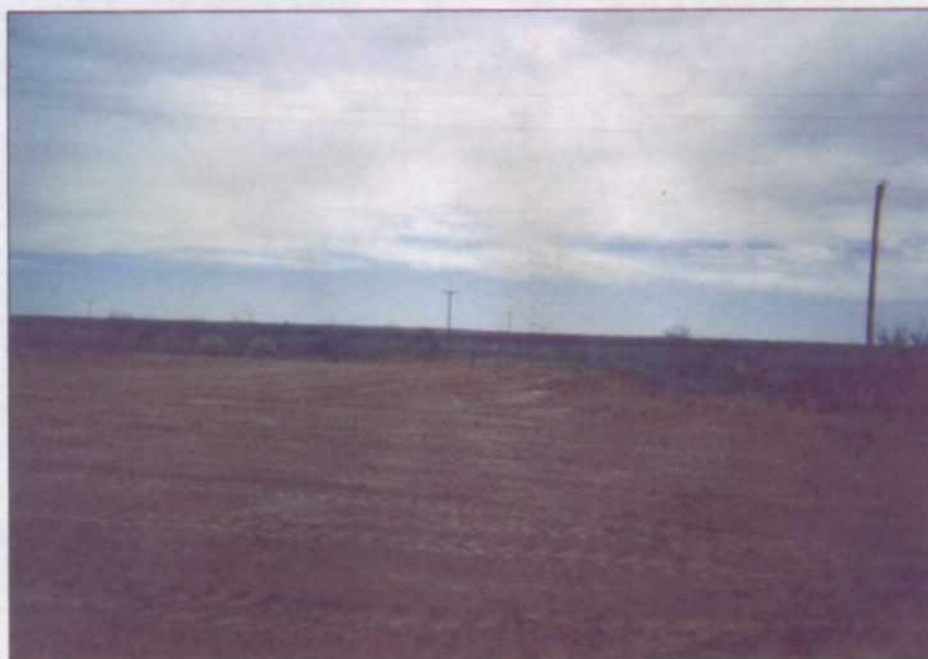
Backfilled
