BD K-21-2 Vent

FINAL REPORT

**RICE OPERATING COMPANY
JUNCTION BOX FINAL REPORT**

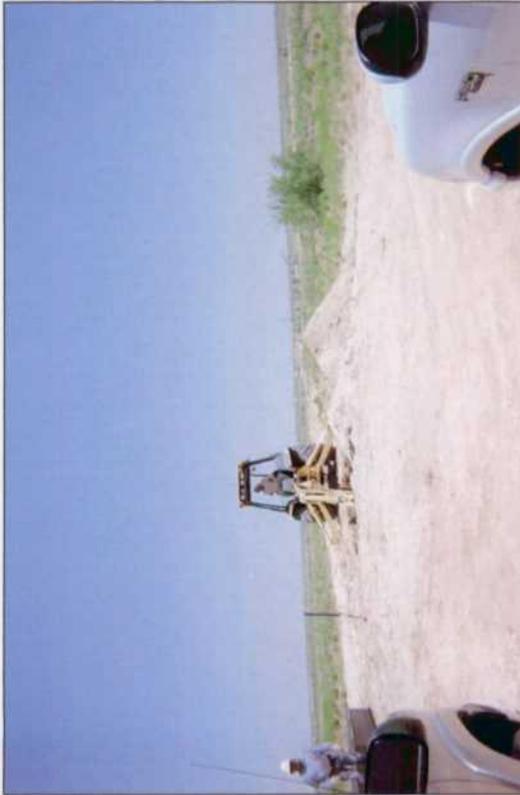
vertical delineation at former box site (looking north) 6/11/2004

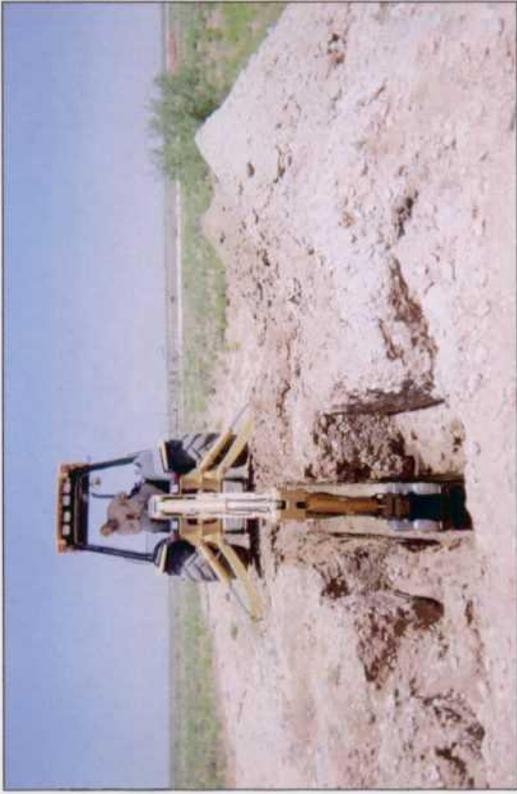
delineation & excavation 10 ft north of junction 6/11/2004

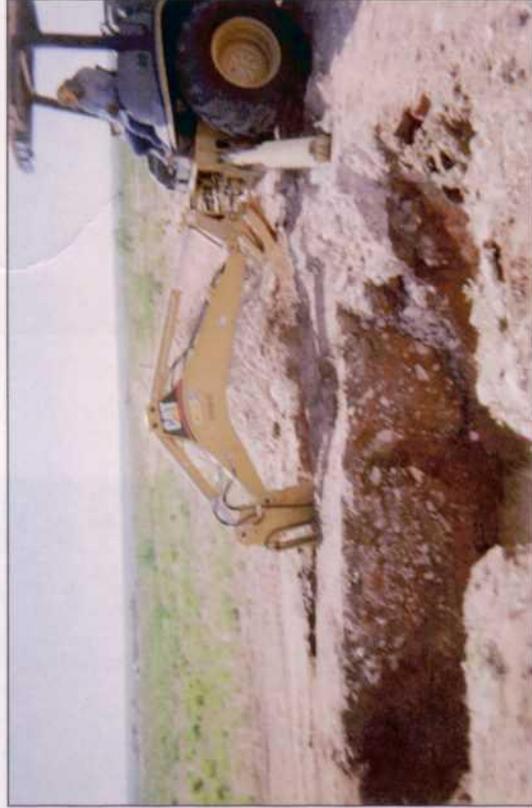
delineation & excavation 15 ft west of junction 6/15/2004

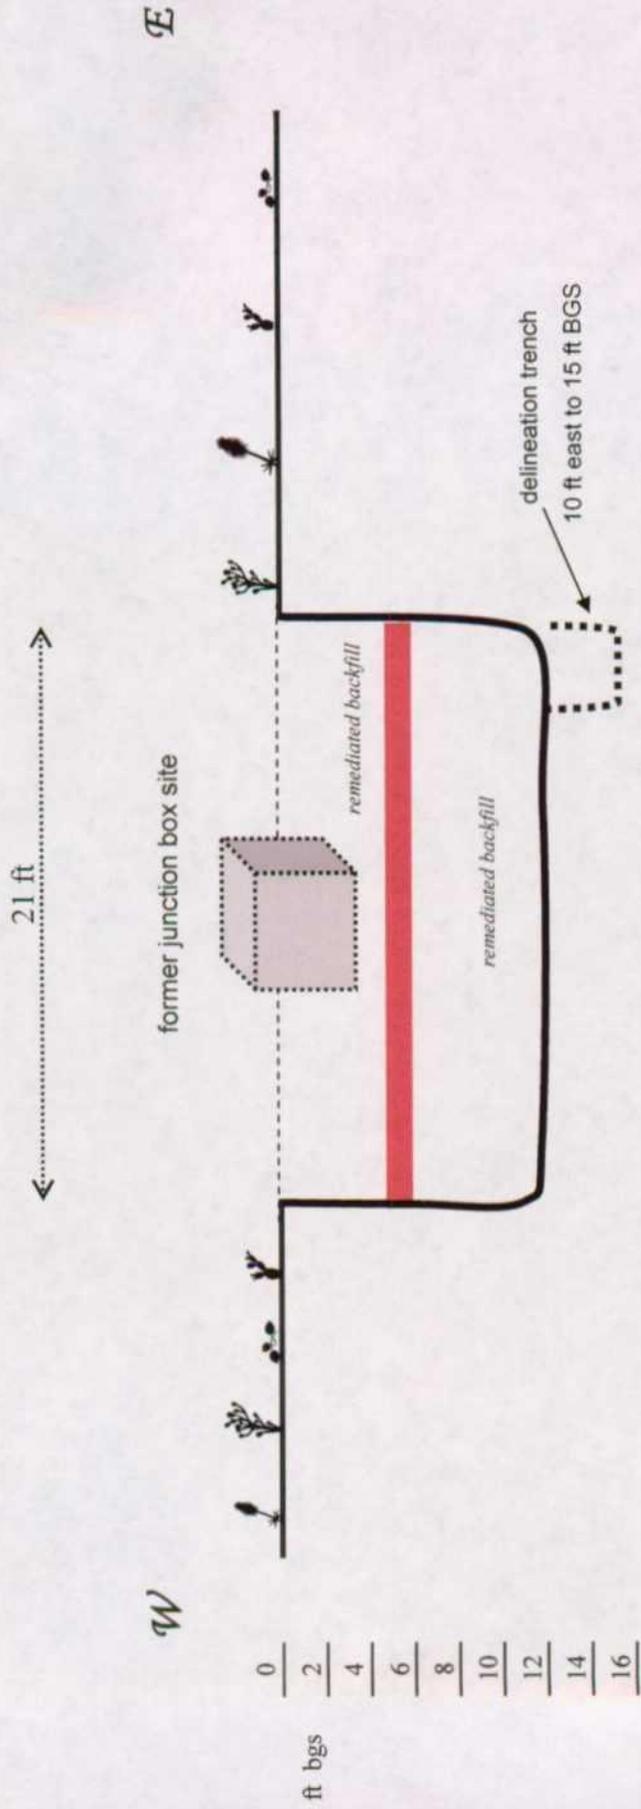
Excavation Cross-Section

21 x 19 x 12-ft-deep

* New junction box has been built 15 ft southwest of the former box site.

soil was blended on site and backfilled into the hole to 6 ft BGS. At 6 ft, a 1-ft-thick compacted clay barrier was installed to inhibit further migration

of remaining chloride. The remaining spoils were backfilled on top of the clay and contoured to the surrounding surface. The disturbed

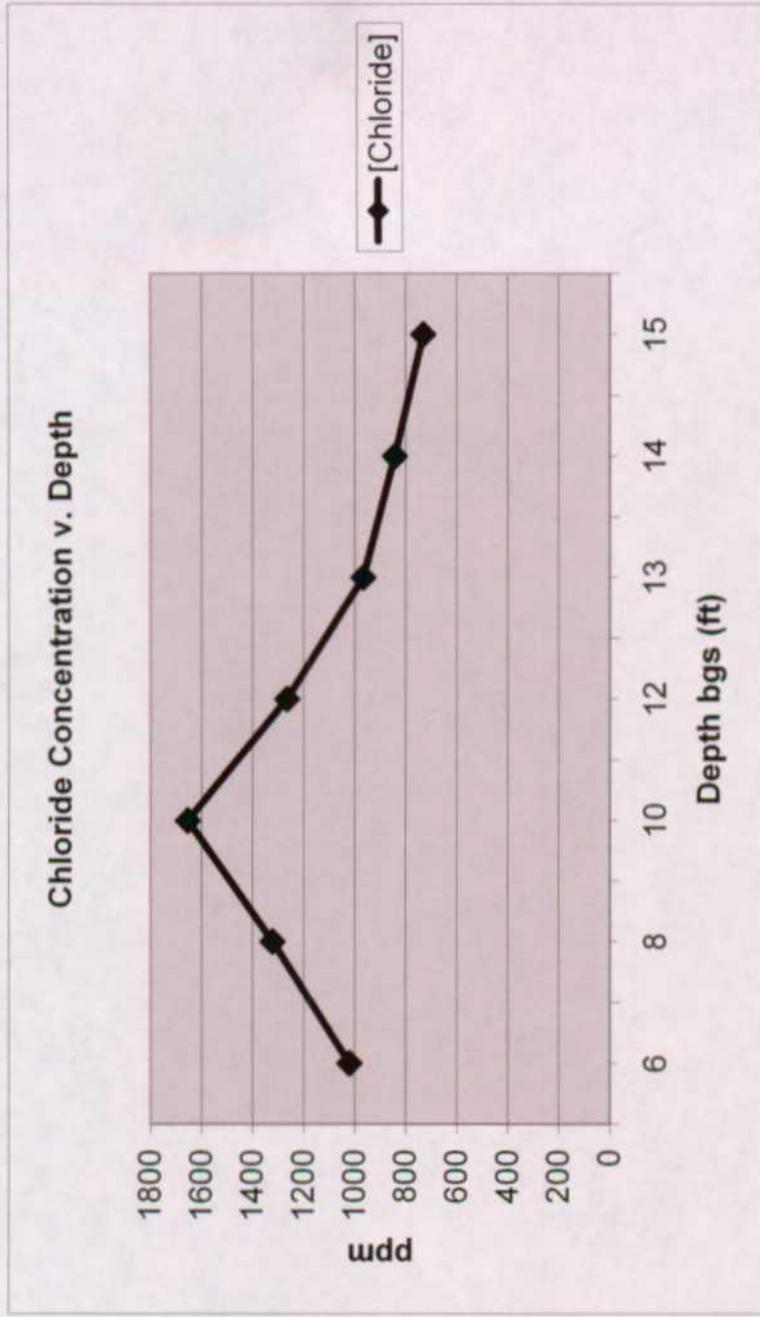
10 ft East of junction

Depth bgs (ft)	[Cl ⁻] ppm
6	1021
8	1322
10	1654
12	1265
13	966
14	843
15	731

Groundwater = 70 ft
