**RICE OPERATING COMPANY  
JUNCTION BOX DISCLOSURE\* REPORT**

EME jct. L-34  
T20S, R36E

Project: L-34 Jct Box

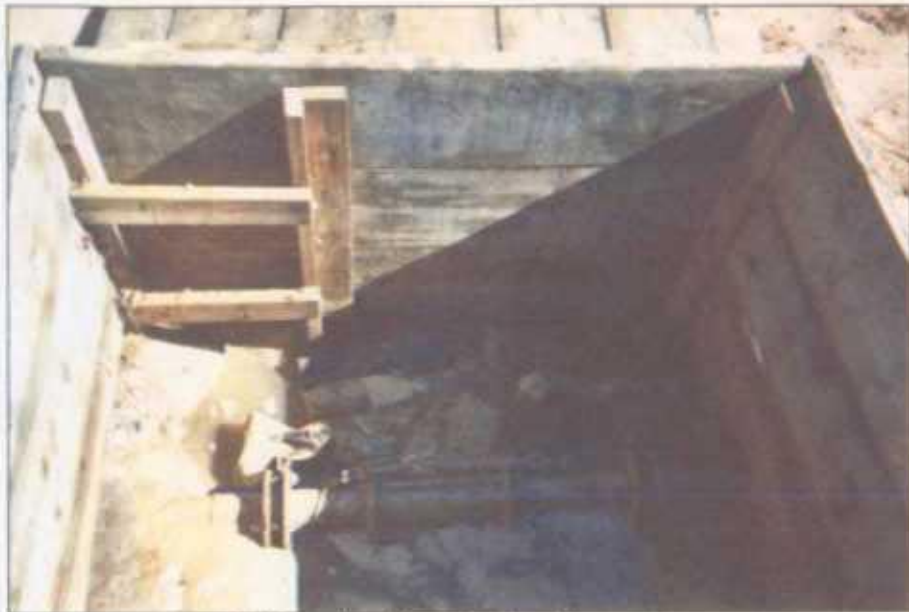
Old Junction Box Before Excavation

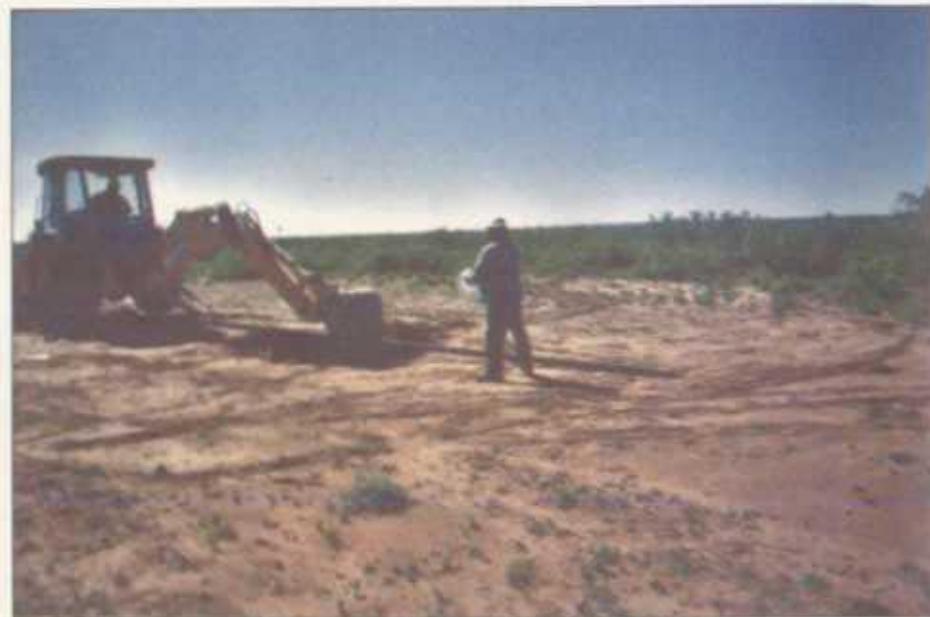
Beginning Excavation—5/29/2003

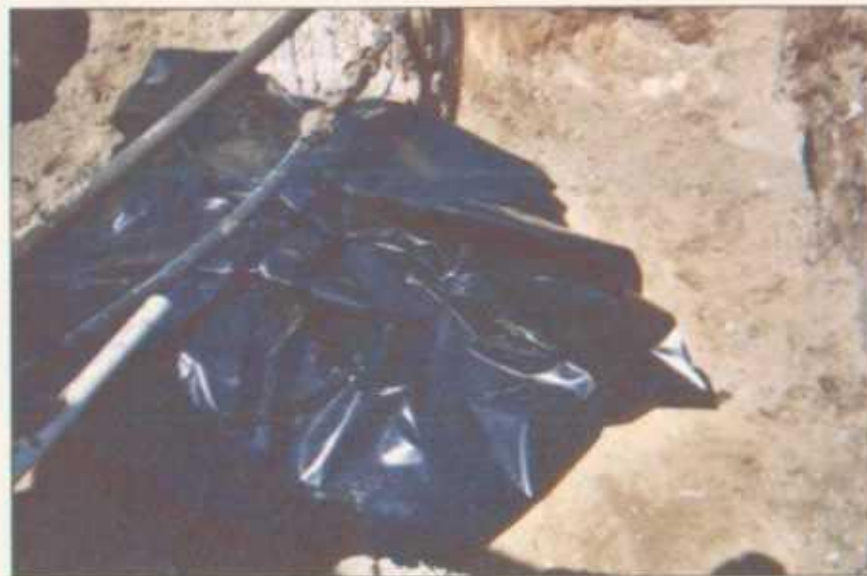
Installing Poly Liner

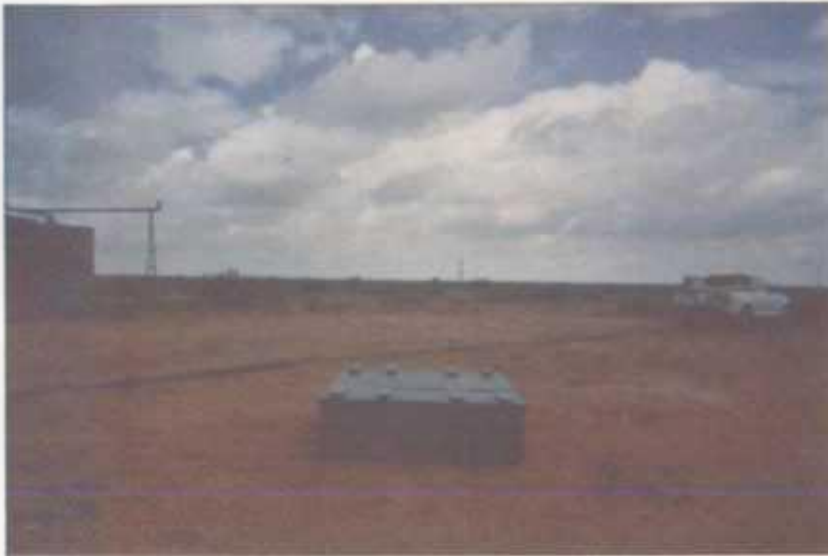
Looking West At Backfilled Site (New Box in Foreground)

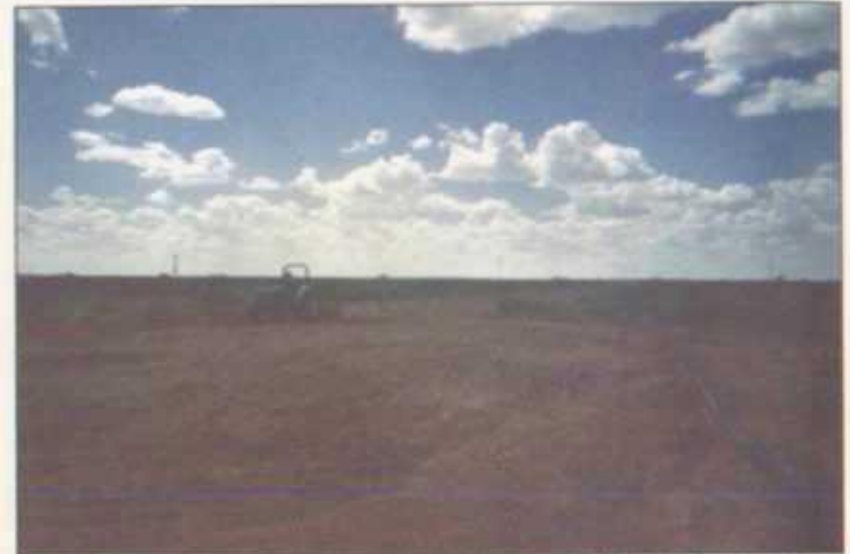
Re-Seeding Excavated Area—7/29/2003

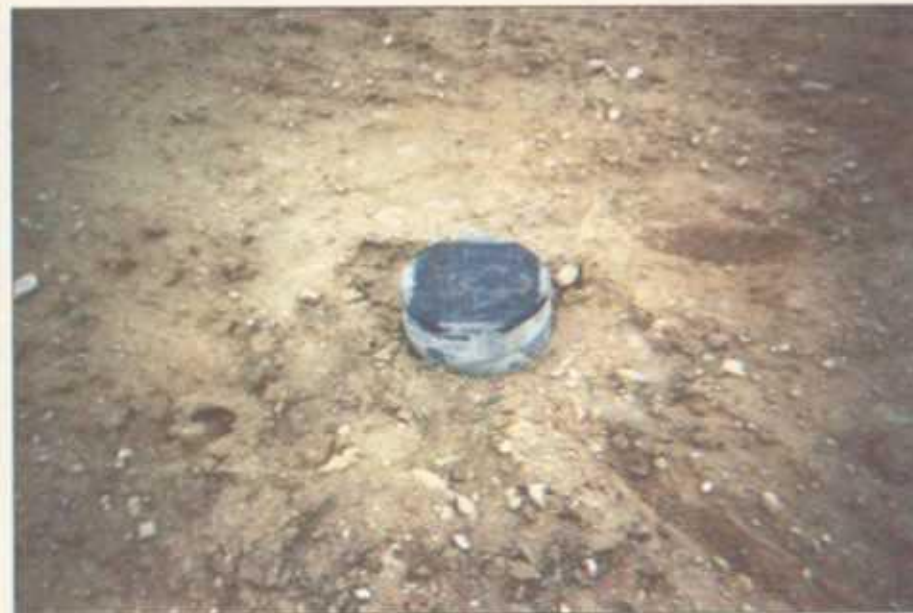
ID Plate Marking Liner at Backfilled Site
