BD C-26 Vent

**FINAL  
REPORT**

**RICE OPERATING COMPANY  
JUNCTION BOX FINAL REPORT**

unit 'C', sec. 26, T21S, R37E

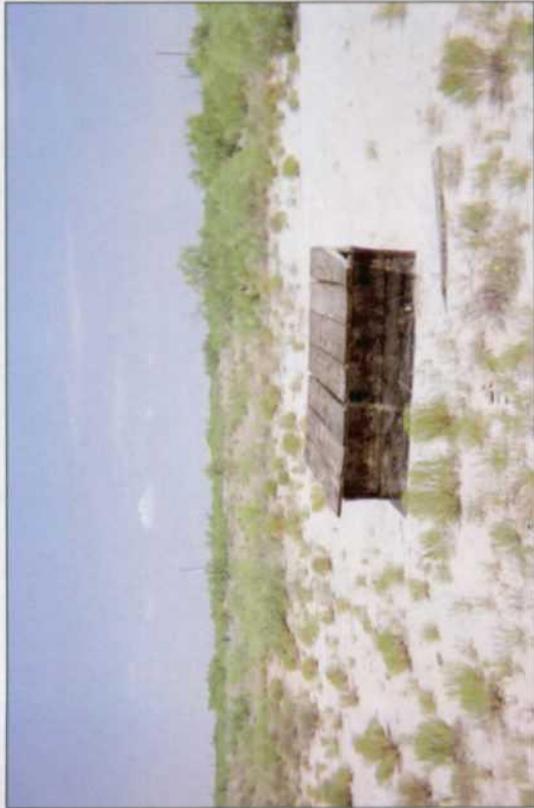
7/23/2003

undisturbed junction box

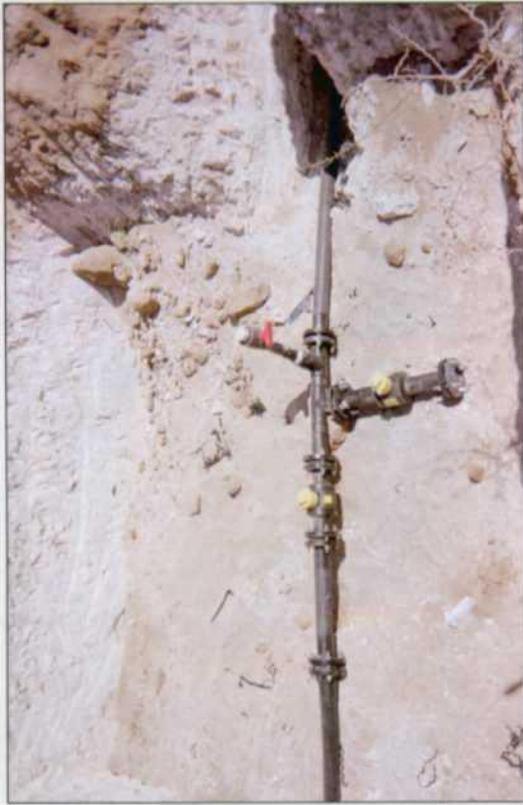
9/5/2003

new plumbing at new box site 120 ft east of former

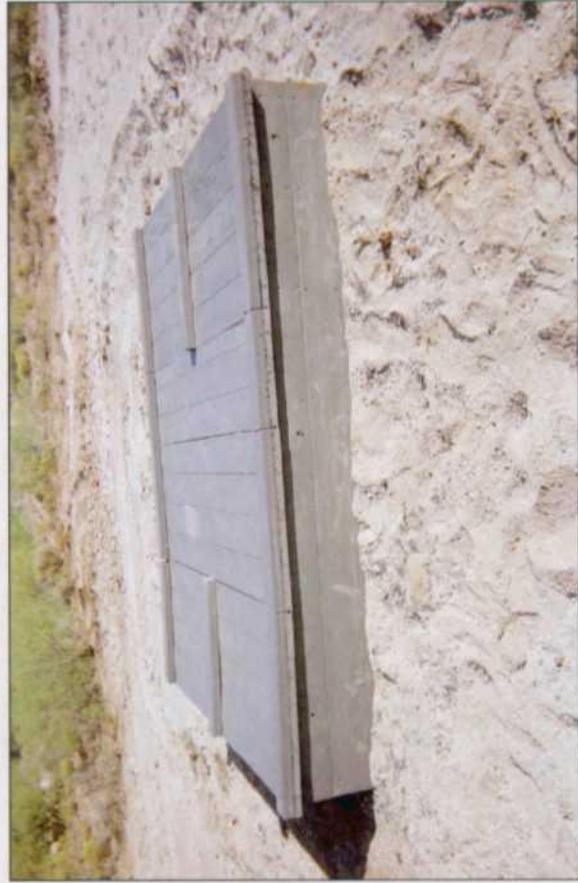
9/29/2003

completed new junction box

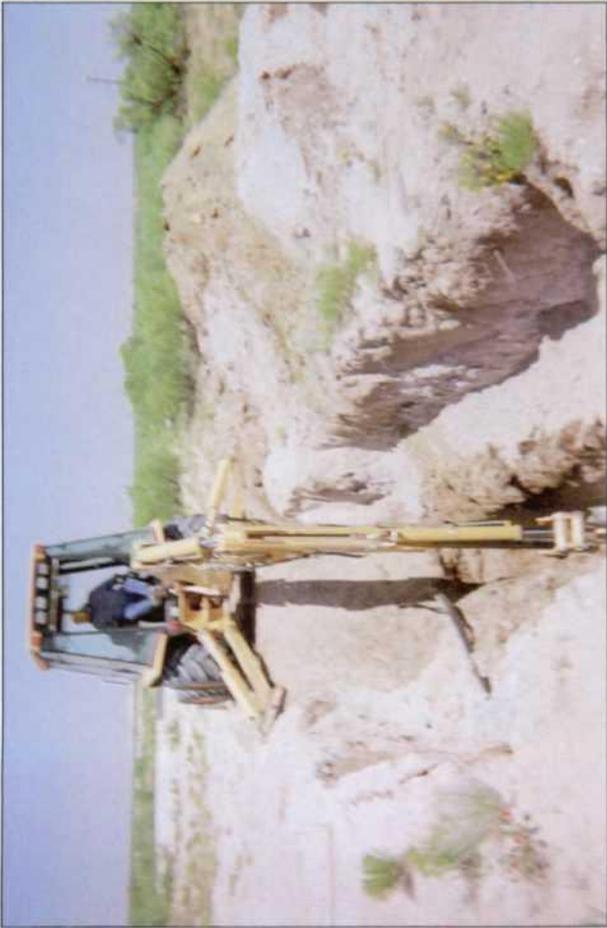
6/7/2004

beginning excavation & delineation

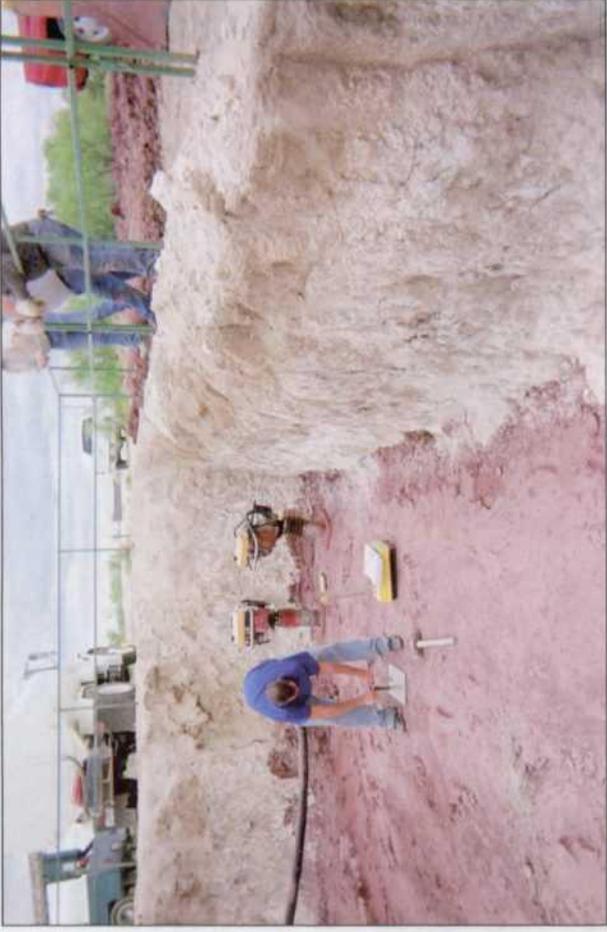
6/22/2004

testing clay barrier at 6 ft BGS

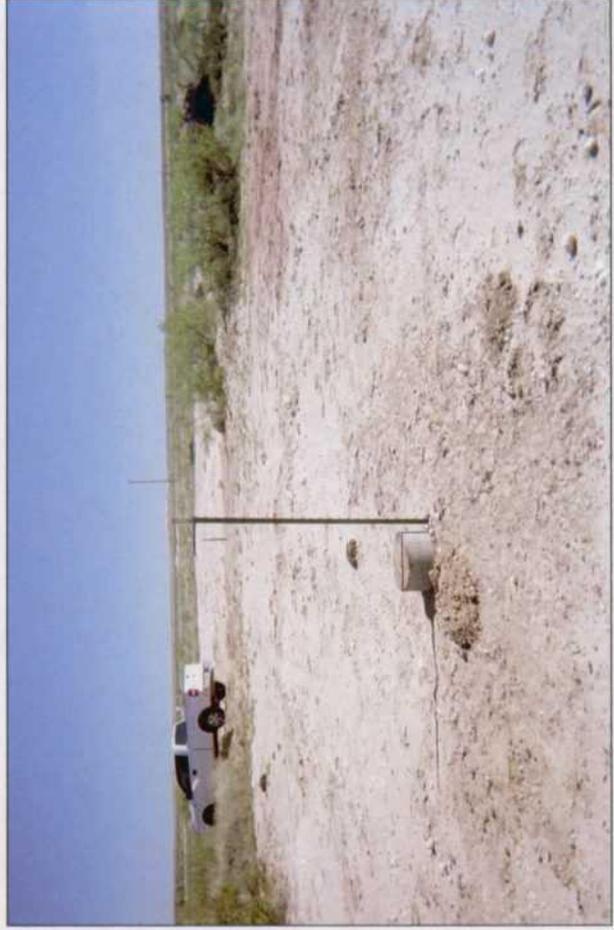
10/29/2004

backfilled site; clay ID plate on surface

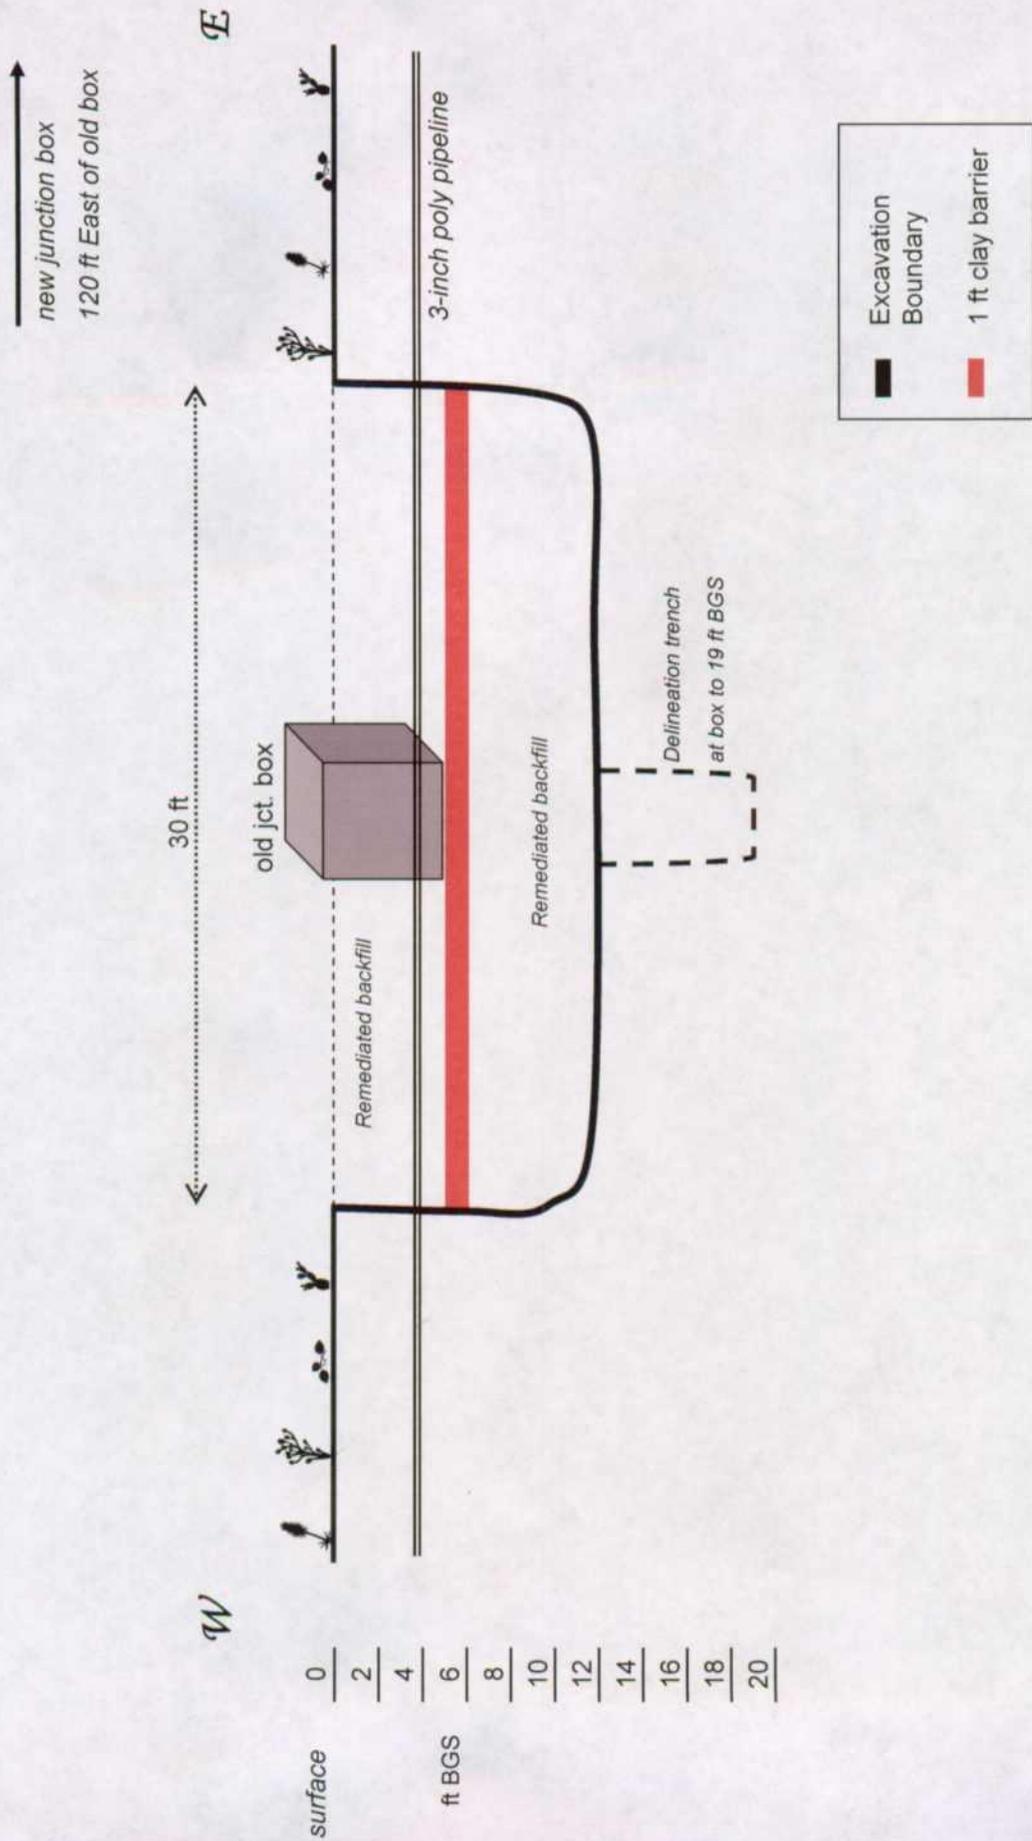
30 x 20 x 12 ft  
Excavation Cross-Section

General Description of Remedial Action: This junction box contained a vent and has been replaced with a new watertight junction box 120 ft East. The old box site was delineated and excavated with a backhoe while chloride field tests and PID screenings were conducted at regular intervals. Chloride concentrations exhibited conclusive vertical and lateral declines, indicating non-saturated vadose conditions (see graph). NMOCD BTEX and TPH guidelines were met. The 30 x 20 x 12-ft-deep excavation was backfilled with the blended, excavated soil to 6 ft BGS. At 6 ft, a 1 ft compacted clay barrier was installed to allow remaining TPH to naturally attenuate (see diagram). The excavation was backfilled with the remaining soils and contoured to the surrounding terrain. The disturbed surface will be seeded with a blend of native vegetation and will be monitored for growth.

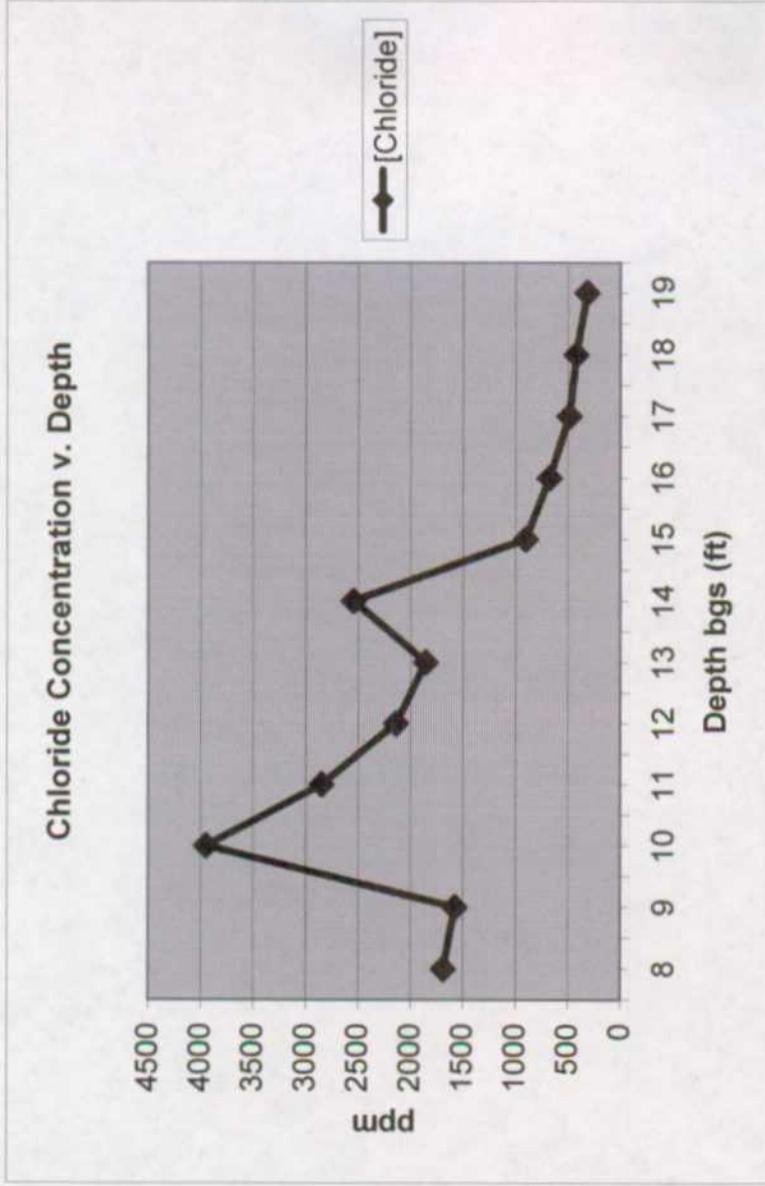
Vertical Delineation at Source

Depth bgs (ft)	[Cl <sup>-</sup> ] ppm
8	1690
9	1576
10	3949
11	2849
12	2140
13	1856
14	2546
15	903
16	674
17	486
18	421
19	318

Groundwater = 61 ft
