1R0427-35

**RICE OPERATING COMPANY  
JUNCTION BOX FINAL REPORT**

## EME jct. E-30

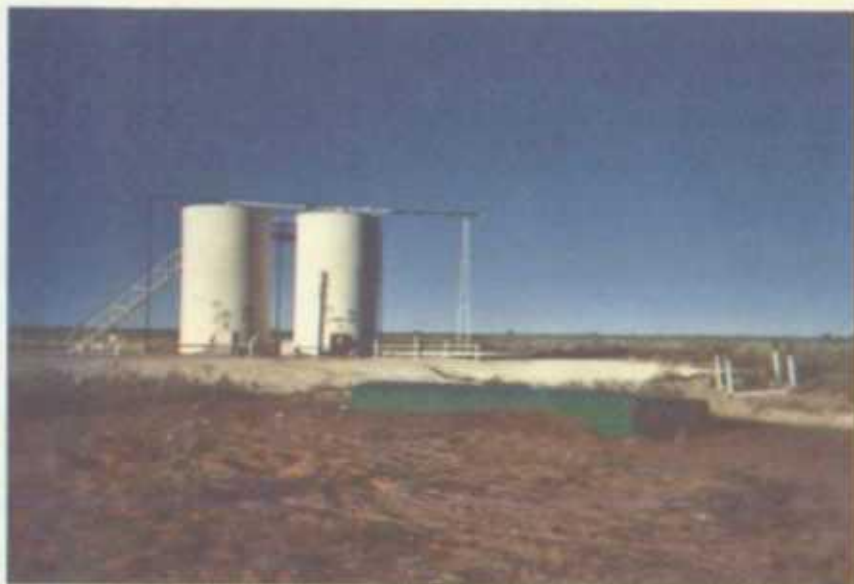
11/18/2003

Undisturbed Junction Box

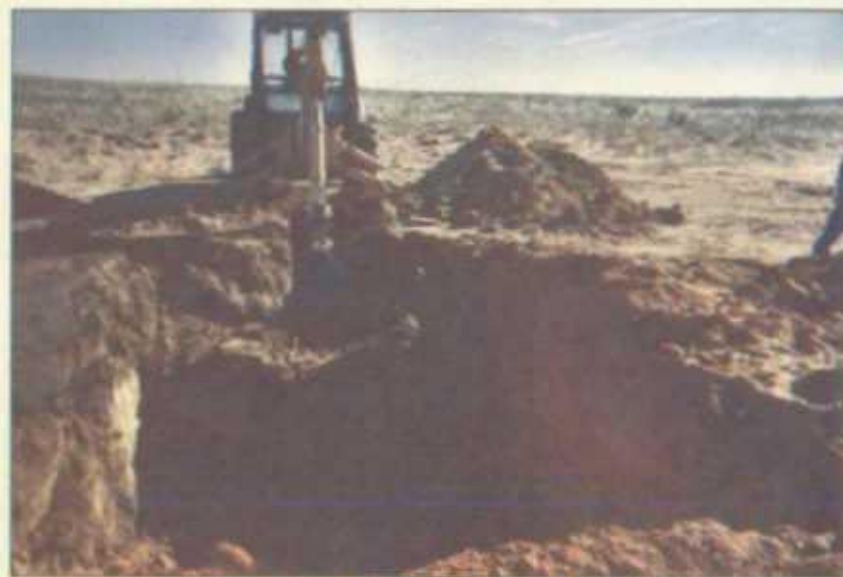
Dec. 2003

Delineation & Excavation

**General Description of Remedial Action:** Vertical delineation at the junction

box exhibited a vertical decline of chloride concentrations with depth. As a 30 x 30 x 9-ft deep excavation was produced, PID readings and chloride tests were performed regularly. PID closure readings were below 100 ppm and lab results confirm that TPH concentrations are below NMOCD guidelines. The excavated soil was mixed and backfilled into the hole and contoured to the surrounding surface. A new watertight junction box has been built 80 ft northwest of this location. The disturbed surface is expected to naturally return to productive capacity at a normal rate.

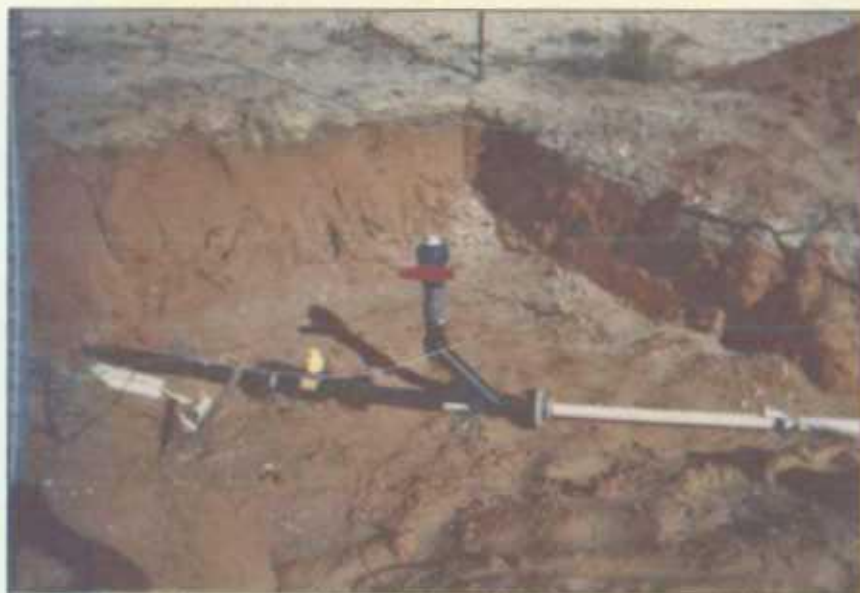
12/8/2003

New plumbing at new box site 70 ft NW of old one

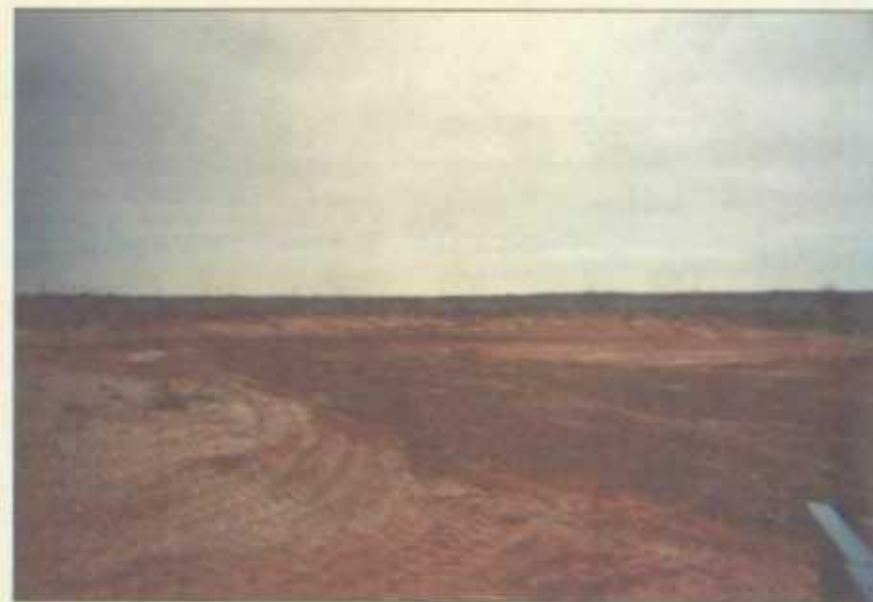
1/23/2004

Backfilled excavation looking SE from new box
