EME T-5

**FINAL
REPORT**

**RICE OPERATING COMPANY
JUNCTION BOX FINAL REPORT**

EME jct. T-5

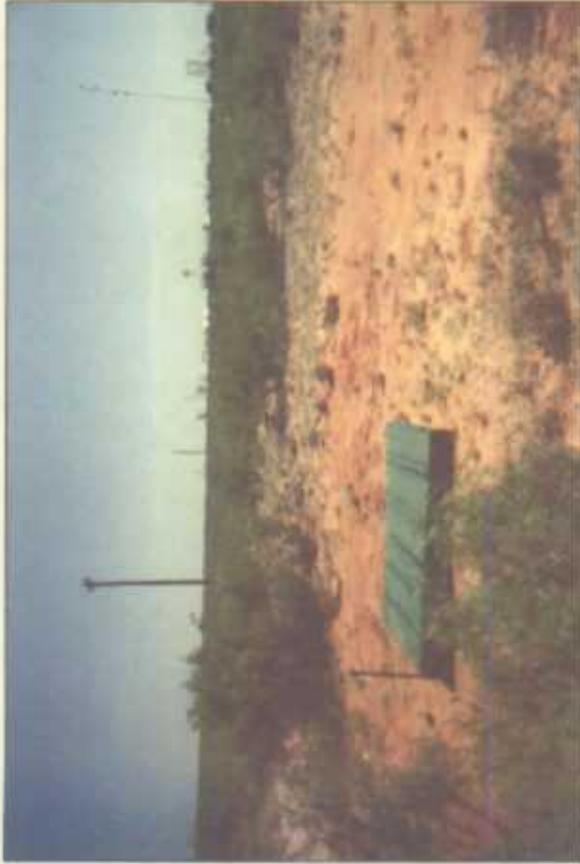
Undisturbed Junction Box

October 2003

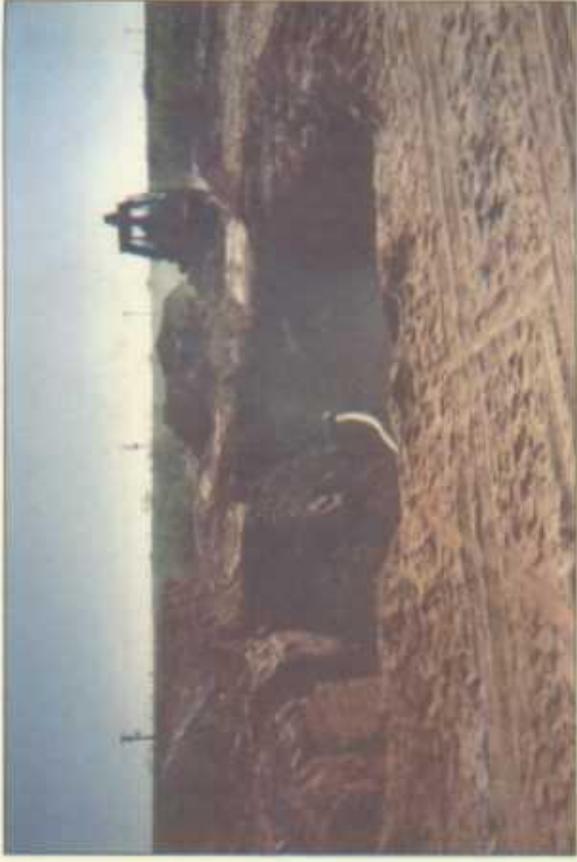
Excavation

General Description of Remedial Action: This box was surrounded by healthy vegetation when it was eliminated. A 20 x 25 x 12-ft-deep excavation was produced with a backhoe while chloride and VOC's were delineated vertically and laterally. Although the greatest source of impact was found 10 ft west of the junction, chloride concentrations exhibited a conclusive trend of decline (see graphs). BTEX and TPH concentrations were well below NMOCD guidelines. Although the west wall exhibited elevated PID readings, a composite under laboratory conditions confirmed BTEX concentrations below NMOCD guidelines (see lab results and PID readings). The excavated soil was landfarmed on site and then backfilled into the hole. A new junction box is not required at this site as the pipeline has been re-plumbed straight through with poly pipe. The disturbed surface is expected to return to productive capacity at a normal rate.

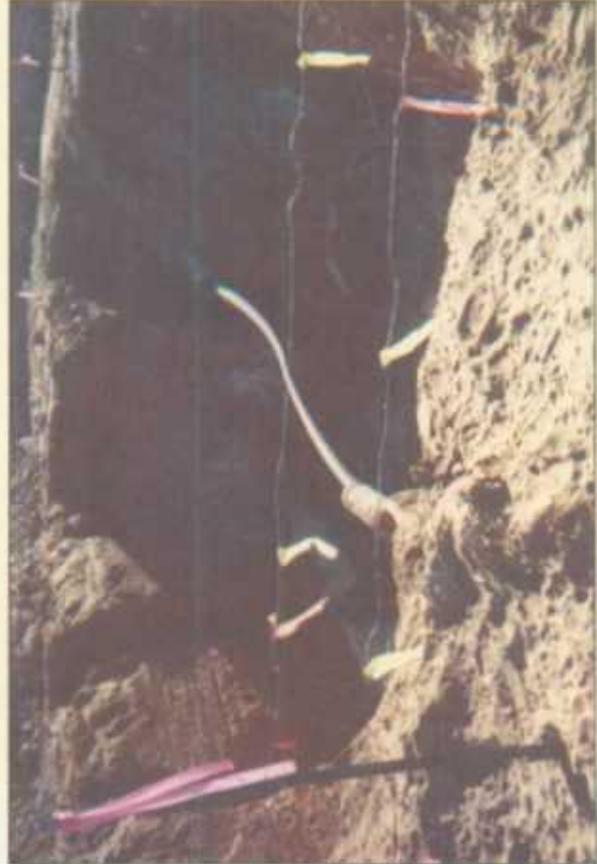
20 x 25 x 12-ft deep Excavation

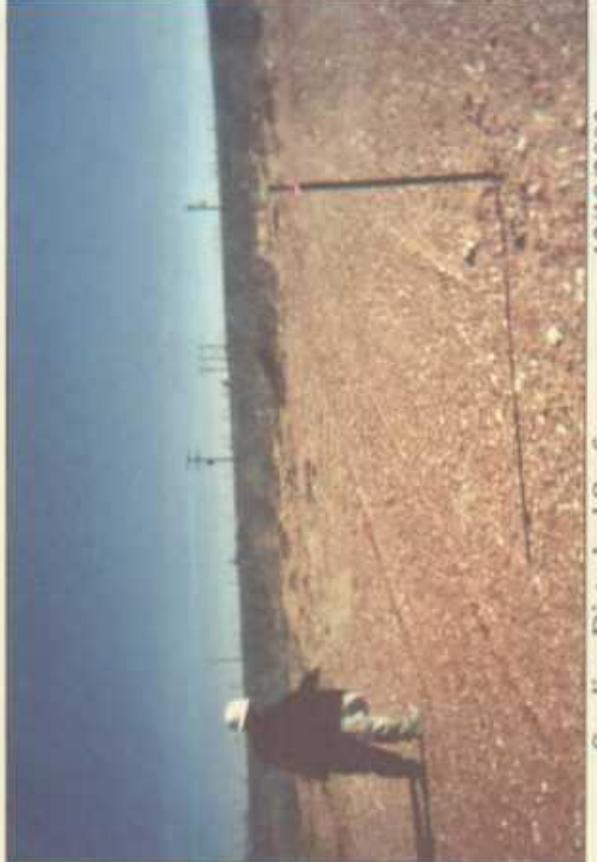
Seeding Disturbed Surface

12/18/2003

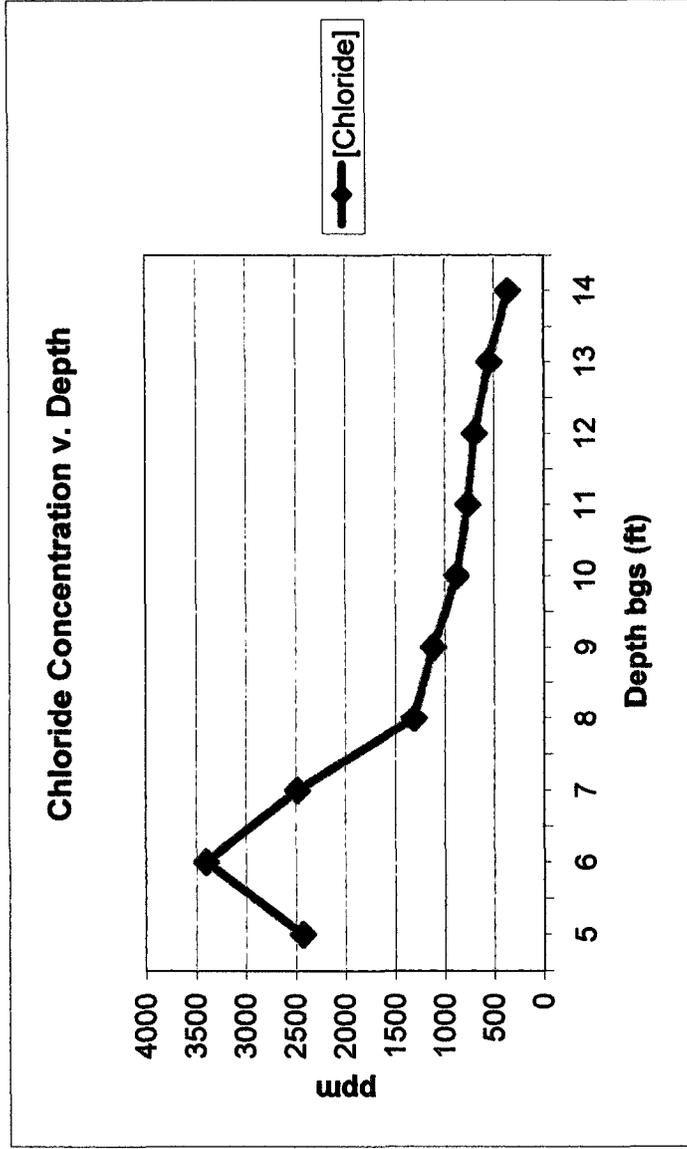
CHLORIDE CONCENTRATION CURVE

10 ft West of Junction

Depth bgs (ft)	[Cl ⁻] ppm
5	2431
6	3403
7	2484
8	1314
9	1117
10	880
11	764
12	696
13	547
14	355

Groundwater = 200 ft

LOCATION	DEPTH (ft)	ppm
Vertical	8	546
	10	678
	12	600
	14	425
10 ft West	6	3403
	8	1314
	10	880
	12	696
	14	355

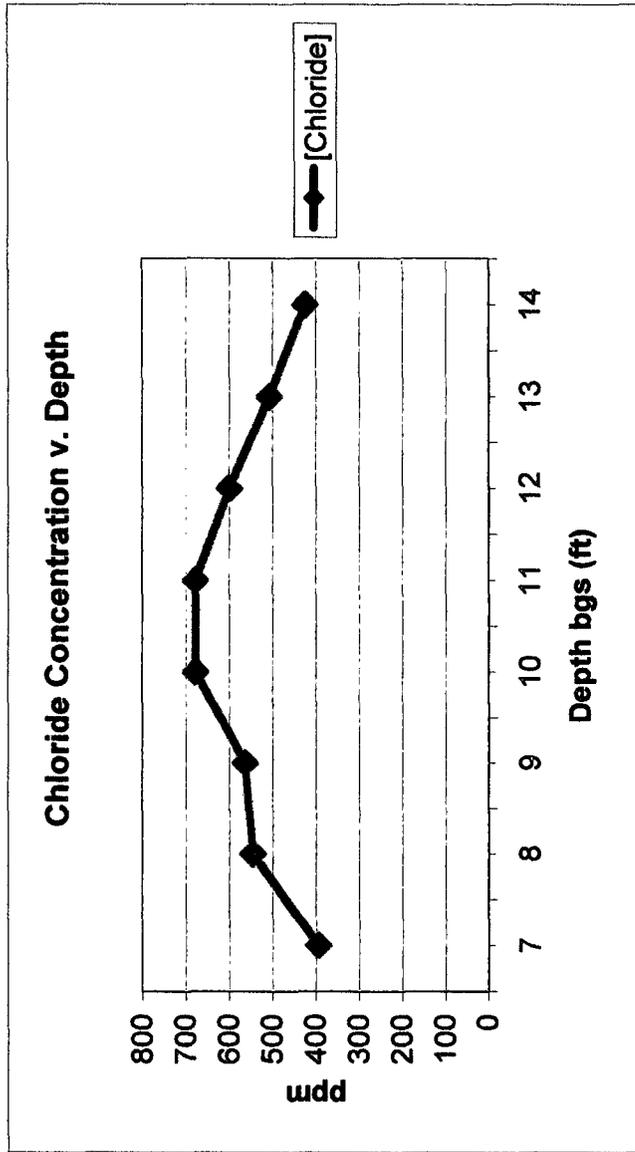
Depth bgs (ft)	[Cl ⁻] ppm
7	395
8	546
9	564
10	678
11	678
12	600
13	508
14	425

Groundwater = 200 ft
