**RICE OPERATING COMPANY
JUNCTION BOX DISCLOSURE* REPORT**

SWD SYSTEM	JUNCTION	UNIT	SECTION	TOWNSHIP	RANGE	COUNTY	BOX DIMENSIONS - FEET		
							Length	Width	Depth
EME	Oil & Gas State 'H' (south)	E	17	20S	37E	Lea	moved 50 ft South

EME State 'H' 17 EOL North & South Boxes

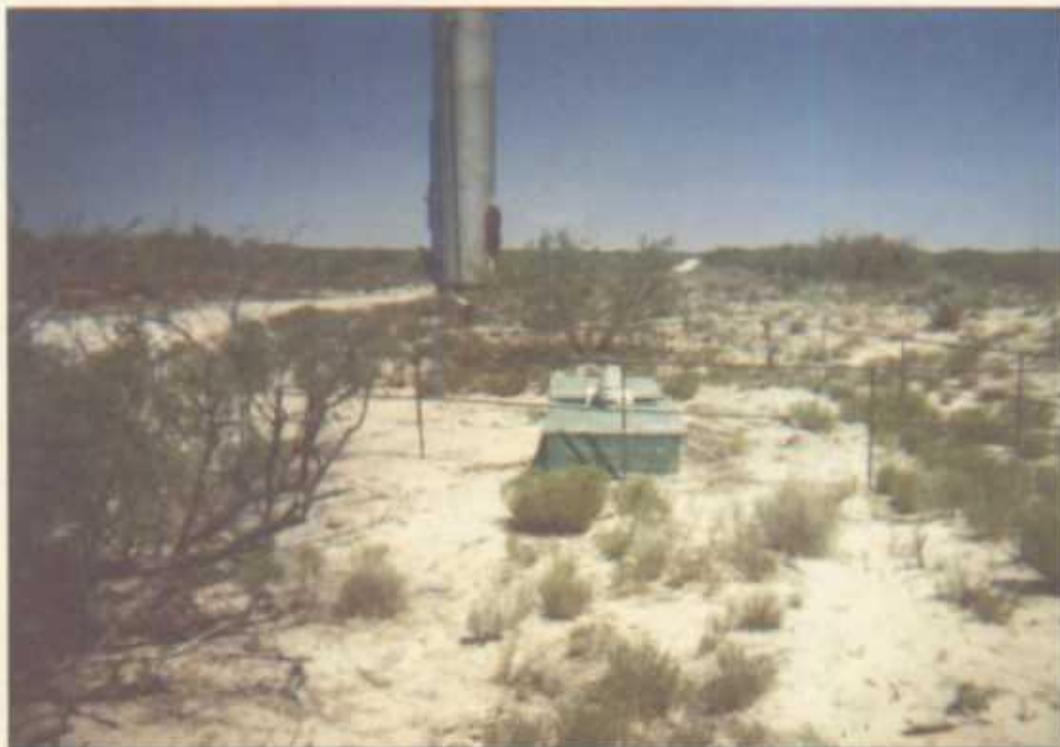
8/6/2003

Undisturbed north and south boxes

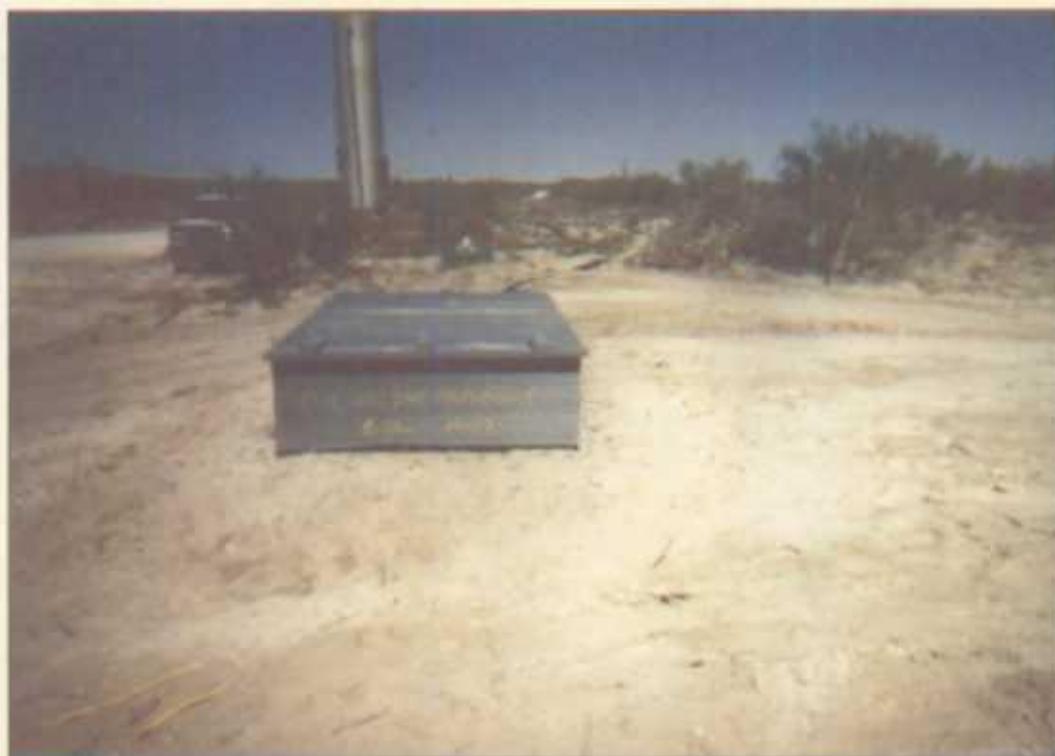
10/15/2003

Completed new box 50 ft south of old boxes in background

General Description of Remedial Action: This site was composed of two boxes that were approximately 5 ft apart. Vertical delineation at each box did not result in a conclusive decline of chloride impact (see graph). All PID readings were 0.0 ppm and TPH concentrations were well below NMOCD guidelines. A 20 x 20 x 4-ft deep excavation was made around the boxes and at 4 ft bgs, a 1.5 ft compacted clay barrier was installed to inhibit further chloride migration. The excavated soil was landfarmed on site and then backfilled on top of the clay and the surface was contoured to the surrounding terrain. The disturbed surface has been seeded with a blend of native vegetation. A new EOL box has been built approximately 50 ft south of this location.

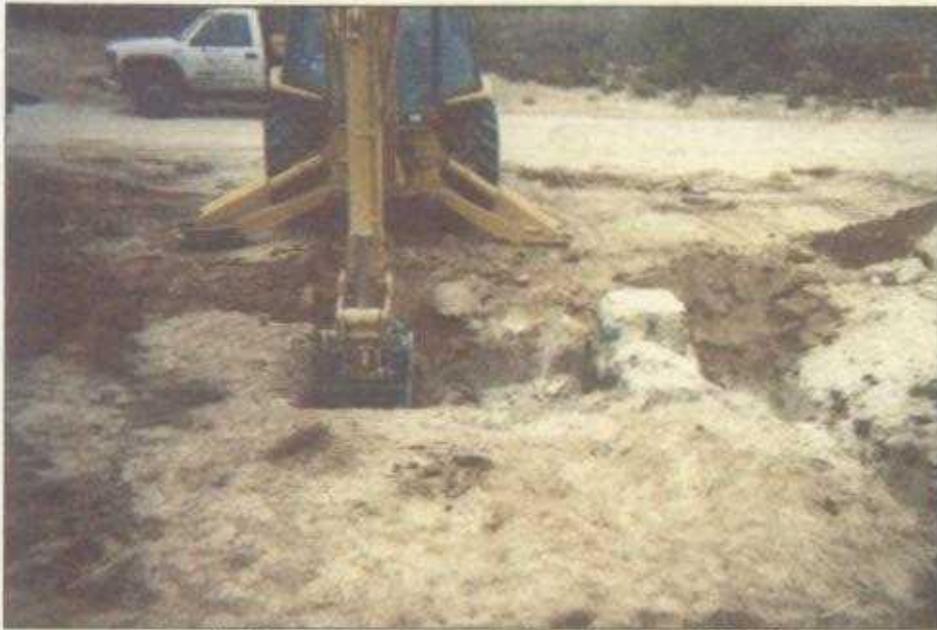
Beginning excavation & delineation 11/6/2003

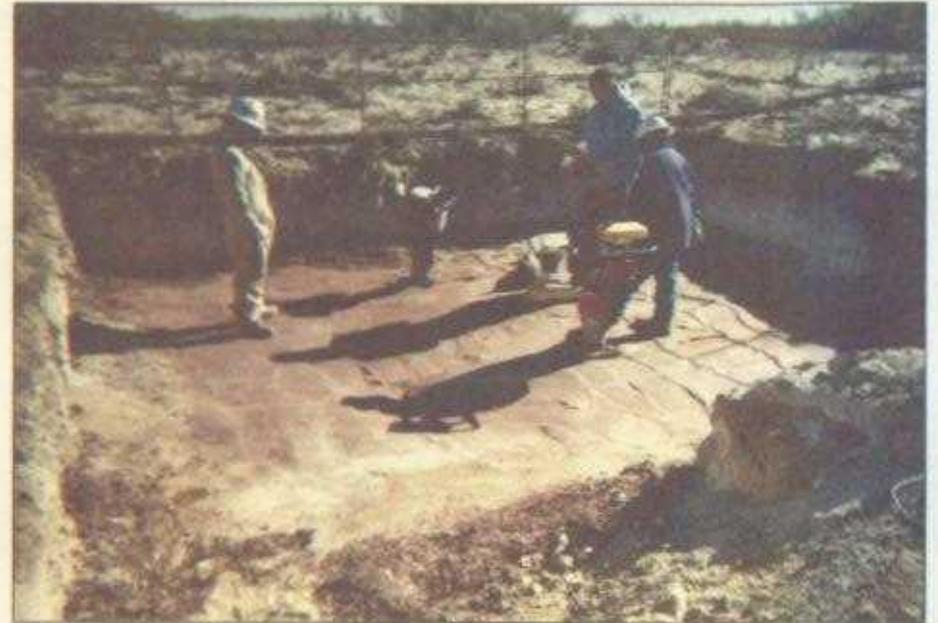
Testing compacted clay 11/20/2003

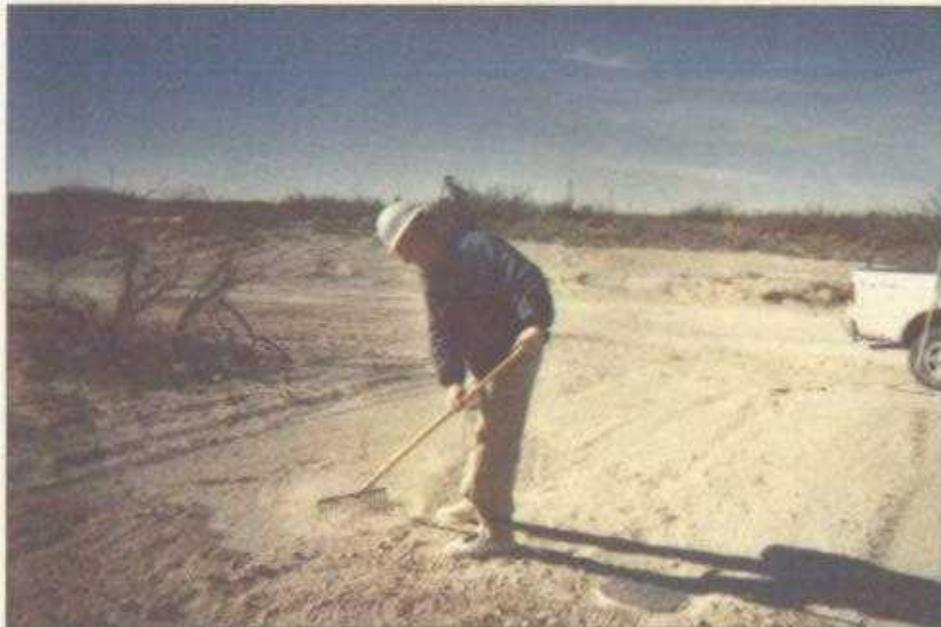
Seeding disturbed surface

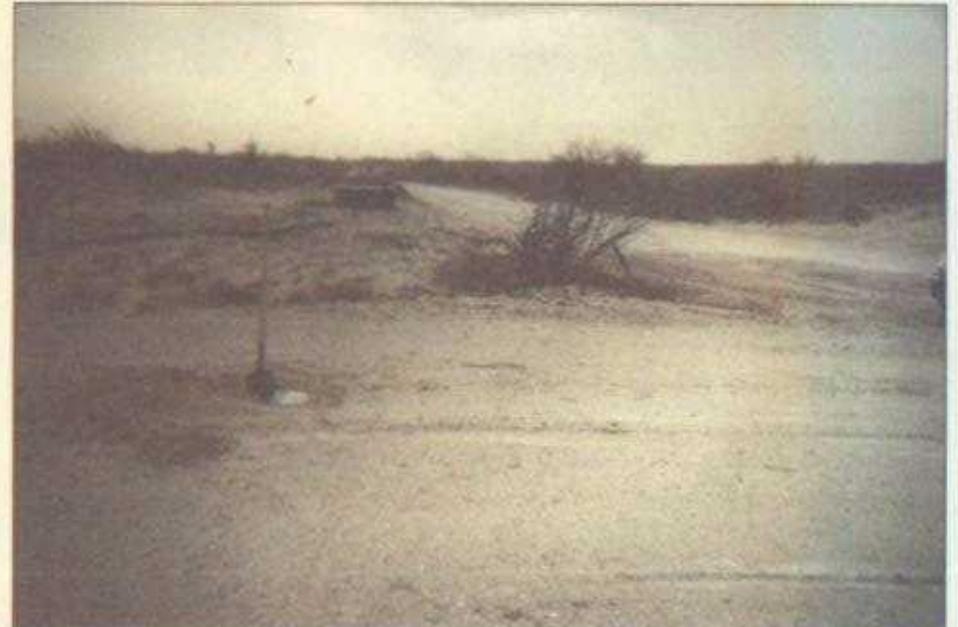
Identification plate marking clay liner

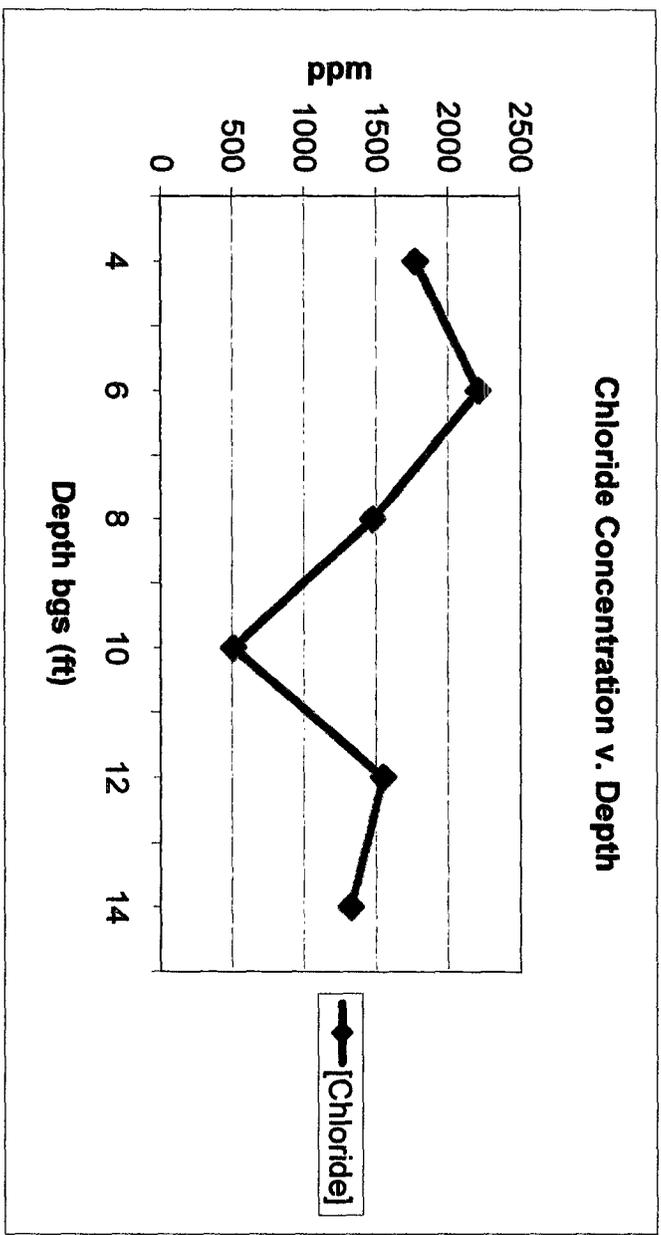
CHLORIDE CONCENTRATION CURVE

Depth bgs (ft)	[Cl ⁻] ppm
4	1775
6	2213
8	1479
10	508
12	1549
14	1327

Groundwater = 27 ft
