# FINAL REPORT

**RICE OPERATING COMPANY  
JUNCTION BOX FINAL REPORT**

| SWD SYSTEM | JUNCTION | UNIT | SECTION | TOWNSHIP | RANGE | COUNTY | BOX DIMENSIONS - FEET | | |
|---|---|---|---|---|---|---|---|---|---|
| EME | H-10-1 | H | 10 | 20S | 36E | Lea | Length | Width | Depth |

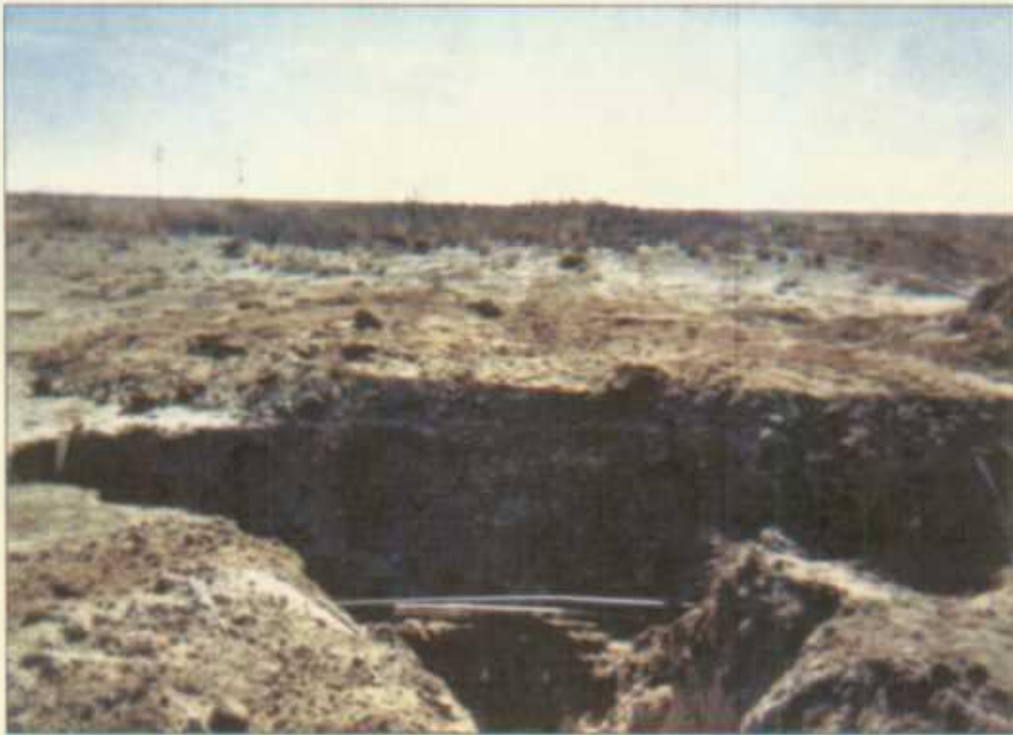
Before Remediation

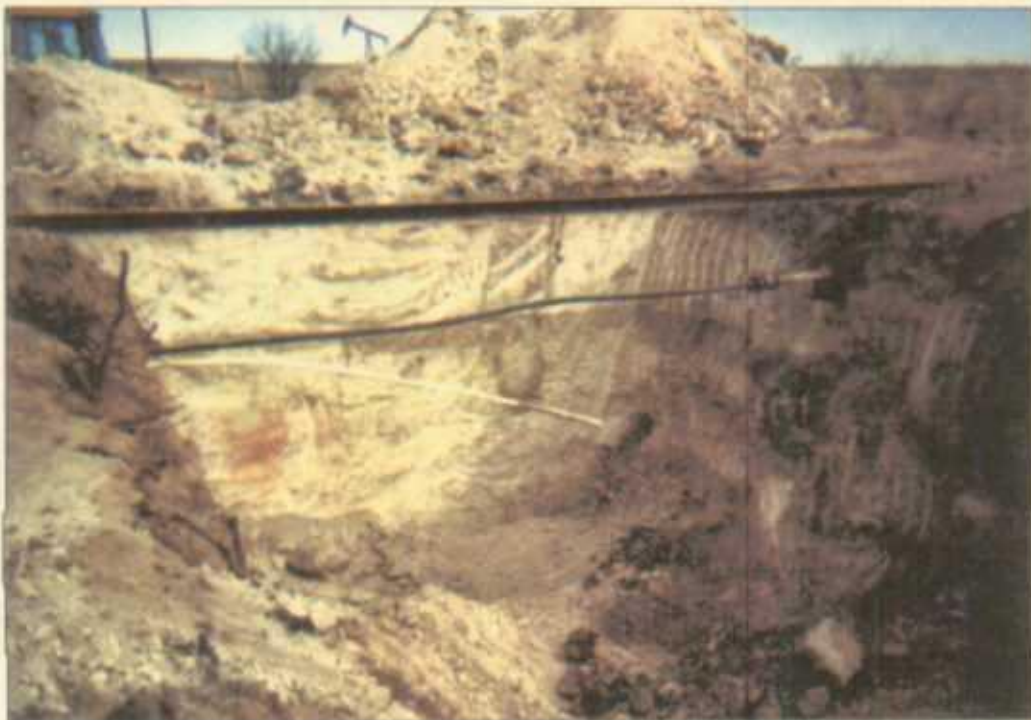
Impact Excavation

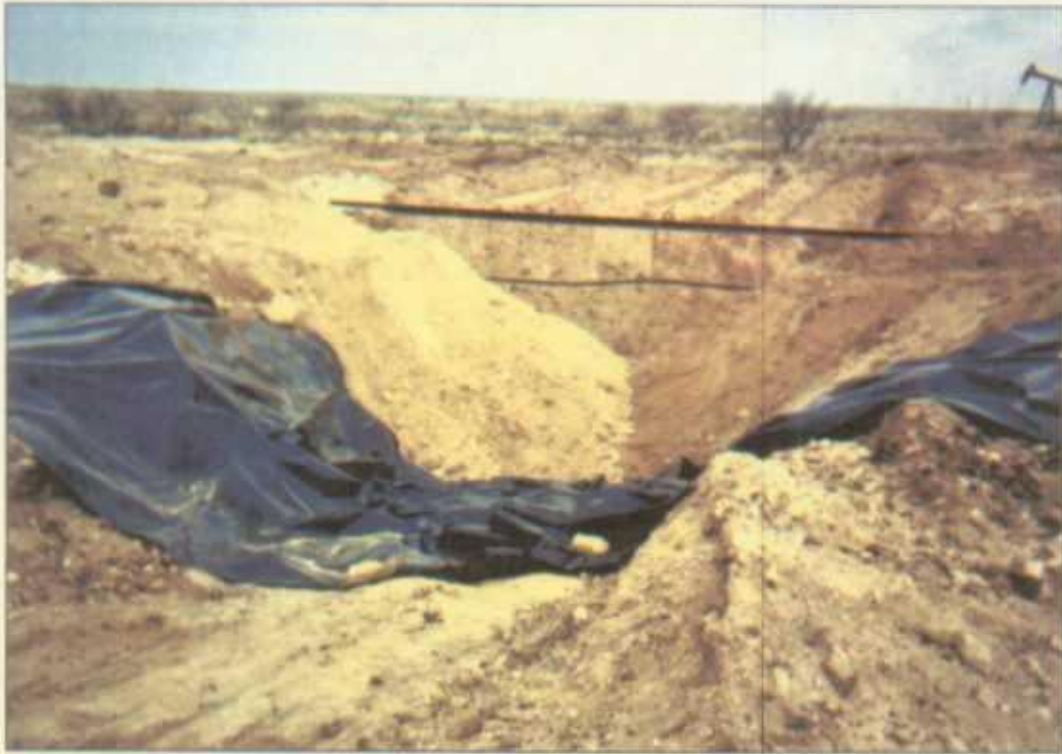
Backfilling Poly Liner

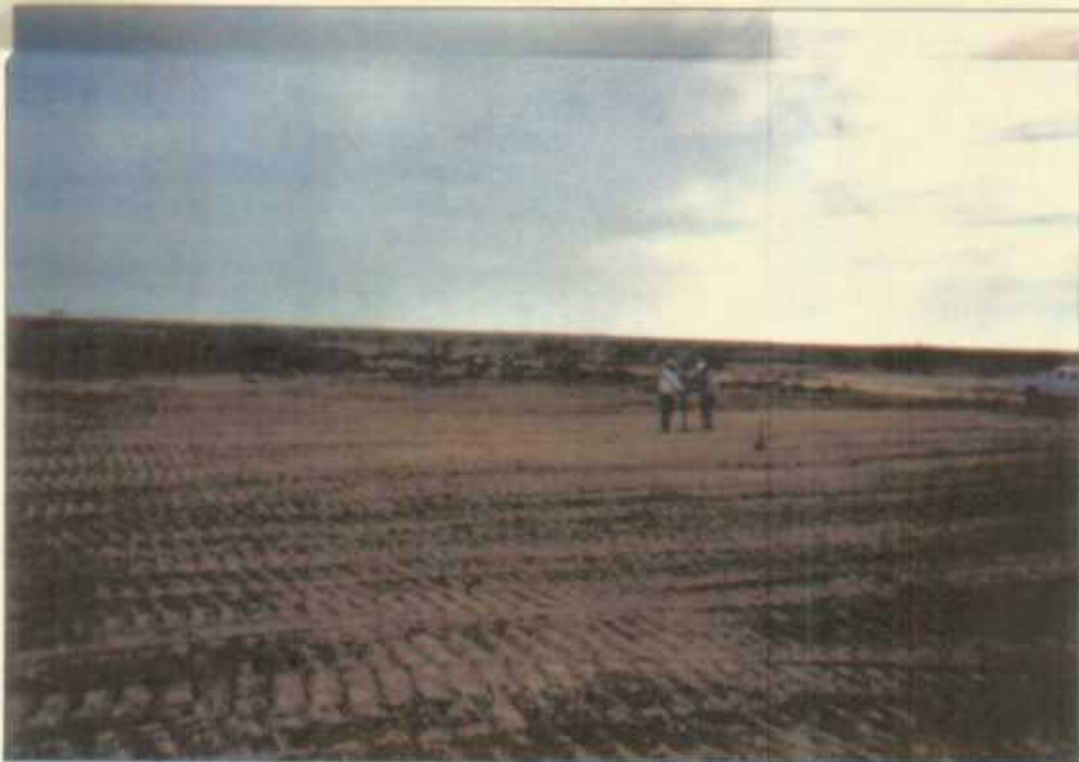
Backfilled (looking north)
