**RICE OPERATING COMPANY  
JUNCTION BOX FINAL REPORT**

SWD SYSTEM	JUNCTION	UNIT	SECTION	TOWNSHIP	RANGE	COUNTY	BOX DIMENSIONS - FEET		
							Length	Width	Depth
EME	State 'B' EOL	D	7	22S	36E	Lea	Moved 50 ft North

# EME State 'B' EOL

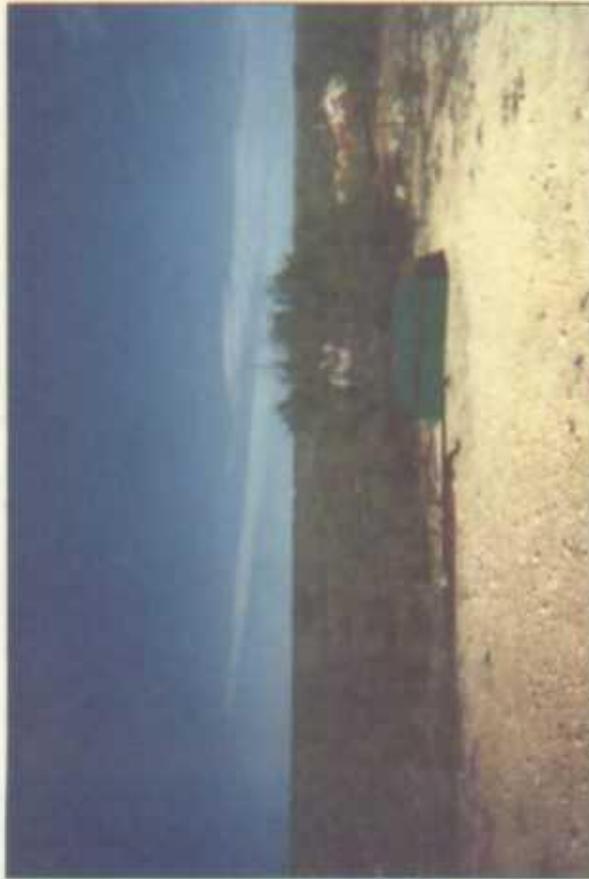
Undisturbed junction box 11/17/2003

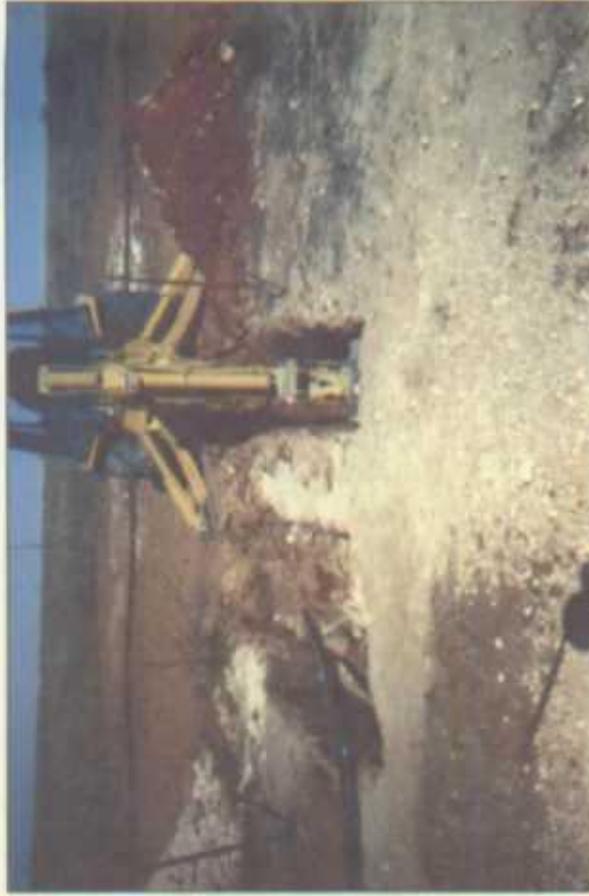
Backhoe delineation 12/10/2003

**General Description of Remedial Action:** This EOL box was located inside the yard of an active production battery. The box was surrounded by healthy, established vegetation. Delineation with a backhoe did not yield a sufficient decline of chloride concentrations with depth. There was no evidence of TPH impact and all PID readings were 0.0. The site was bored with a split-spoon auger on 12/30/2003. The soil bore delineation yielded a conclusive decline in chloride concentrations and boring was ceased at 80 ft (see graph). Because the box was inside an active facility, excavation larger than the trenches was not possible. The site was backfilled and leveled to the surrounding terrain. A new junction box was built 50 ft north of this site. Disturbed vegetation is expected to return at a normal rate. Based on the chloride trend of declination, ROC concludes that groundwater is not threatened at this site.

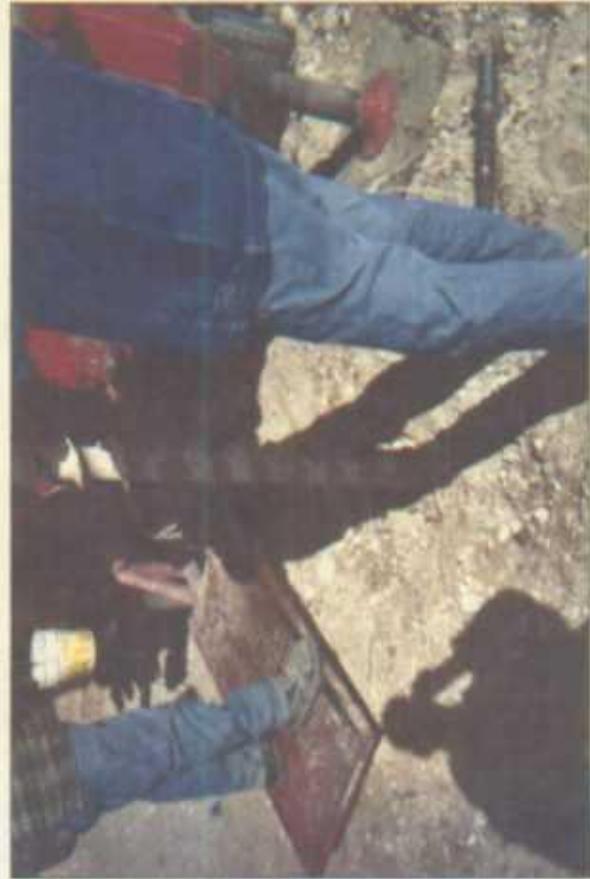
Soil bore delineation 12/30/2003

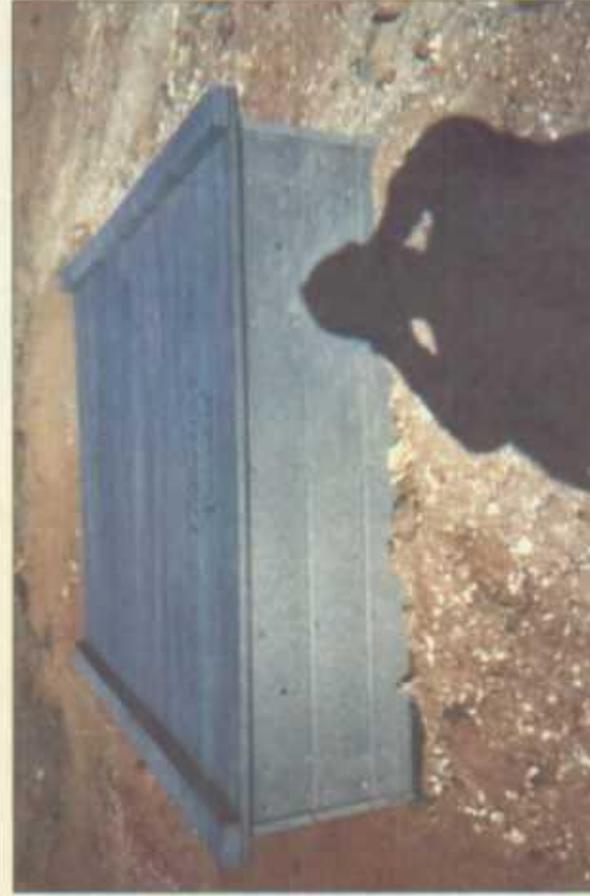
Completed new box 50 ft north of old box 12/3/2003

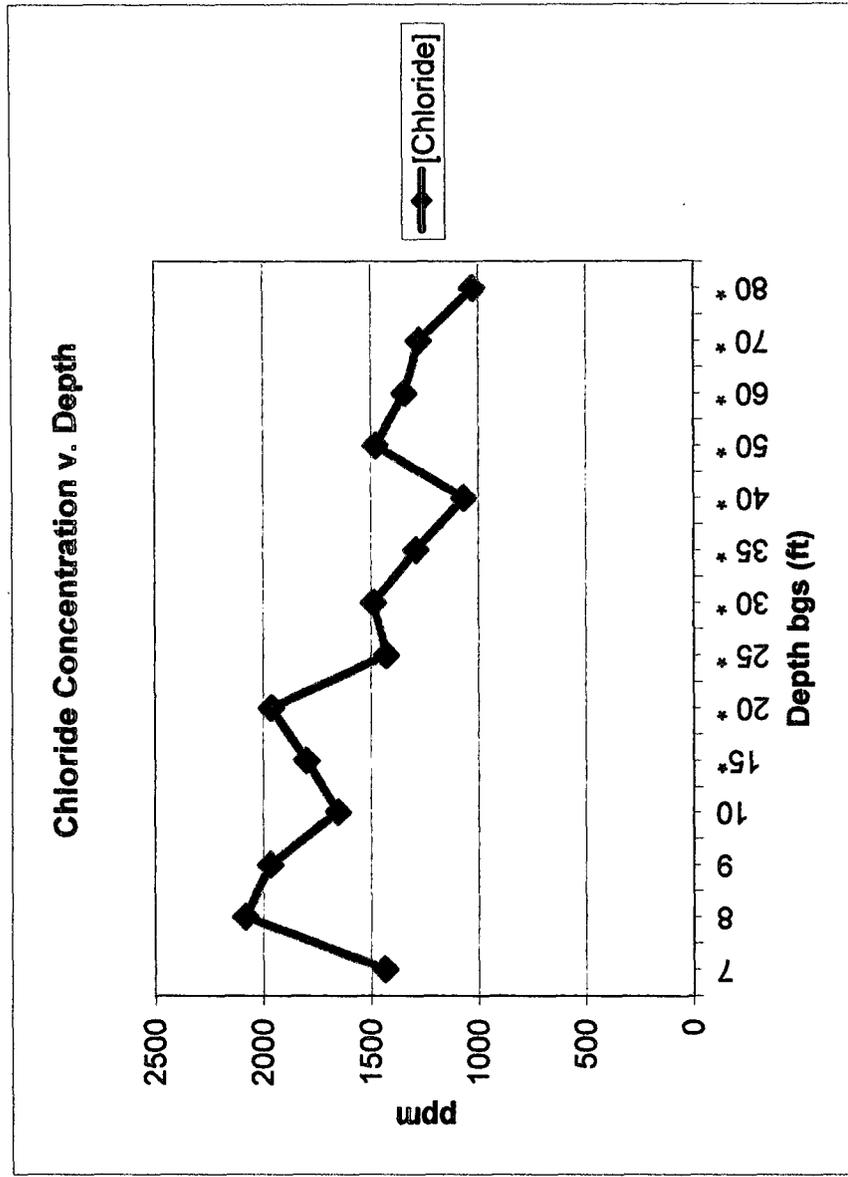
**CHLORIDE CONCENTRATION CURVE**

*Vertical Delineation at Source*

Depth bgs (ft)	[Cl <sup>-</sup> ] ppm
7	1436
8	2085
9	1968
10	1654
15*	1799
20*	1963
25*	1429
30*	1488
35*	1290
40*	1069
50*	1477
60*	1343
70*	1275
80*	1027

Groundwater = 180 ft

\* Soil bore samples
