# FINAL REPORT

**RICE OPERATING COMPANY  
JUNCTION BOX FINAL REPORT**

**BOX LOCATION**

## BD jct. K-20-1

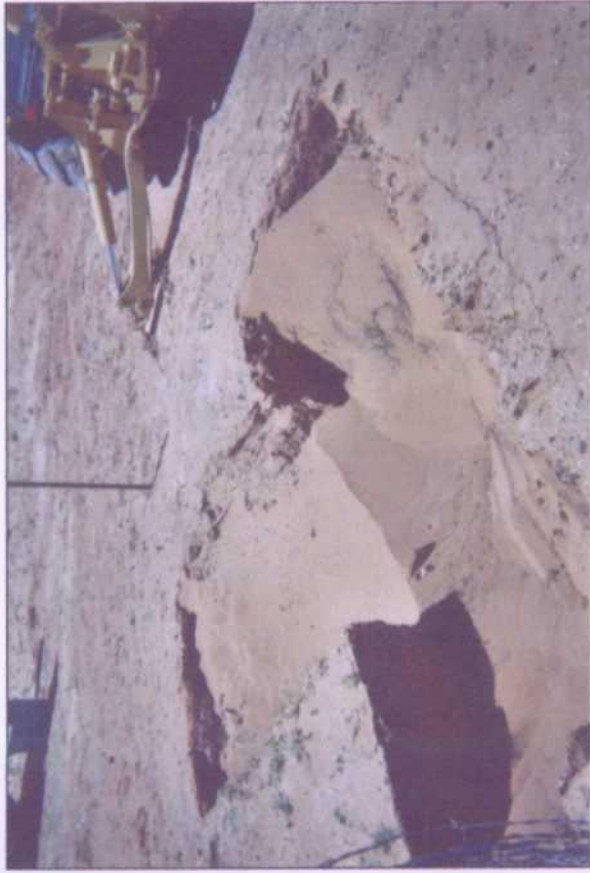
Junction Box Site Before Excavation

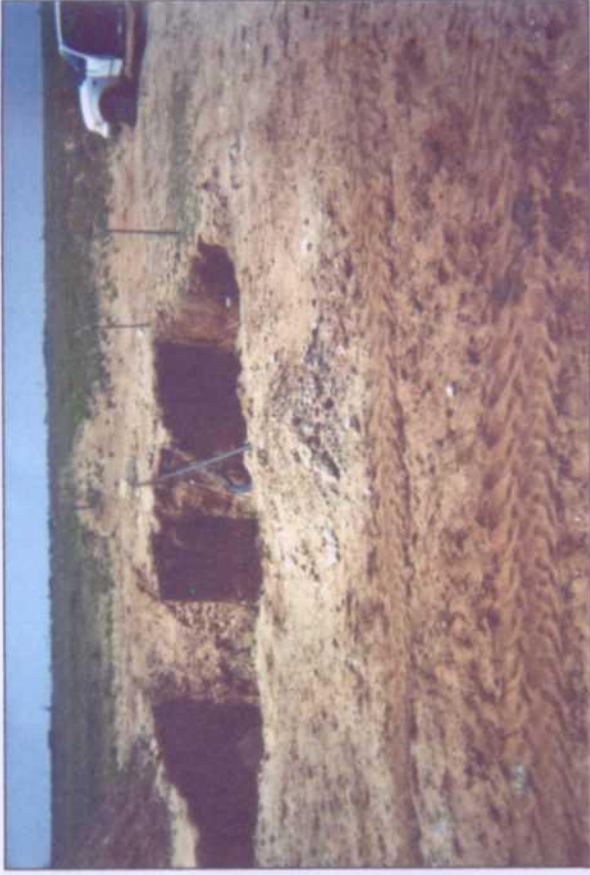
Excavation—May 2003

near the surface surrounding the junction box site, the walls of the 30 x 30 x 12 ft excavation were dug deeper in an effort to confirm a chloride trend. With the deeper delineation, chloride impact did in fact significantly decline with depth, indicative of unsaturated conditions (see graphs). TPH concentrations remained well below NMOCD guidelines. Due to these trends, ROC contends groundwater is not threatened at 87 ft below. A new watertight junction box has been built 45 ft north of this location. The surface disturbed by these activities will be re-seeded with a blend of native vegetation in September to inhibit downward migration of chloride left in place. The site will be monitored for growth.

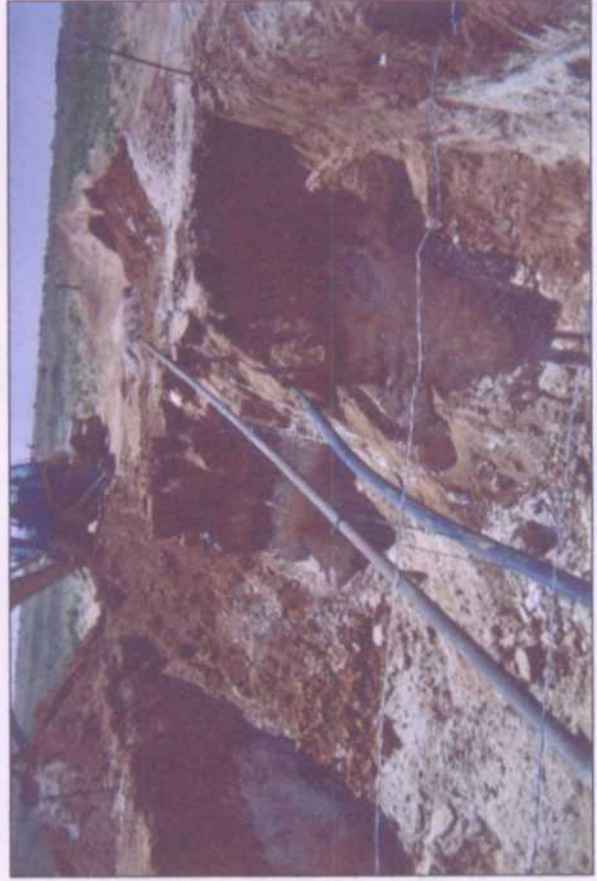
Sloping Excavation—May 2003

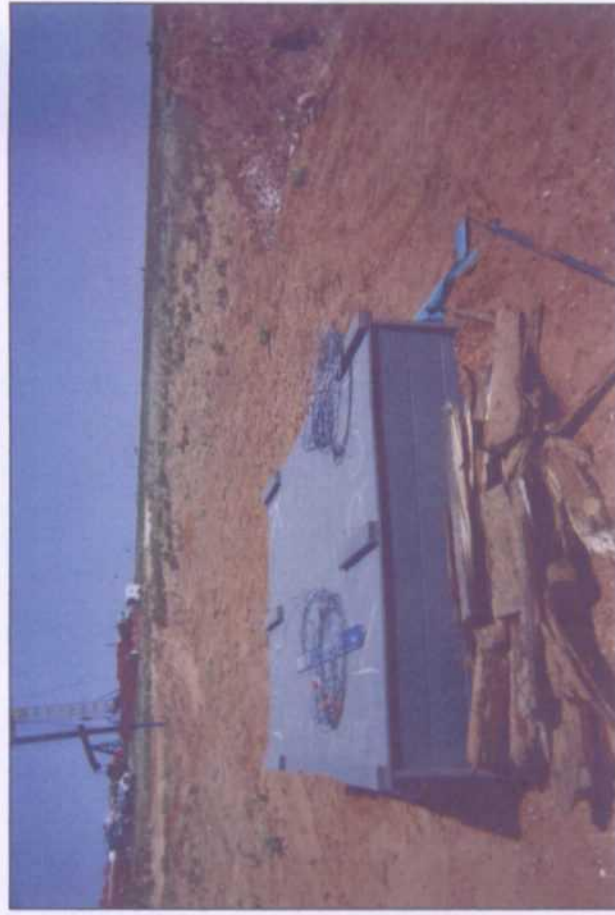
New Watertight Junction Box 45 ft North of Excavation

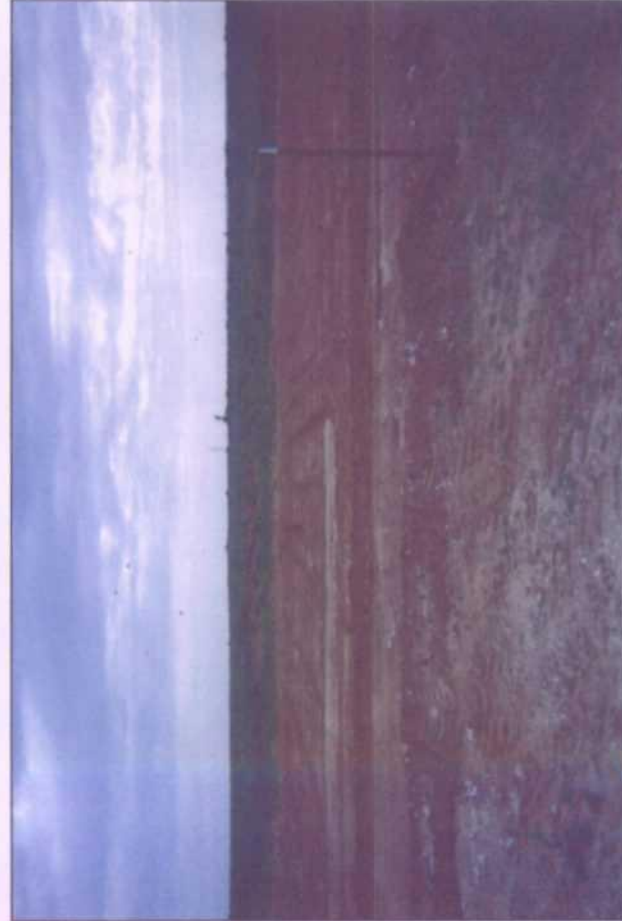
Backfilled—8/6/2003

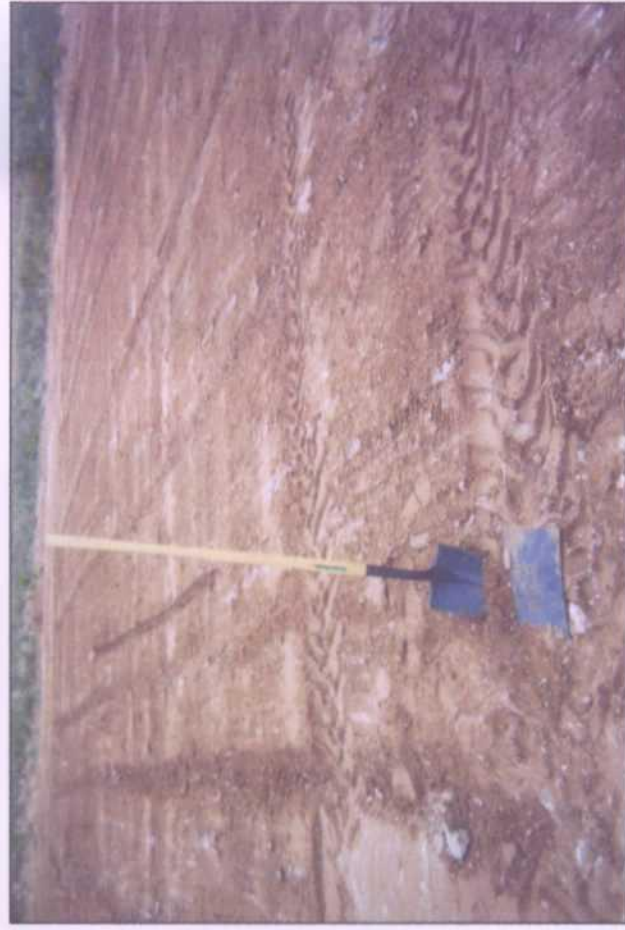
ID Plate At Backfilled Site
