# DISCLOSURE REPORT

**RICE OPERATING COMPANY  
JUNCTION BOX DISCLOSURE\* REPORT**

BD Hardy EOL

UL 'K', Sec. 20, T21S, R37E

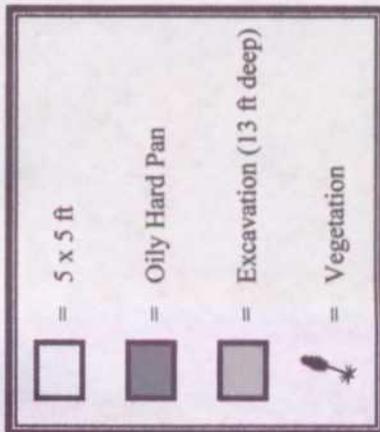
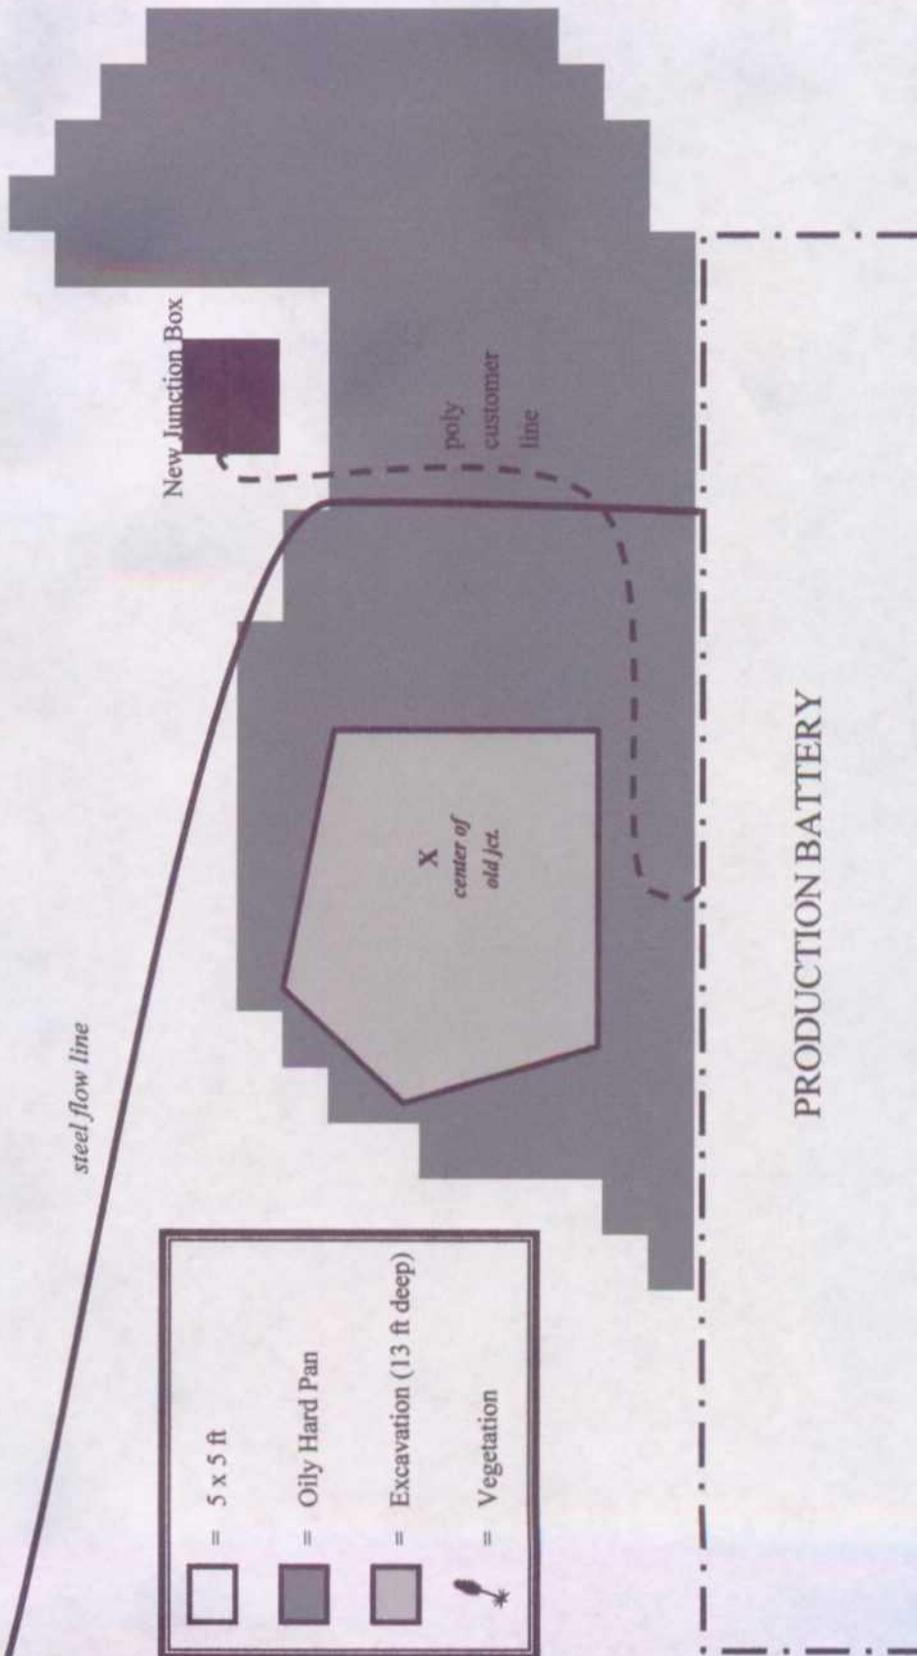
R O A D

PRODUCTION BATTERY

steel flow line

New Junction Box

poly customer line

X  
center of  
old jct.

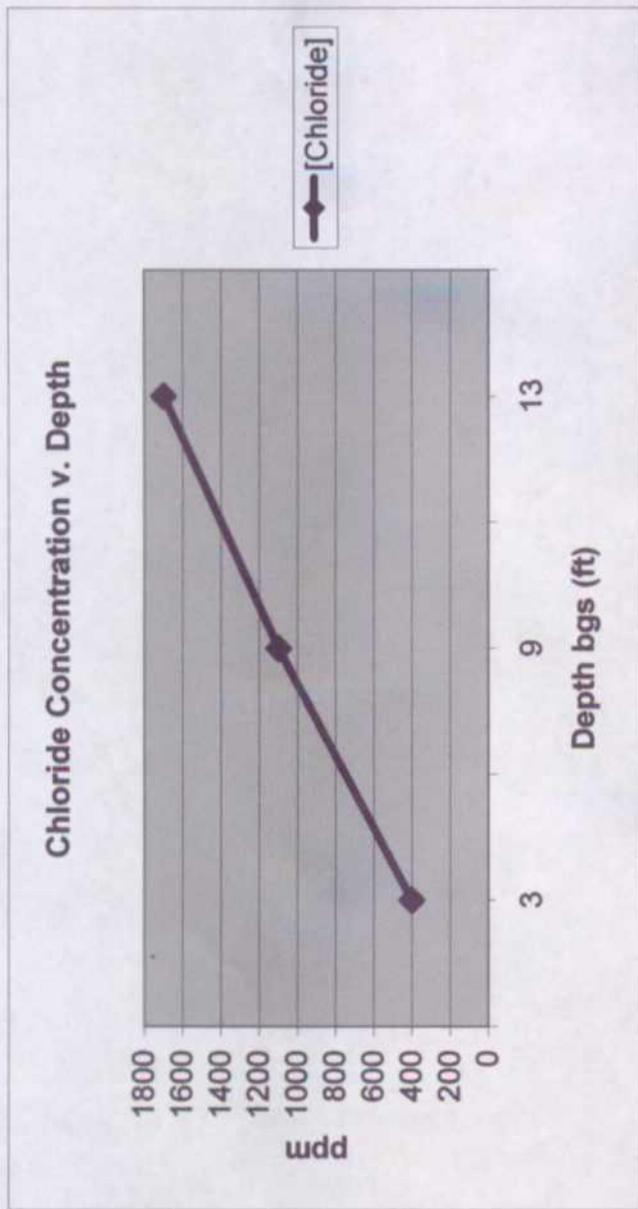
Depth bgs (ft)	[Cl <sup>-</sup> ] ppm
3	400
9	1100
13	1700

Groundwater = 99 ft

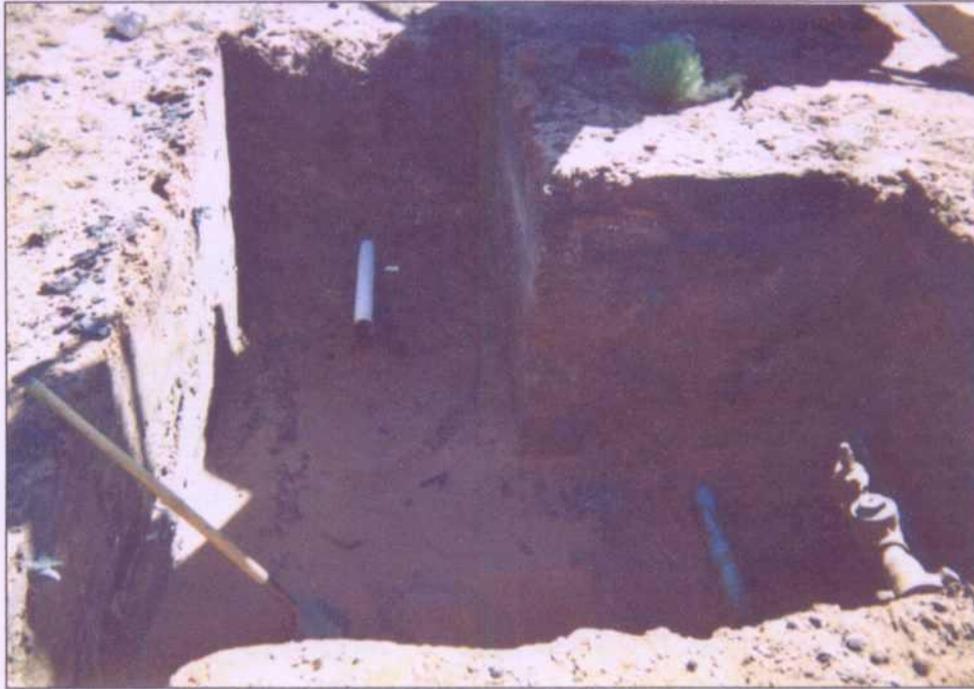
Junction Box Site with Old Plumbing (after NORM)

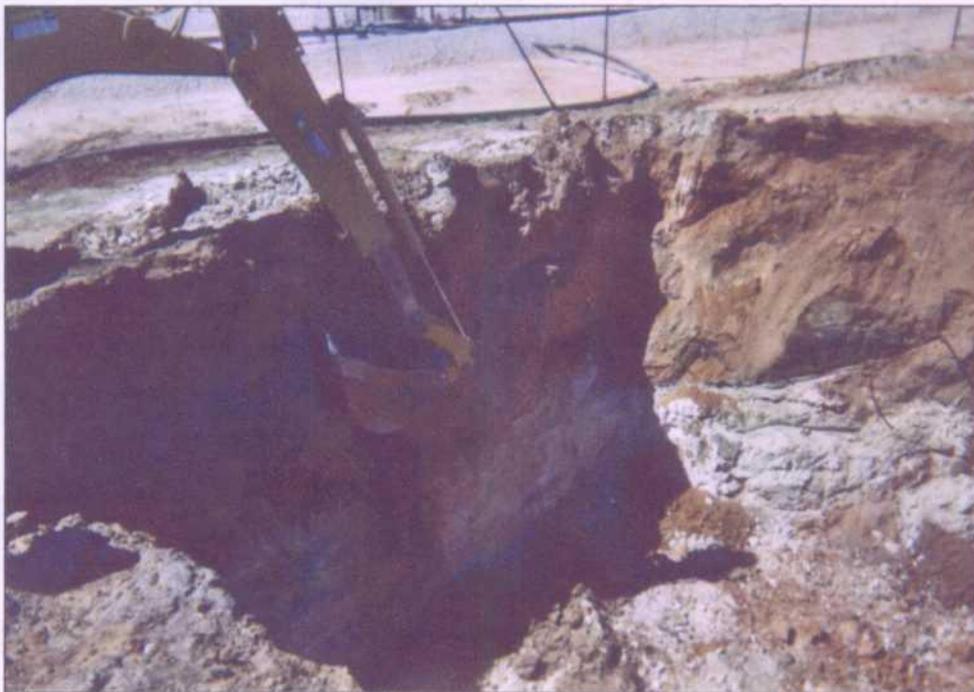
Excavation--May 2003

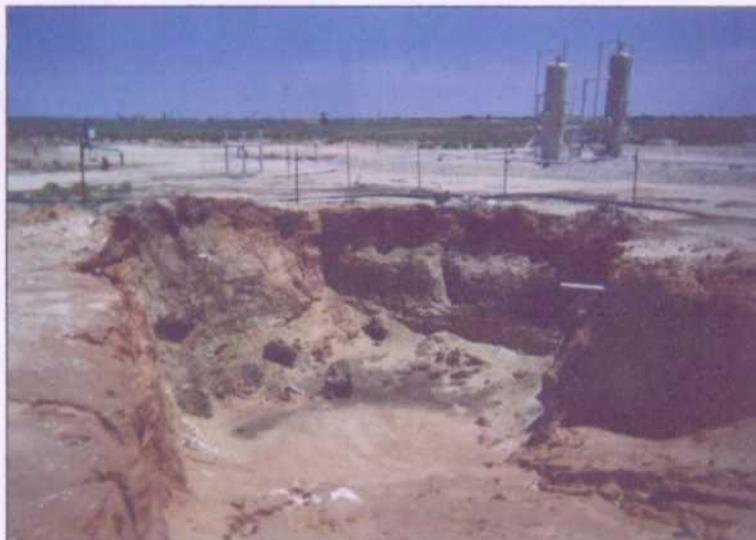
Final Excavation (looking Southeast)—May 2003

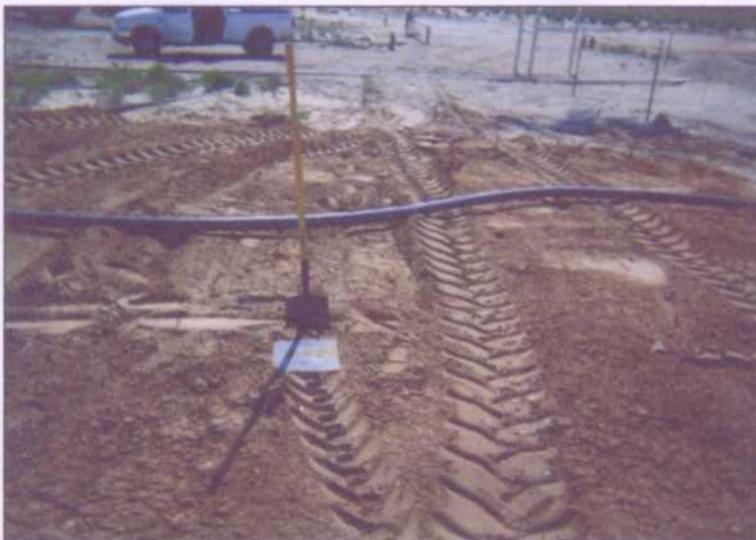
Backfilled with ID plate (looking East)—August 2003

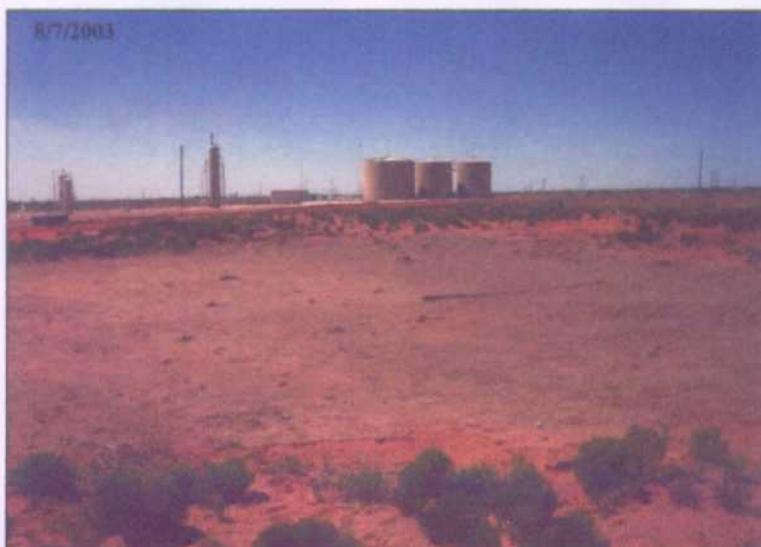
Collection Area ~140 ft North of Old Junction Box Site (new box in left background)—8/7/2003
