**JUNCTION BOX FINAL REPORT**

**BOX LOCATION**

SWD SYSTEM	JUNCTION	UNIT	SECTION	TOWNSHIP	RANGE	COUNTY	BOX DIMENSIONS - FEET		
							Length	Width	Depth
B-D	C-16	C	16	22S	37E	Lea	No Box

## BD jct. C-16

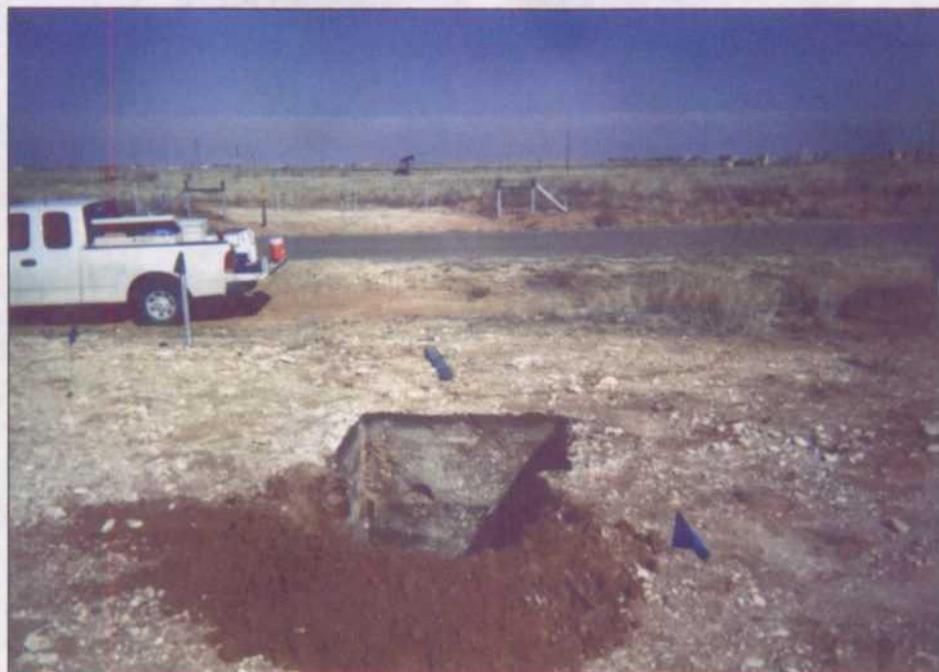
Junction Box Location (before excavation)

General Description of Remedial Action: The walls and bottom were excavated laterally and vertically to below the NMOCD TPH guidelines. The junction box was excavated down to 12' bgs. The chlorides declined from 1955 at the surface to 752 ppm chlorides at 12' bgs, therefore it can be assumed that groundwater was not impacted. The depth to groundwater is 85' bgs. A compacted clay liner was installed to slow the migration of any impact left in place. The excavated soil was blended and landfarmed at the location and then backfilled into the excavation and contoured to the surrounding area.

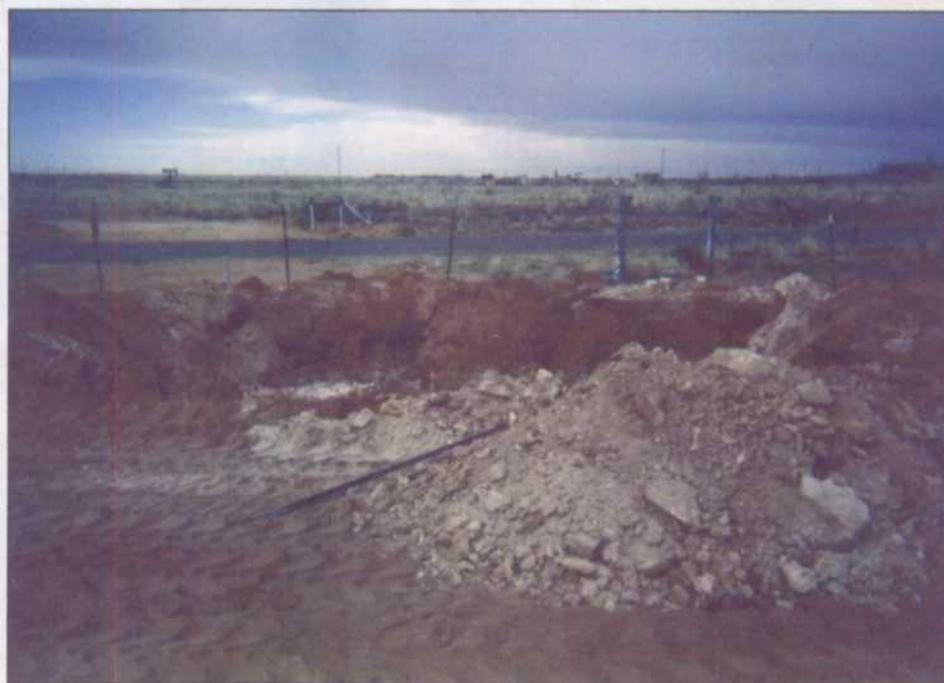
Excavation

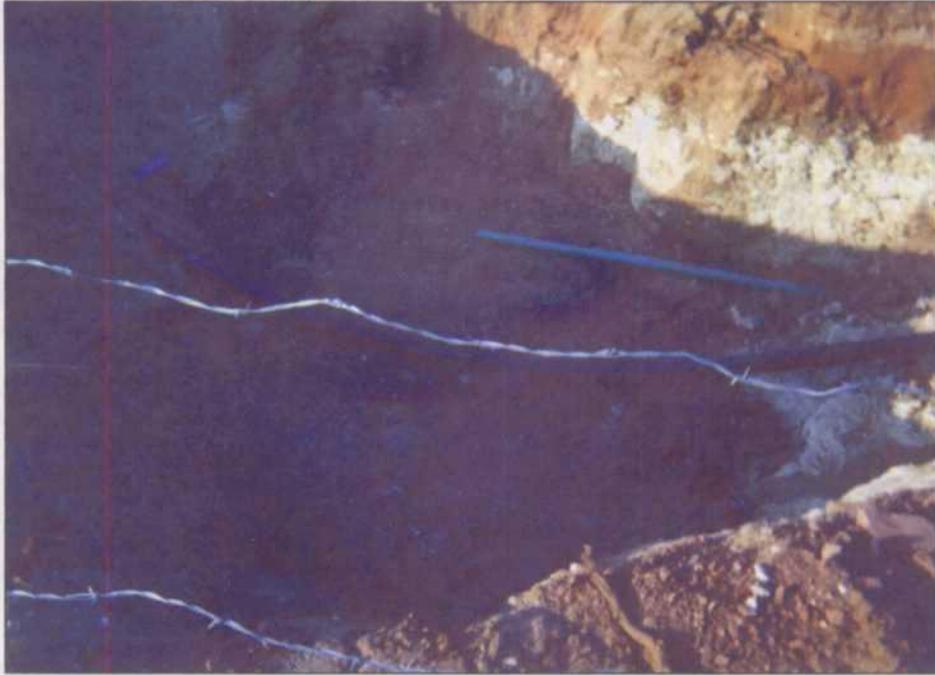
Compacted Clay Barrier

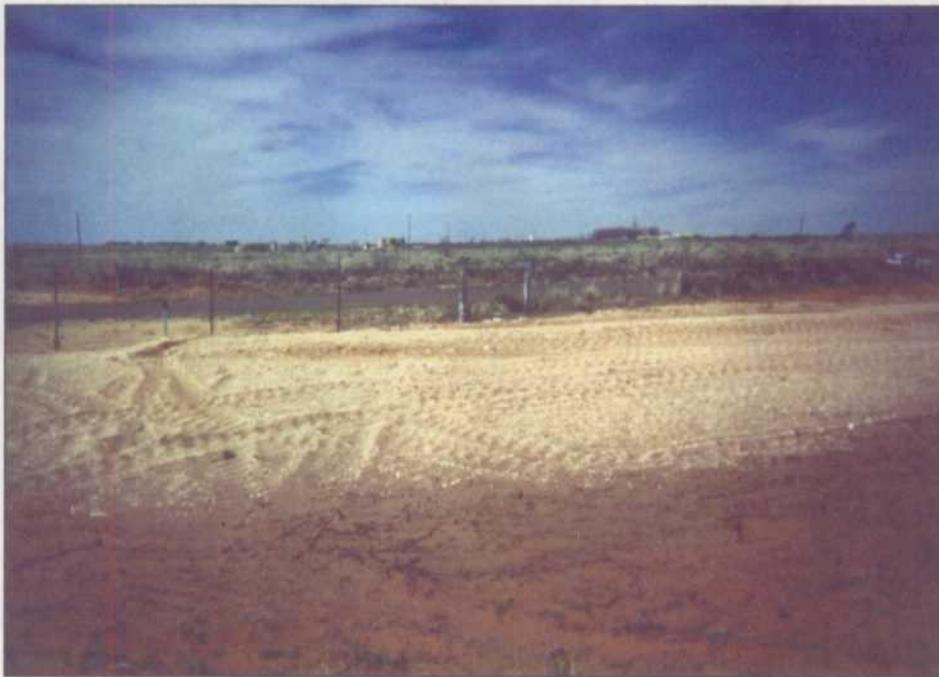
Backfilled

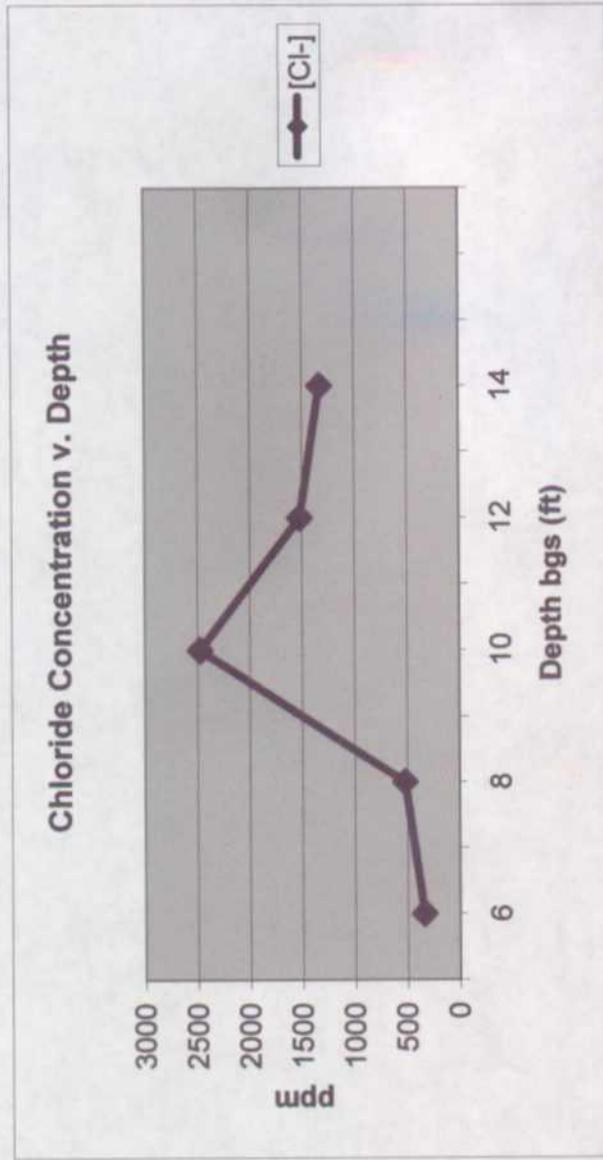
CHLORIDE CONCENTRATION CURVE

BD jct. C-16  
T22S, R37E

Depth bgs (ft)	[Cl <sup>-</sup> ] ppm
6	340
8	520
10	2475
12	1520
14	1330

Groundwater = 87 ft
