Vac. Jct J-26-2

Final Report

RICE OPERATING COMPANY
JUNCTION BOX FINAL REPORT

Vacuum jct. J-26-2

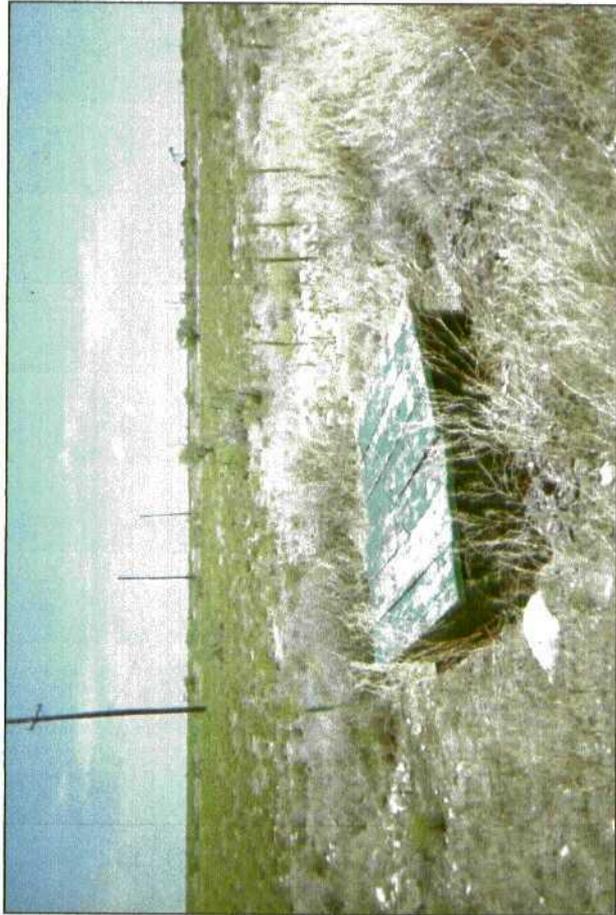
7/1/2005

undisturbed junction box

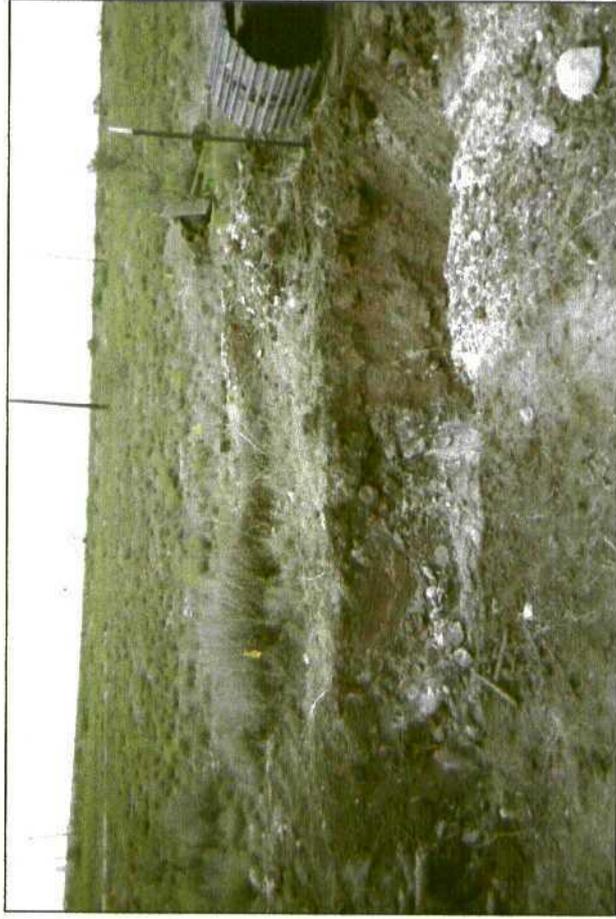
8/4/2005

delineation trench at former junction site

as part of the Vacuum SWD System abandonment. After the box was removed, a delineation trench was made at the former junction site using a backhoe while soil samples were collected every ft of depth from 1 to 7 ft BGS. Chloride field tests yielded low concentrations and exhibited a conclusive trend of decline with depth. The soil samples did not exhibit any physical indications of hydrocarbon or chloride impact and PID screenings were also very low. A grab sample from 7 ft BGS was analyzed at a laboratory for confirmation of field tests. TPH concentrations were not present within the lab's detection limits (<10.0 ppm), meeting NMOCD guidelines. The excavated soil was blended on site and then backfilled into the trench and contoured to the surrounding surface. The disturbed surface was seeded with a blend of native vegetation and is expected to return to productive capacity at a normal rate. Since the Vacuum SWD System is no longer active, a new junction box is not required.

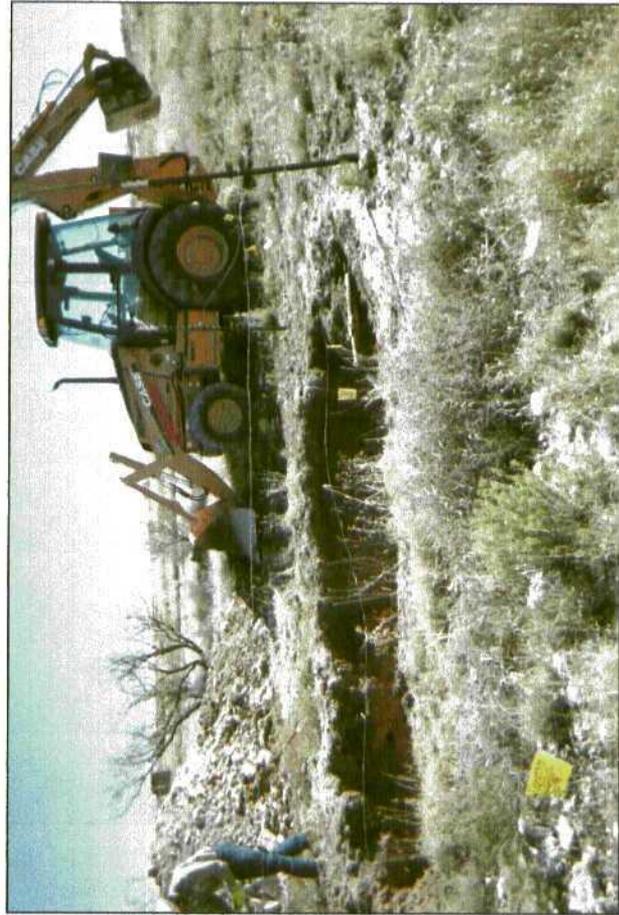
11/21/2005

backfilling trench

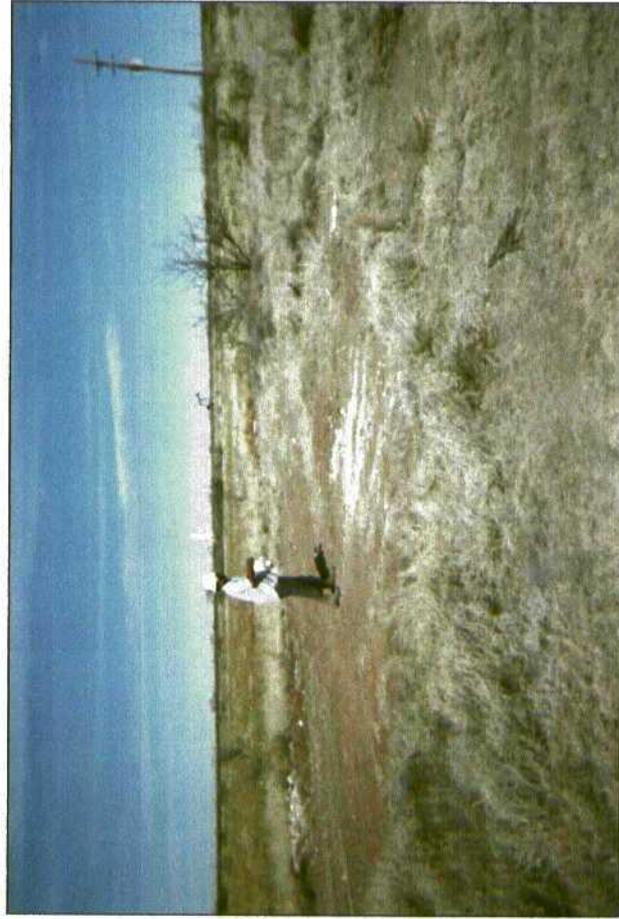
11/23/2005

seeding backfilled site

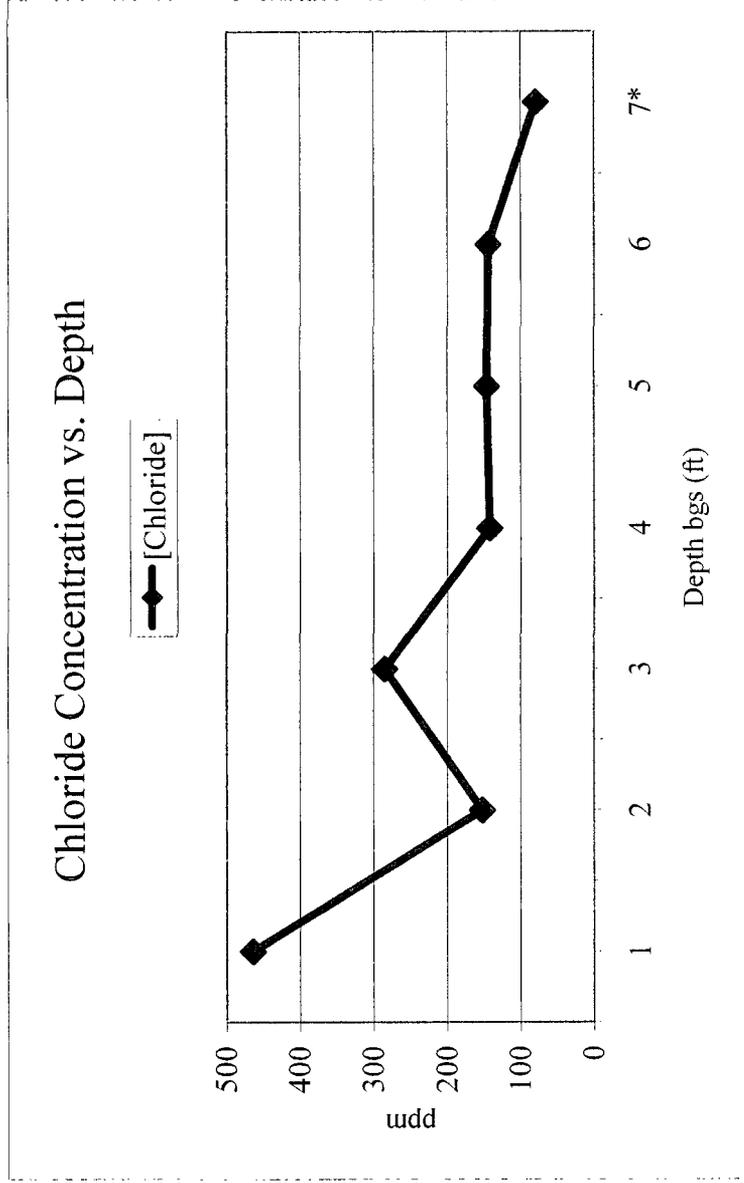
Vertical Delineation at Junction

Depth bgs (ft)	[Cl] ppm
1	464
2	152
3	285
4	142
5	146
6	144
7*	79.1

Groundwater = 55 ft

*Laboratory analysis
