Uac Jct 6-33

Final Report

**RICE OPERATING COMPANY
JUNCTION BOX FINAL REPORT**

SWD SYSTEM	JUNCTION	UNIT	SECTION	TOWNSHIP	RANGE	COUNTY	BOX DIMENSIONS - FEET		
							Length	Width	Depth
Vacuum	jct. G-33	G	33	17S	35E	Lea	no box--System abandoned

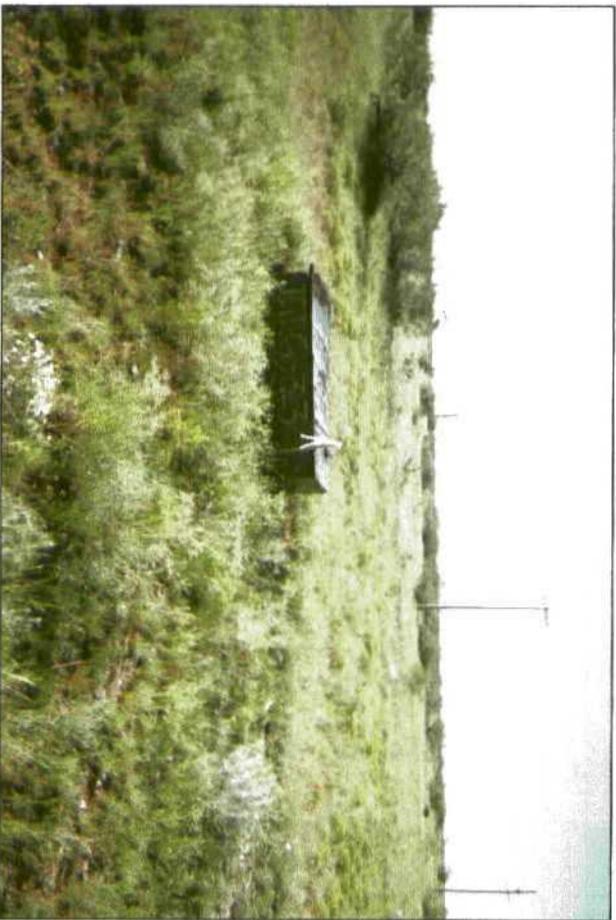
undisturbed junction box (facing south)

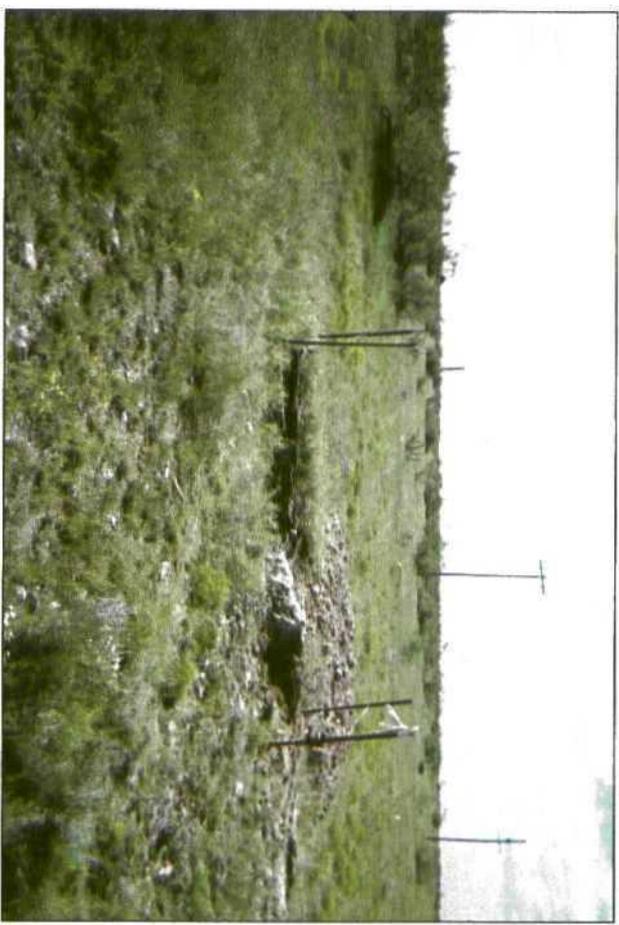
box removed, prior to excavation (facing south)

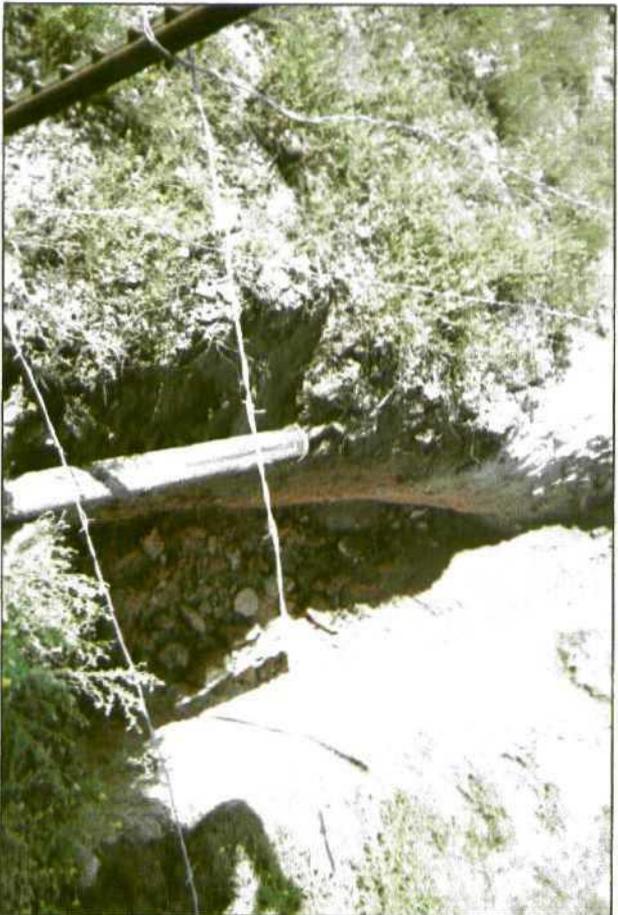
delineation trench at former junction box site

part of the Vacuum SWD System abandonment. A delineation trench was made at the junction to 6 ft BGS using a backhoe. Soil samples were collected every vertical ft of depth from 2 to 6 ft. Chloride field tests were conducted on these samples and yielded a conclusive trend of decline with depth, indicative of non-saturated vadose conditions. The laboratory analysis of the 6 ft sample confirmed the low concentration of 67.1 ppm, similar to background level. PID screenings performed on the soil samples were all 0.0 ppm and there were no indications of hydrocarbon impact. TPH was not present in detectable concentrations (<10.0 ppm), meeting NMOCD guidelines. The excavated soil was blended on site and then backfilled into the trench. The disturbed surface was seeded with a blend of native vegetation and is expected to return to productive capacity at a normal rate. Because the SWD System is no longer active, a new junction box is not required.

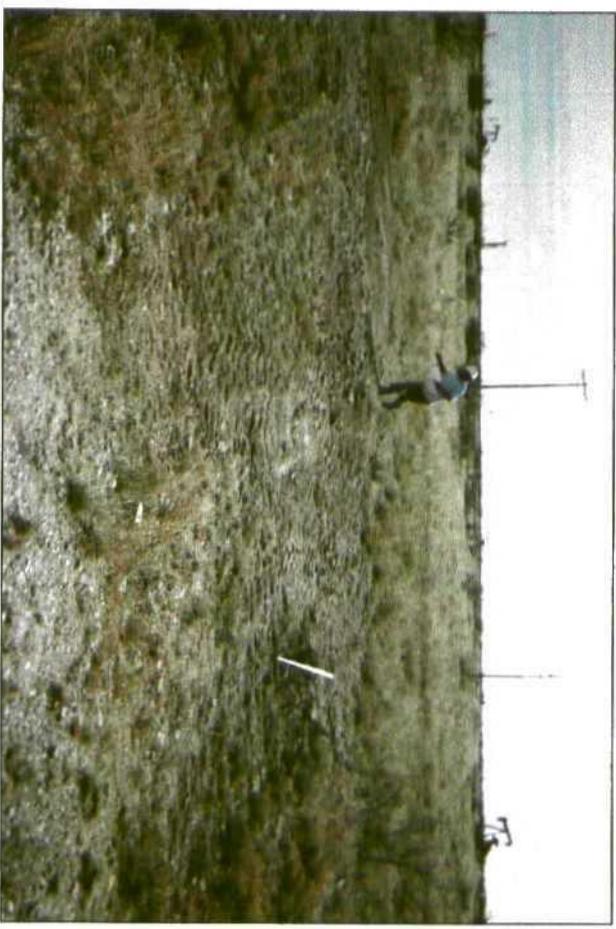
seeding disturbed surface after backfill
