EME A-8 boat

# FINAL REPORT

**RICE OPERATING COMPANY  
JUNCTION BOX FINAL REPORT**

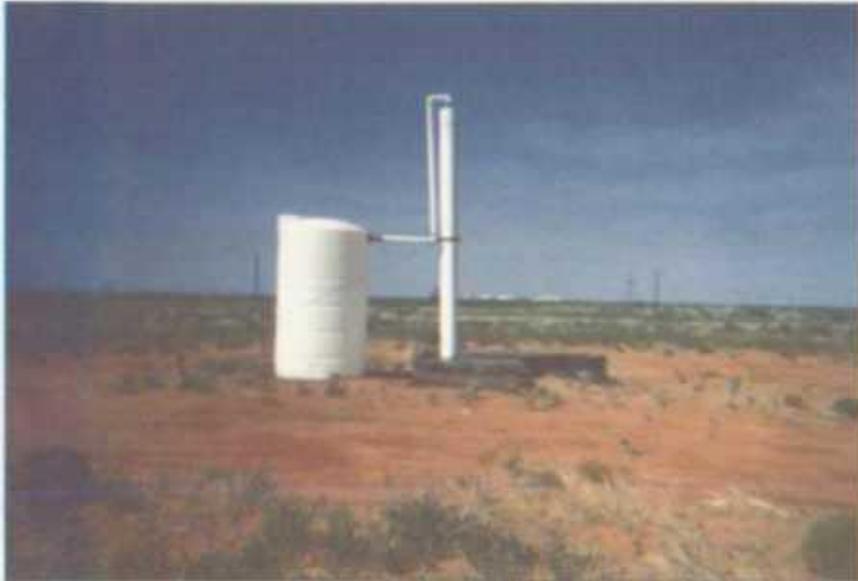
Undisturbed Box & Boot Before NORM Removal (2/18/2003)

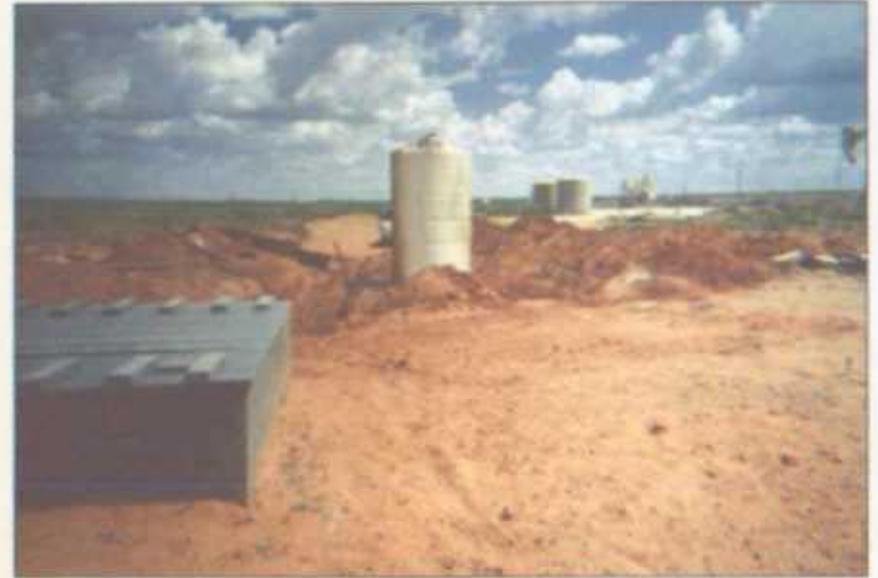
New Junction Box in Foreground, Moved 60 ft West (Aug. 2003)

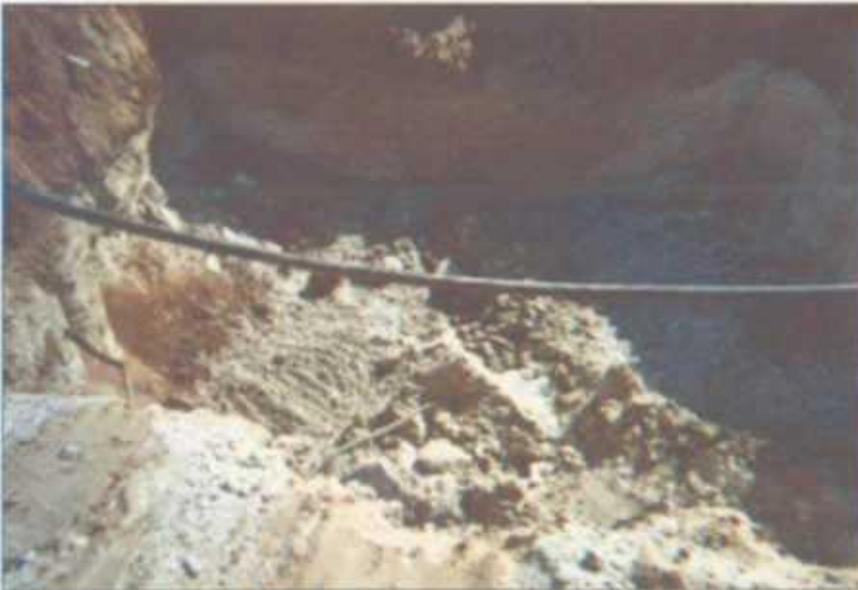
30 x 30 x 11-ft-deep Excavation (Sept. 2003)

General Description of Remedial Action: The site was delineated vertically and laterally with a backhoe while chloride tests and PID readings were performed at regular intervals. Chloride concentrations exhibited a vertical and lateral decline. TPH concentrations were well below NMOCD guidelines. Bottom composite and 4-wall composite samples were taken for closure from the final 30 x 30 x 11 ft deep excavation. The excavated soil was blended at the location and then backfilled into the excavation. The disturbed surface area was re-seeded with native vegetation on 10/15/2003 and will be monitored for growth.

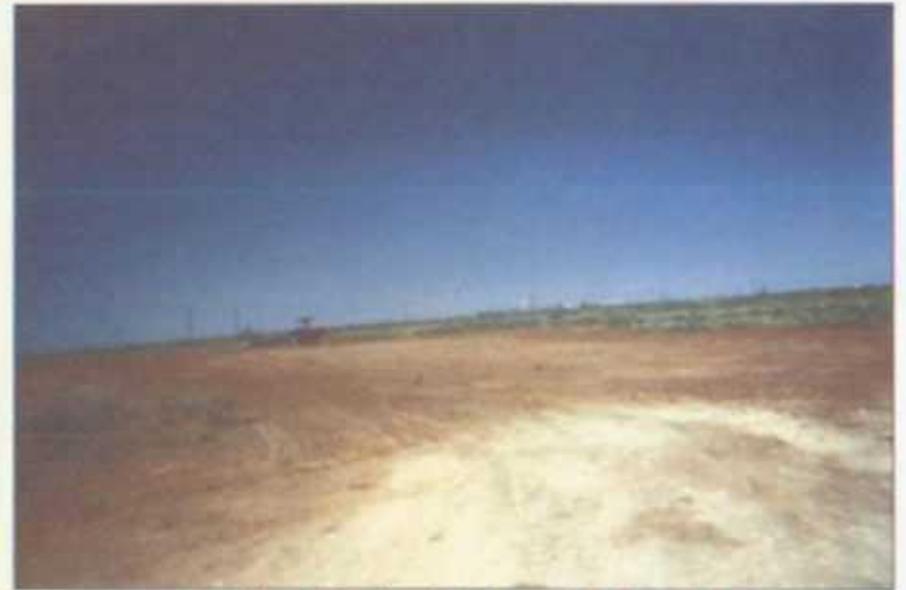
Seeding Disturbed Surface (10/15/2003)

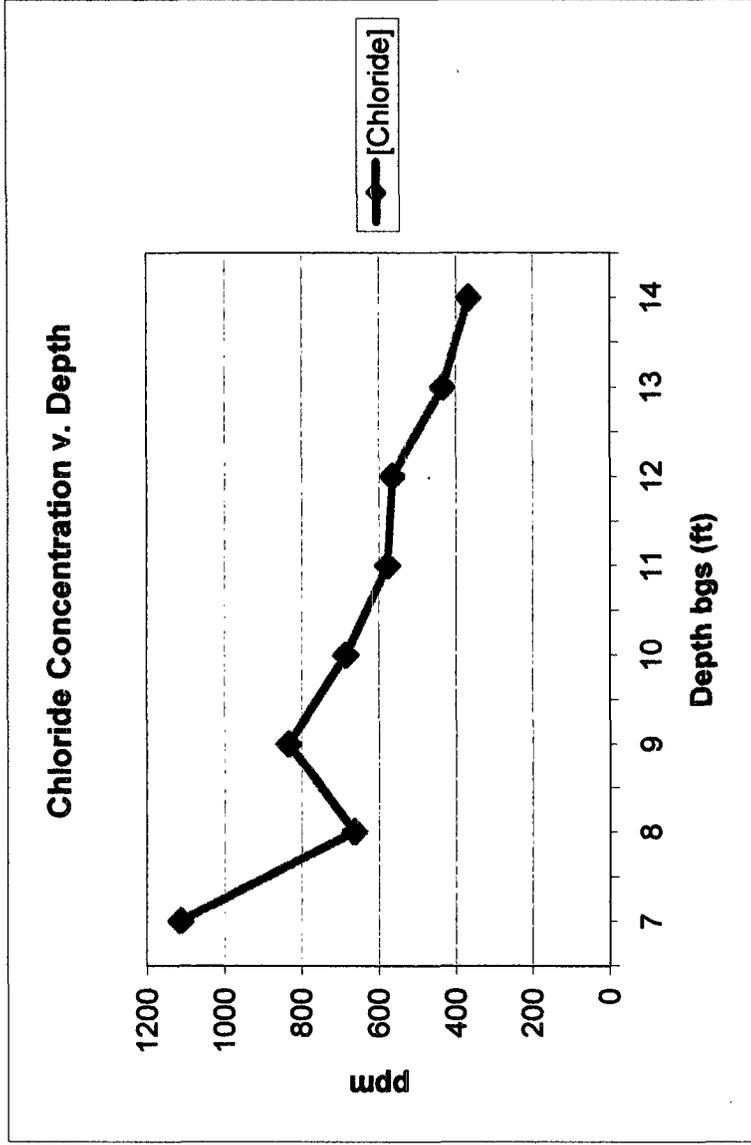
**CHLORIDE CONCENTRATION CURVE**

Depth bgs (ft)	[Cl <sup>-</sup> ] ppm
7	1113
8	664
9	834
10	685
11	577
12	565
13	434
14	367

Groundwater = 200 ft

LOCATION	DEPTH (ft)	ppm
vertical @ jct.	7	1113
	8	664
	9	834
	10	685
	11	577
	12	565
	13	434
	14	367
4-wall comp.	n/a	381
remed. comp.	n/a	374
