# FINAL REPORT

**RICE OPERATING COMPANY  
JUNCTION BOX FINAL REPORT**

# EME GM State EOL 15' x 20' x 12' Excavation

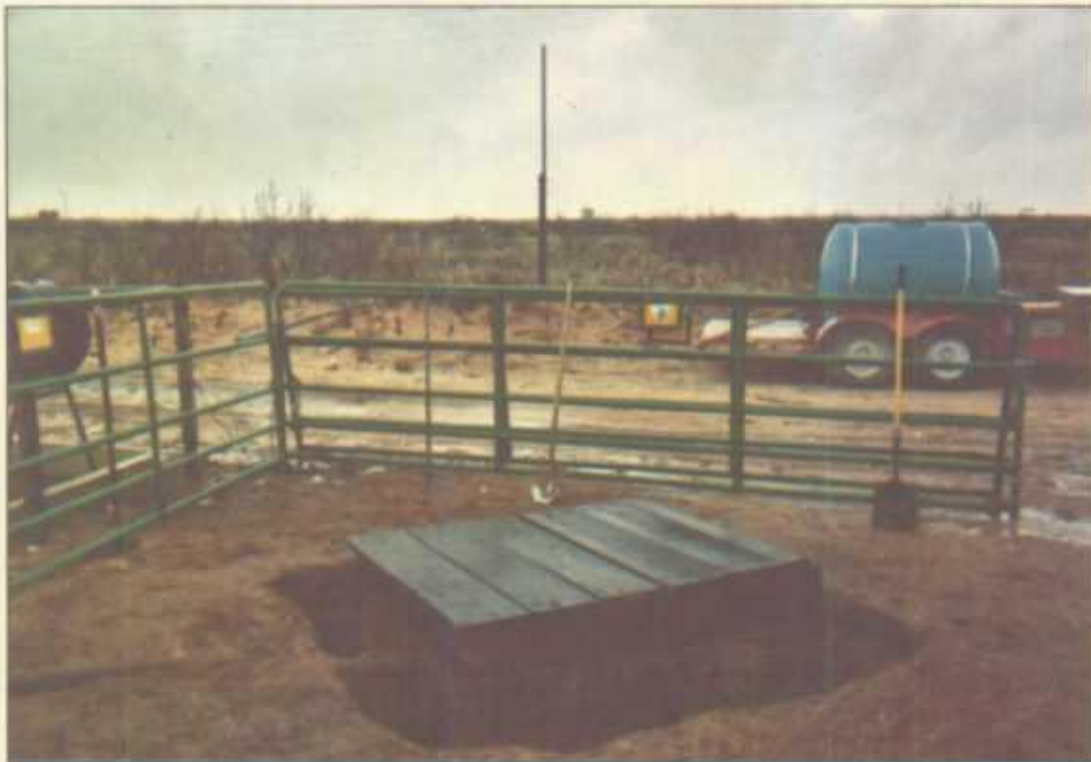
Old Junction Box

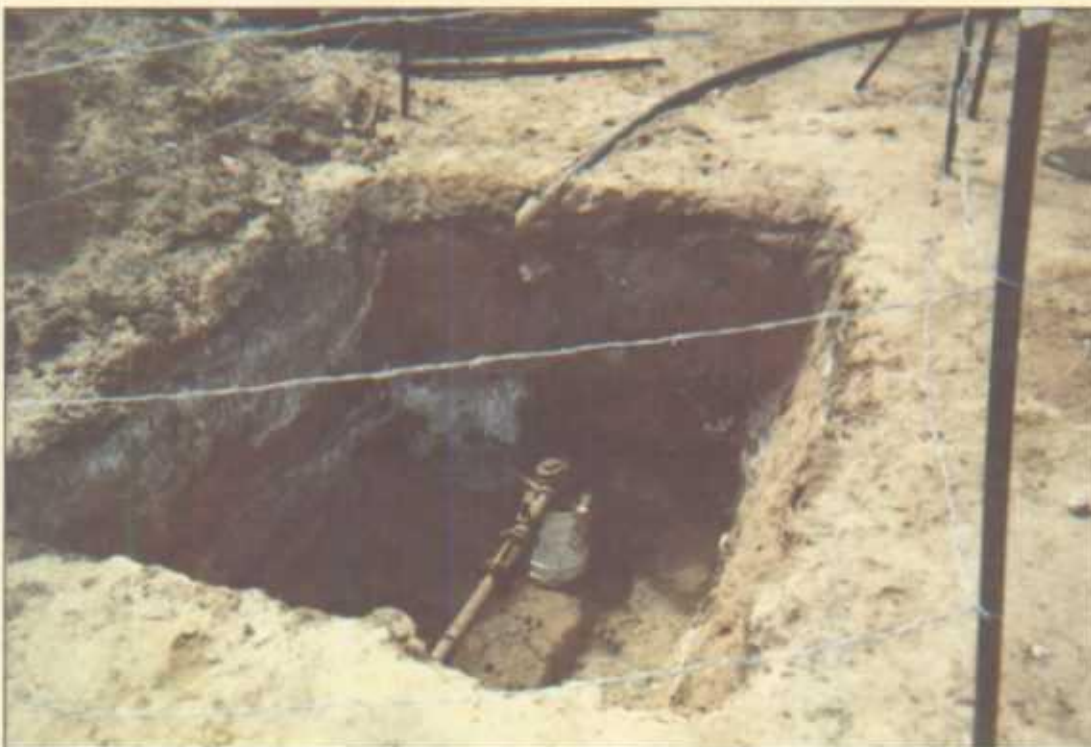
After NORM Removal; Before Remediation

**General Description of Remedial Action:** Chloride impact was vertically consistent at this junction box located next to an active production facility. The surrounding surface area is oil-stained and overlain by hardpan. There is evidence of saltwater spills near the water tank at the battery. A 20' x 15' area at the box was excavated down to 12' bgs, where a compacted clay barrier was installed to inhibit downward migration of remaining chloride impact. NMOCD TPH guidelines were met on the walls and bottom. The excavation was then backfilled with the soil that was landfarmed on site. A new watertight box has been built on the other side of the road away from the active facility (see diagram).

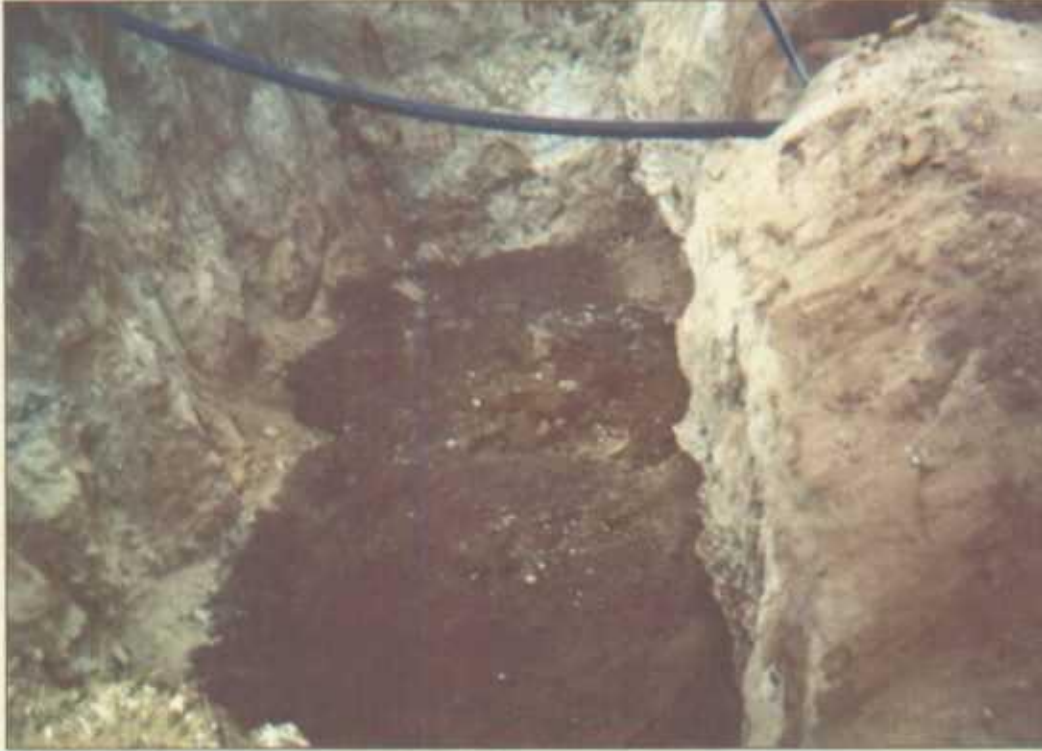
Excavation with Clay Liner at Bottom

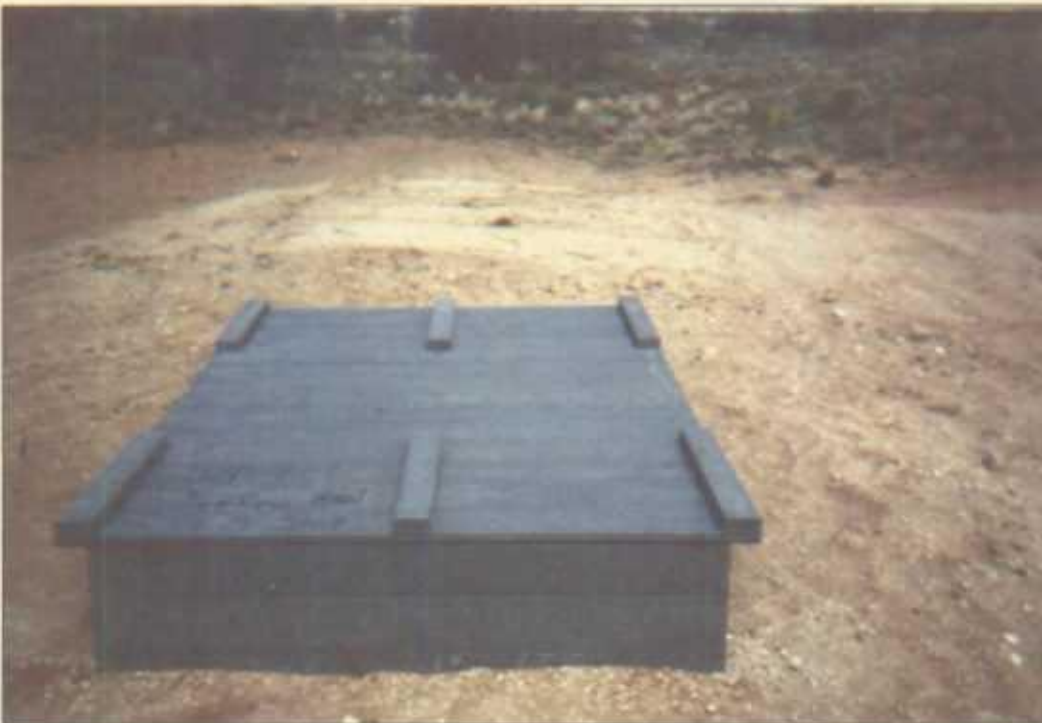
New Junction Box North of Road (see diagram)

new jct. box  
moved 20' north
