BD JCT B-25

1R0426-104

DISCLOSURE REPORT

**RICE OPERATING COMPANY
JUNCTION BOX DISCLOSURE * REPORT**

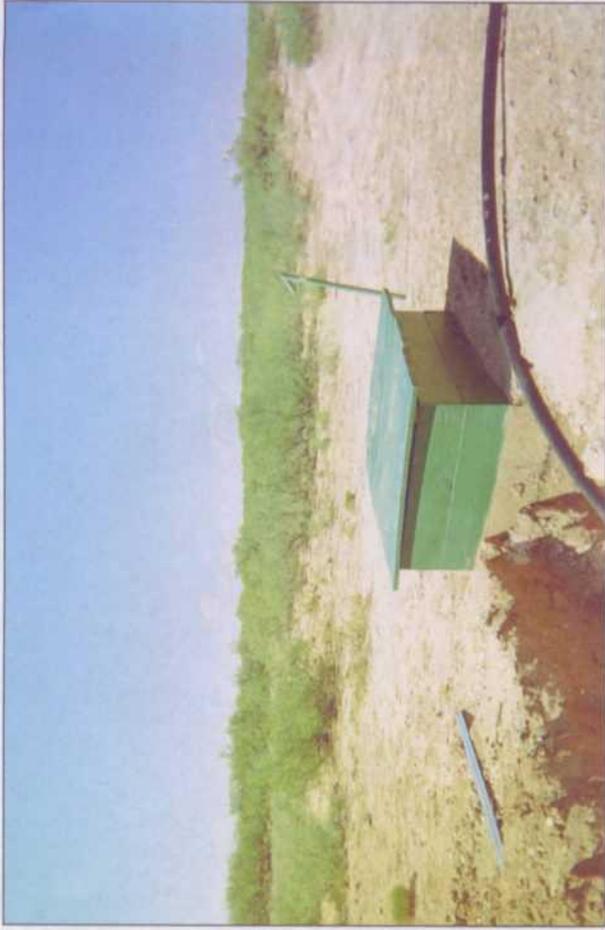
undisturbed junction box

7/22/2003

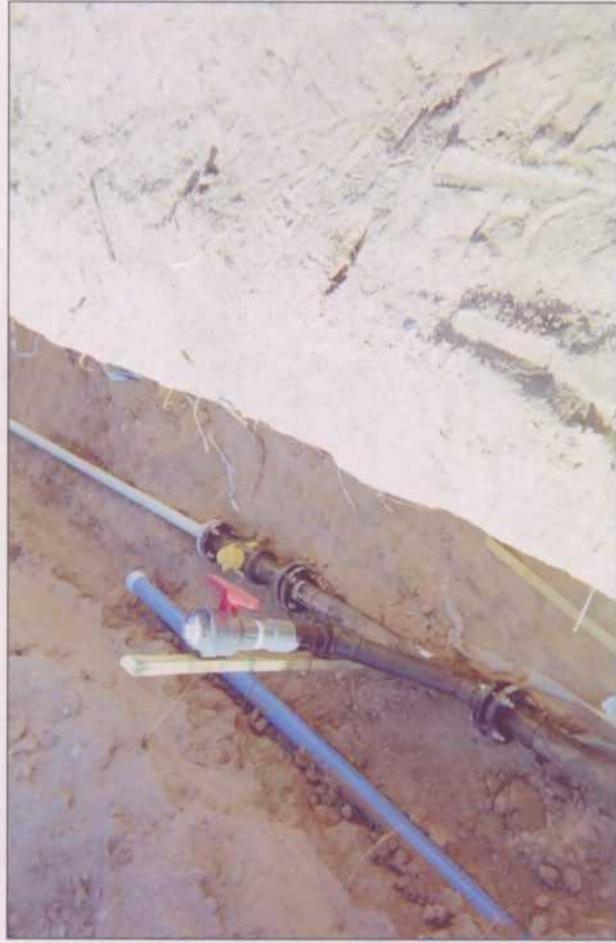
new plumbing at new box location 20 ft south

8/20/2003

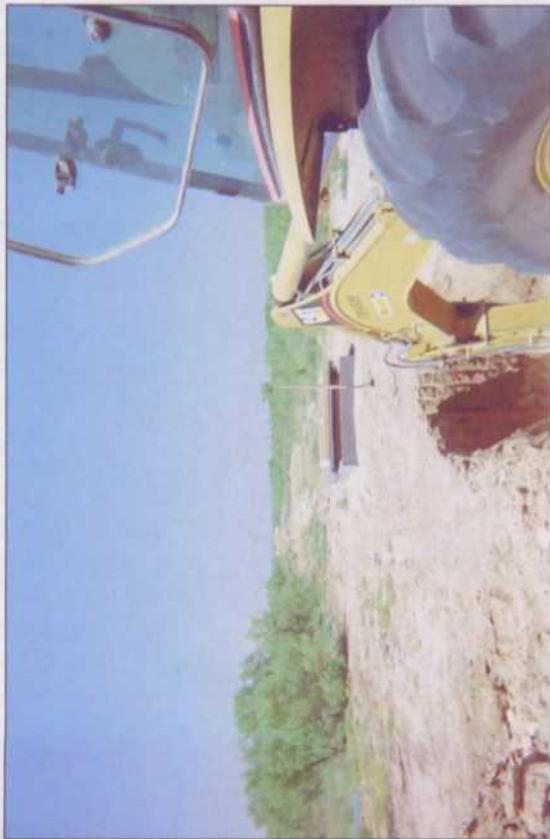
beginning delineation & excavation at former box site;
new junction box in background 5/26/2004

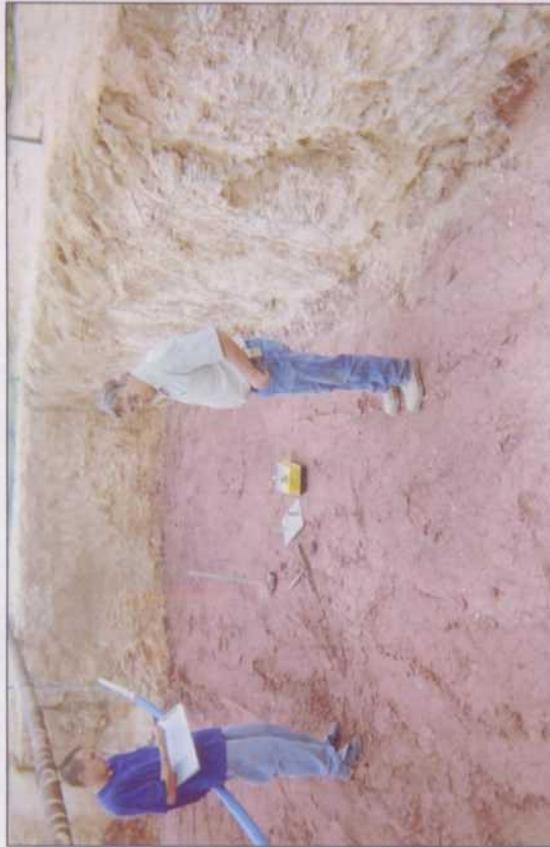
testing compacted clay at 6 ft BGS

6/22/2004

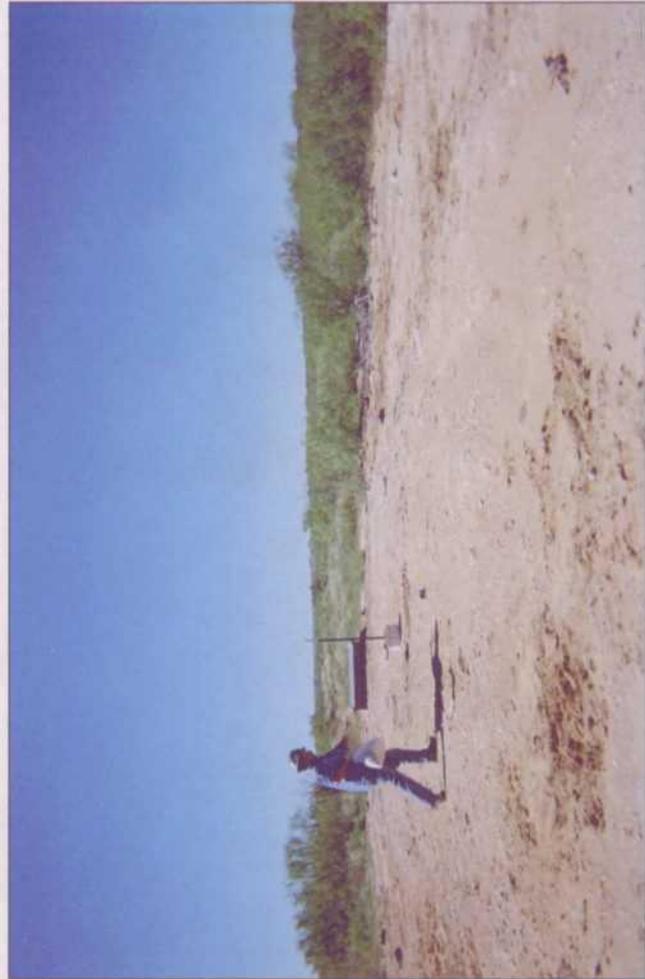
seeding disturbed area; ID plate on surface

10/15/2004

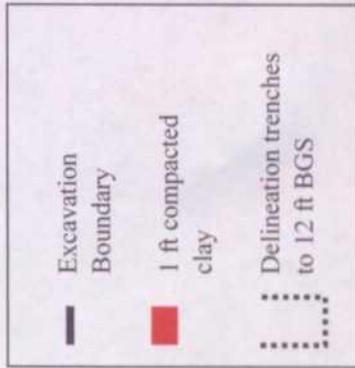
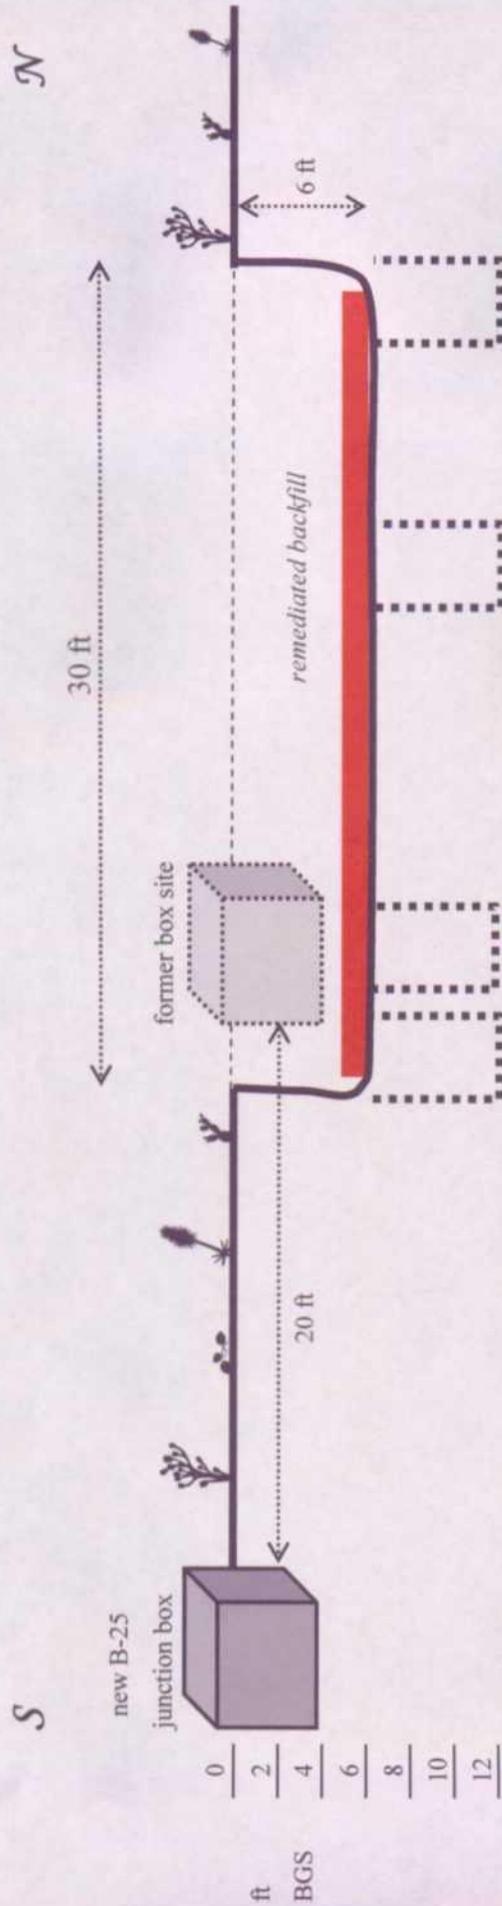
Excavation Cross-Section

BD jct B-25

30 x 20 x 6-ft-deep

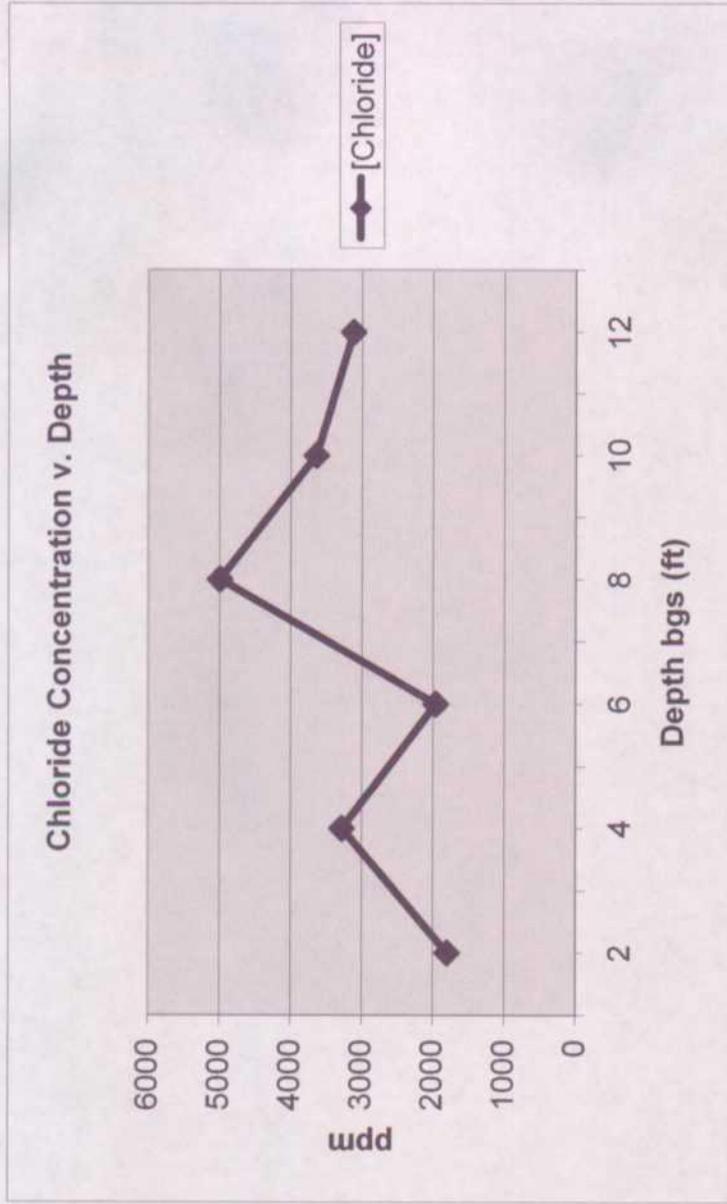
10 ft WEST of junction

Depth bgs (ft)	[Cl ⁻] ppm
2	1800
4	3278
6	1962
8	4992
10	3639
12	3119

Groundwater = 37 ft

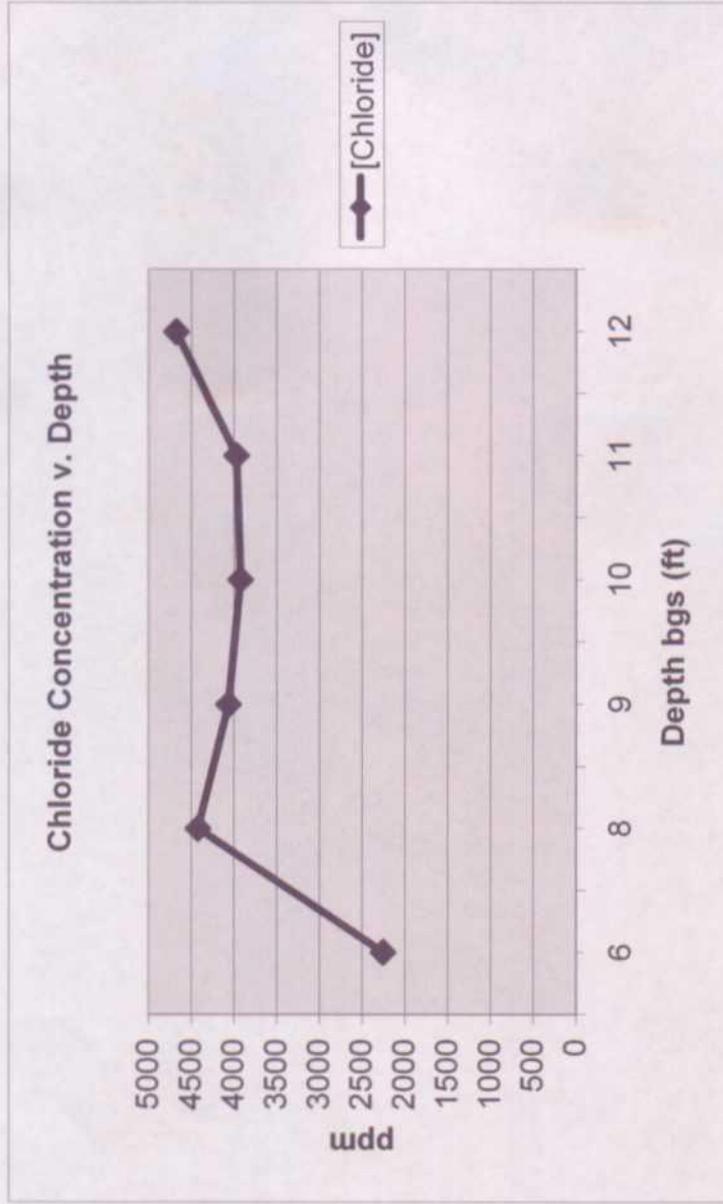
Vertical Delineation at Source

Depth bgs (ft)	[Cl ⁻] ppm
6	2257
8	4421
9	4063
10	3925
11	3970
12	4678

Groundwater = 37 ft
