Vac. Vent B-5-1 (Boat)

Final Report

**RICE OPERATING COMPANY
JUNCTION BOX FINAL REPORT**

Vacuum B-5-1 boot vent

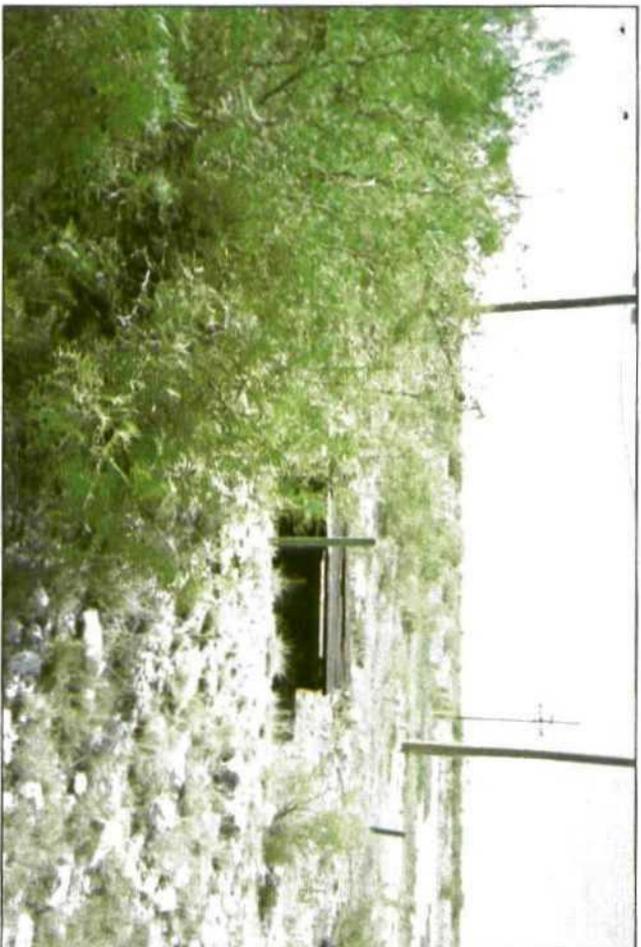
7/28/2005

undisturbed junction box

Unit 'B', Sec. 5, T18S, R35E

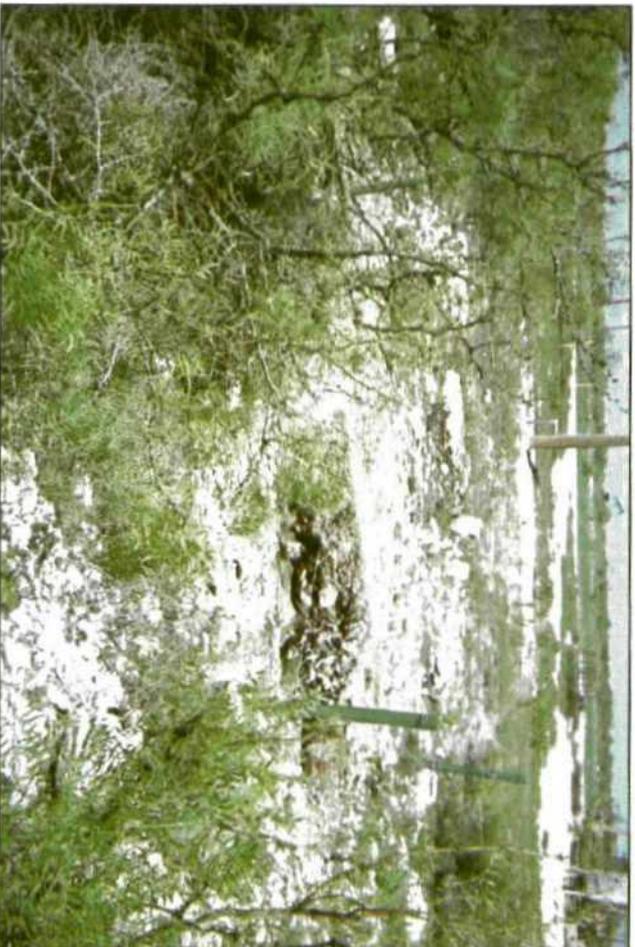
8/18/2005

junction box removed

boot and was addressed as part of the Vacuum SWD System abandonment. After the box was removed, a delineation trench was made at the junction with a backhoe. Soil samples were collected every ft of depth from 3 to 8 ft BGS. Chloride field tests were conducted on every sample and concentrations were <100 ppm for all samples. Laboratory analysis of the 8 ft grab sample yielded 46.9 ppm chloride, similar to background level. There were no physical indicators of hydrocarbon impact in the soil samples and all PID screenings performed on the samples were 0.0 ppm. Lab analysis confirmed that NOMCD TPH guidelines were met. The excavated soil was blended on site and then backfilled into the trench. The disturbed surface was seeded with a blend of native vegetation on 12/2/2005 and is expected to return to productive capacity at a normal rate.

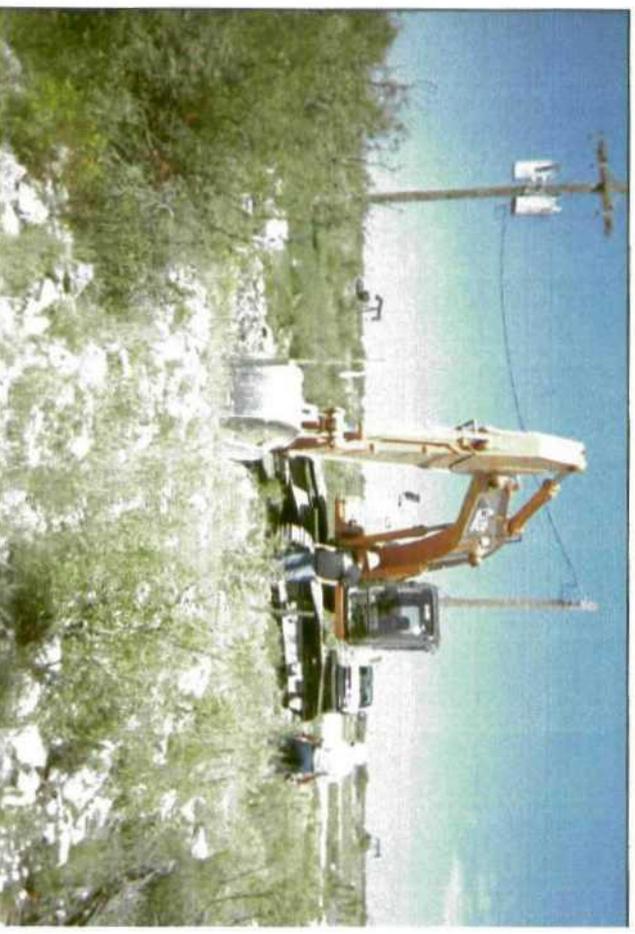
9/13/2005

delineation trench at former box site

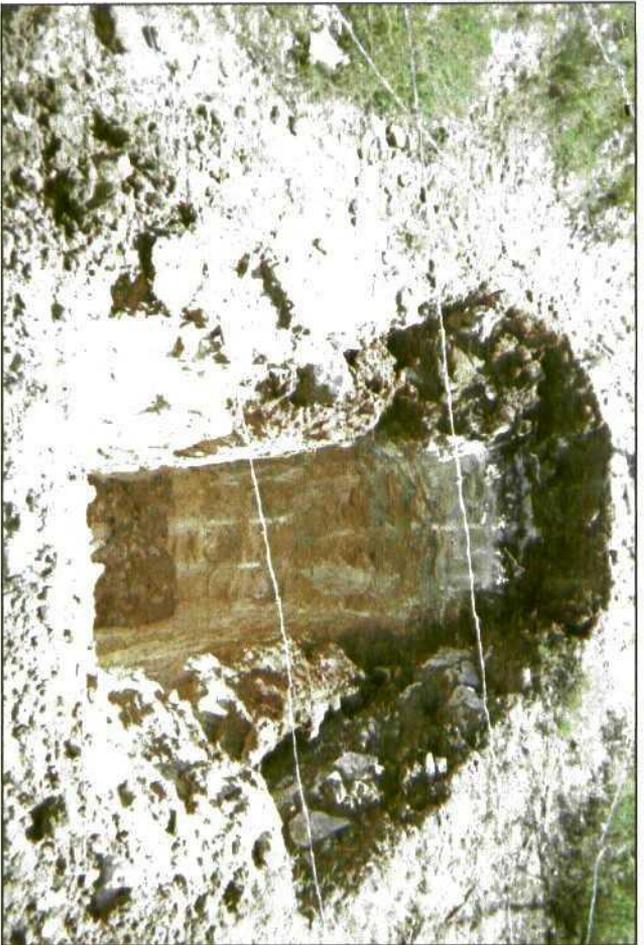
9/13/2005

LOCATION	DEPTH (ft)	ppm
delineation trench at junction	3	52
	4	92
	5	85
	6	87
	7	72
	8	57
background	surface	72

8-ft-deep delineation trench

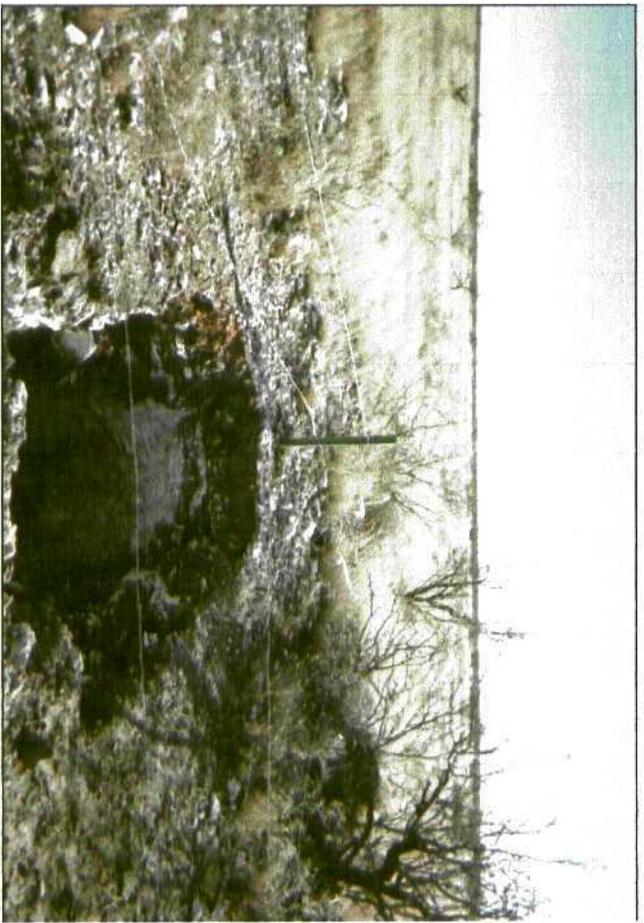
9/13/2005

8-ft-deep delineation trench

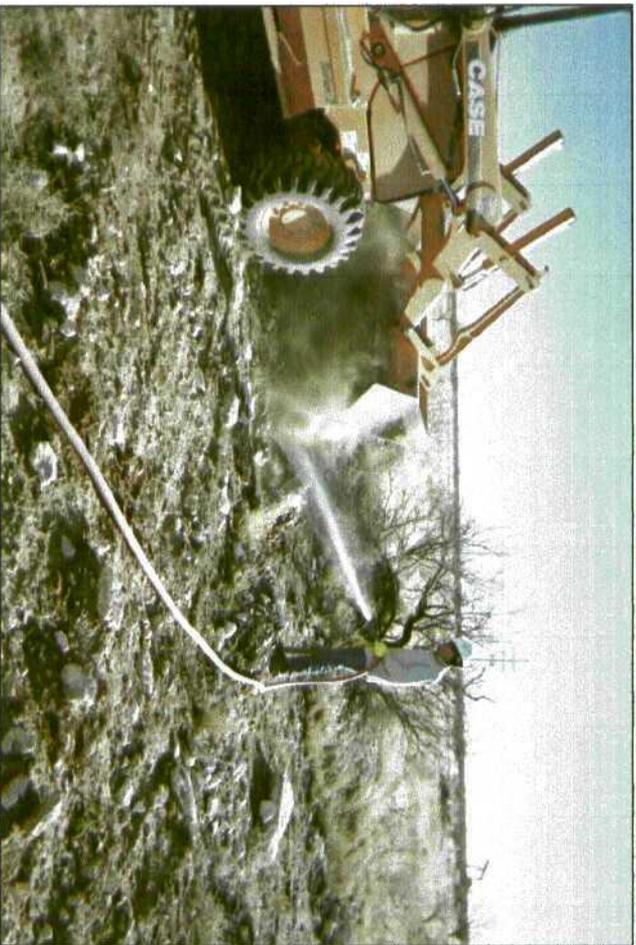
12/2/2005

backfilling and compacting trench

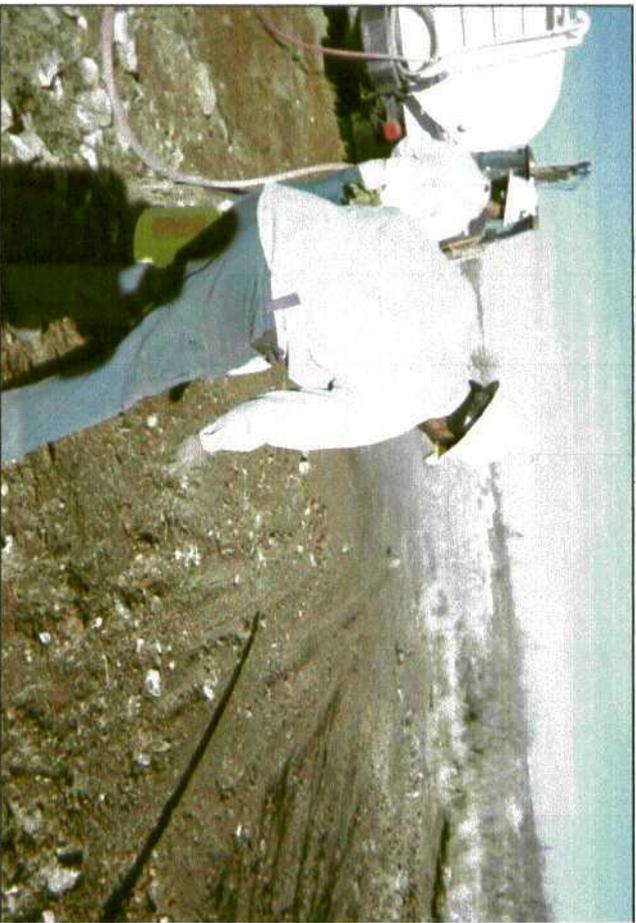
12/2/2005

seeding and watering backfilled site
