EME 'B' 30 EOL

**RICE OPERATING COMPANY  
JUNCTION BOX FINAL REPORT**

Unit 'M', Sec. 30, T21S, R36E

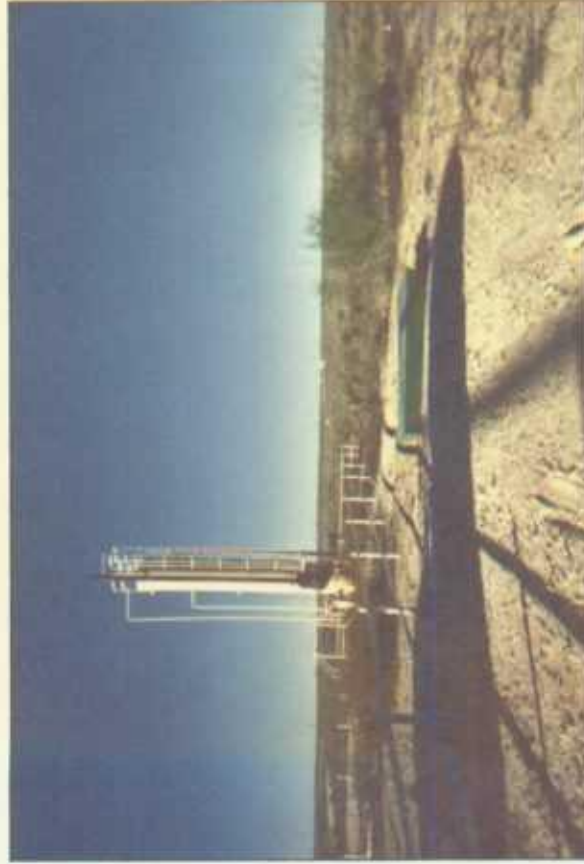
Undisturbed Junction Box (looking North) 11/18/2003

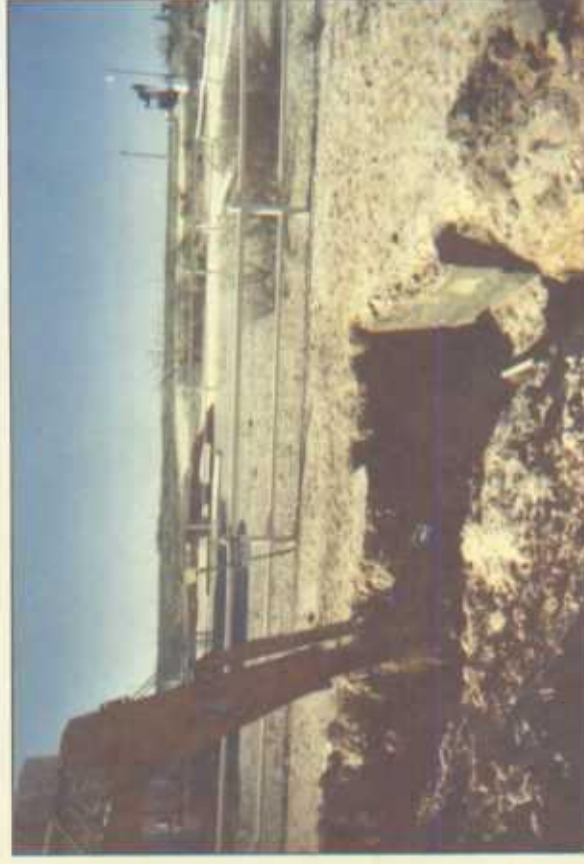
Excavation & Delineation Jan. 2003

General Description of Remedial Action:   This EOL box was located along the eastern fence of an active production facility. The box was removed and the site was delineated with a backhoe and PID readings and chloride tests were performed regularly. All PID readings were minimal; lab results confirm that TPH concentrations are below NMOCD guidelines. Chloride concentrations exhibited a trend of declination with depth (see graph). The 10 x 15 x 14-ft deep excavation was then backfilled with the excavated soil that was landfarmed on site. The concentrations of chloride and TPH left in place are unlikely to adversely impact groundwater quality under this site.

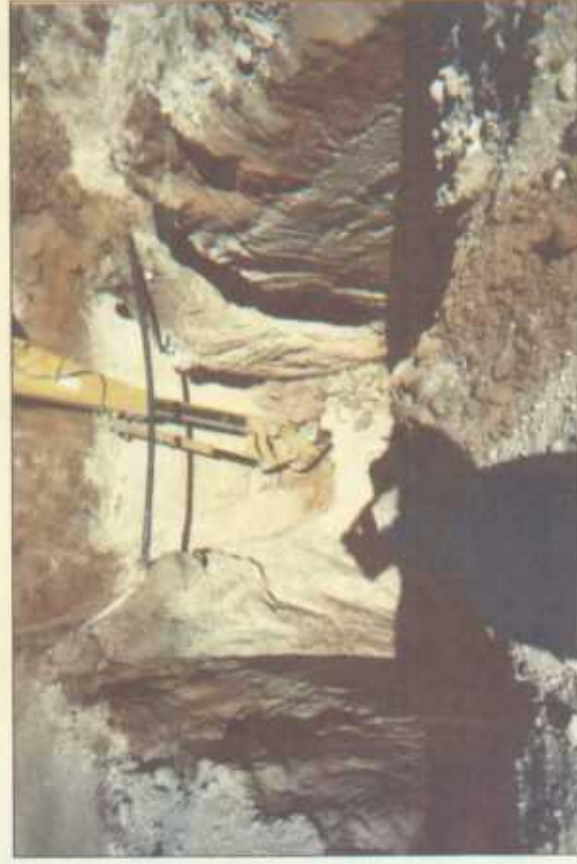
Excavation & Delineation Jan. 2003

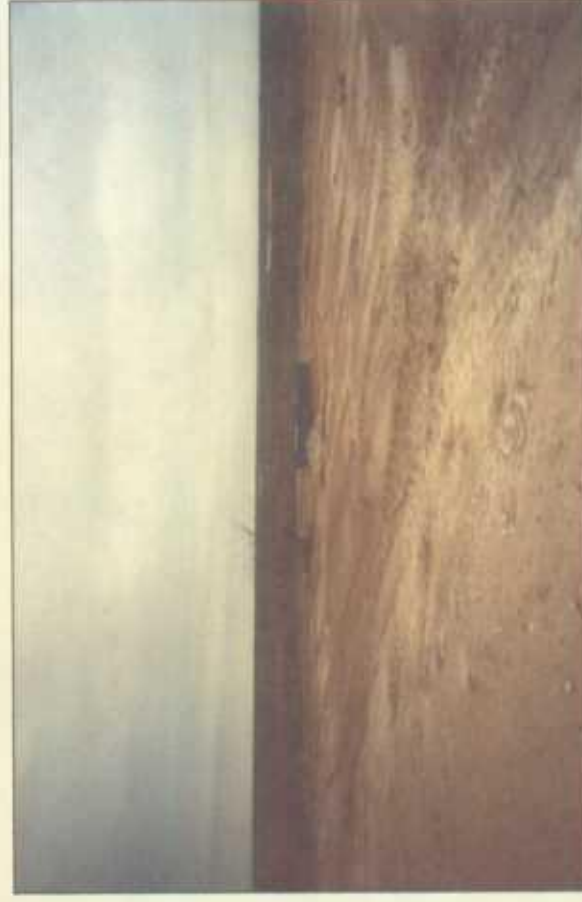
Backfilled Excavation with New Junction Box 25 ft East 1/23/2004
