EME Vent P-30

1R0427-133

FINAL REPORT

**RICE OPERATING COMPANY
JUNCTION BOX FINAL REPORT**

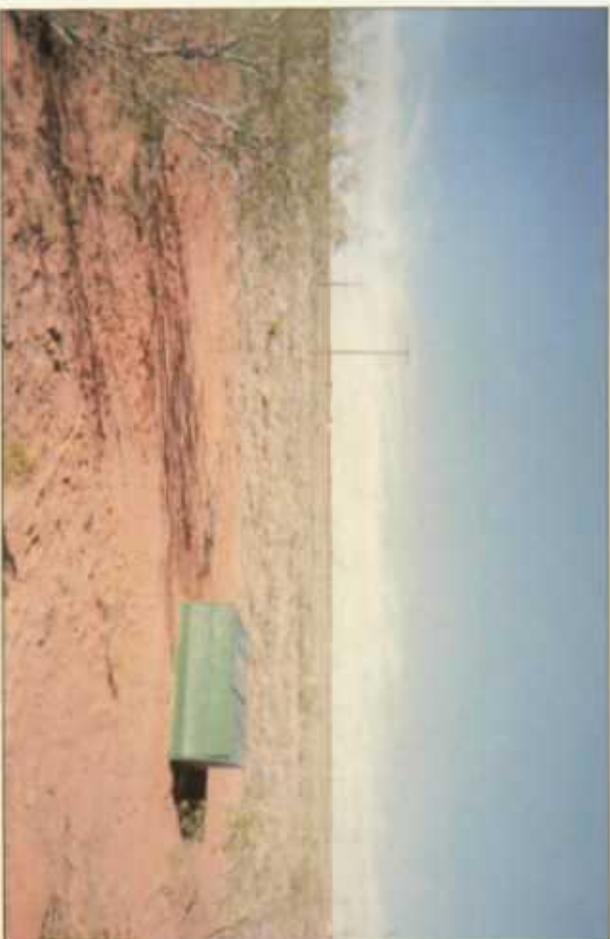
EME P-30 vent

undisturbed junction box

11/20/2003

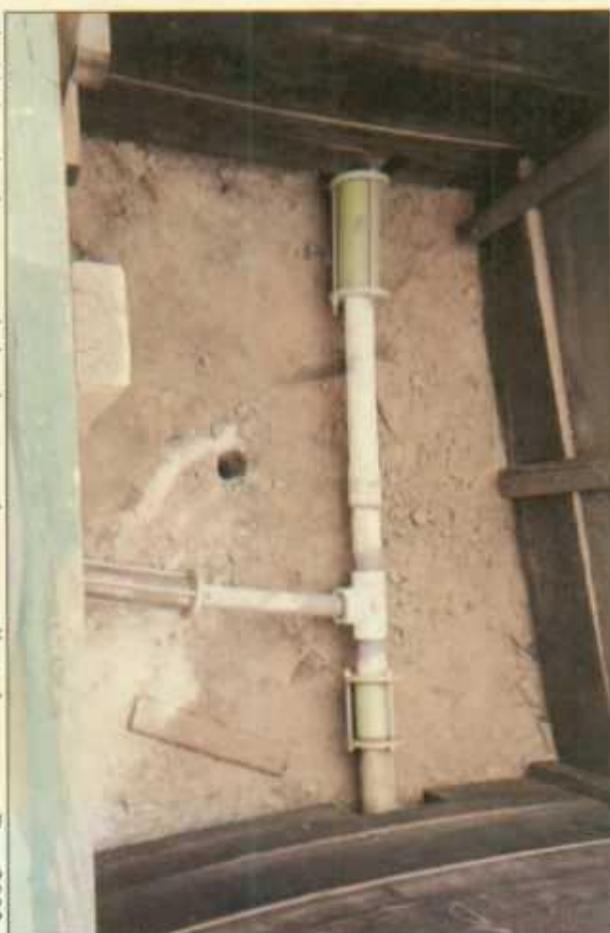
unit 'p', sec. 30, T21S, R36E

inside junction box; auger hole where samples were collected

Dec. 2003

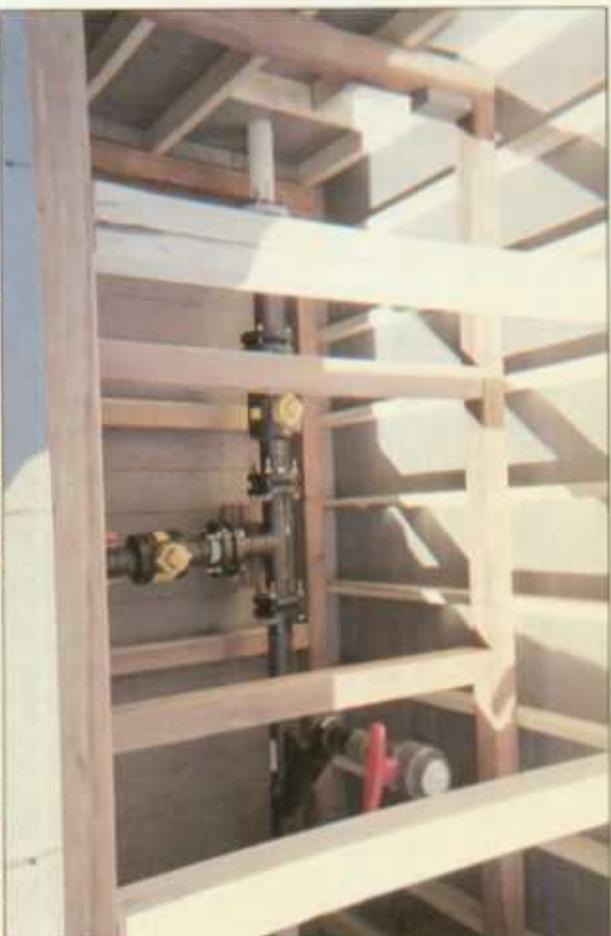
inside of new box with new plumbing 10 ft west

1/28/2004

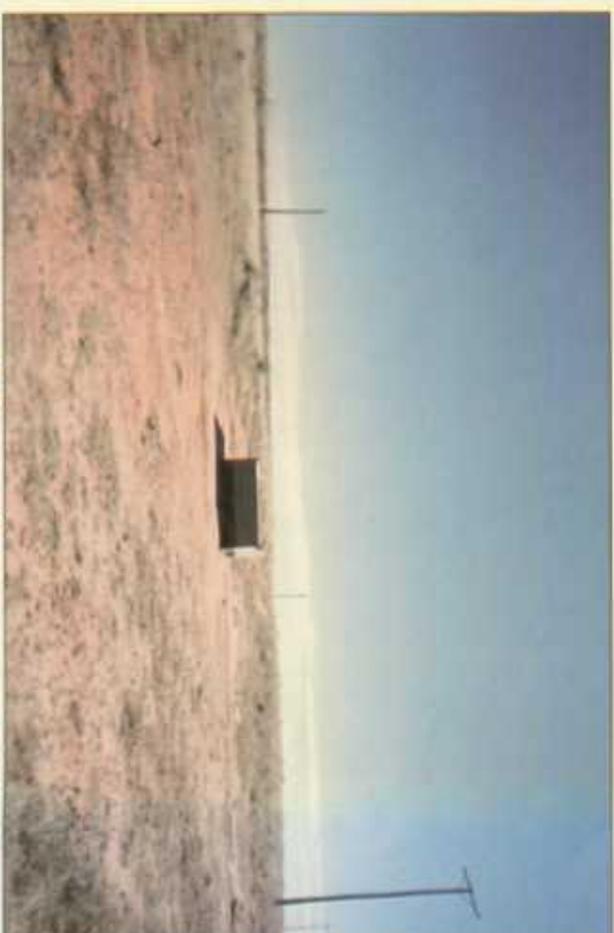
new junction box 10 ft west of former

1/25/2005

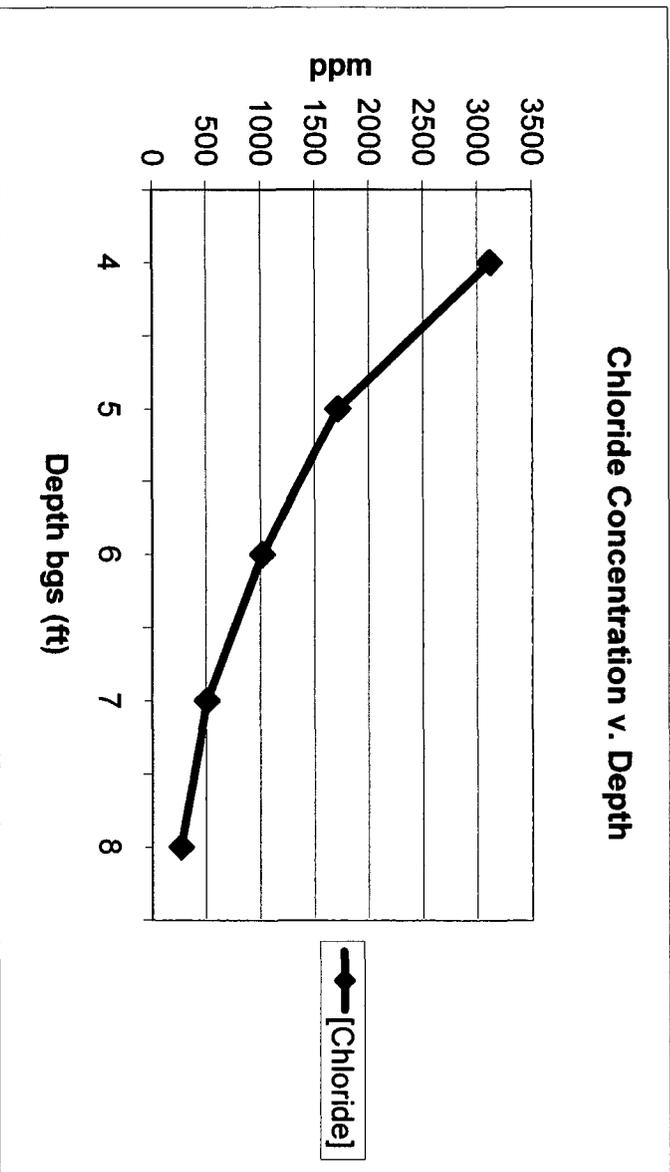
CHLORIDE CONCENTRATION CURVE

EMME P-30 vent

Vertical Delineation at Source

Depth bgs (ft)	[Cl ⁻] ppm
4	3121
5	1718
6	1017
7	513
8	269

Groundwater = 230 ft

LOCATION	DEPTH (ft)	ppm
vertical at junction box	4	3121
	5	1718
	6	1017
	7	513
	8	269
surface adjacent to junction box	0.5	179
background	0.5	88
