EME C-11 EOL Boot

FINAL
REPORT

**RICE OPERATING COMPANY
JUNCTION BOX FINAL REPORT**

SWD SYSTEM	JUNCTION	UNIT	SECTION	TOWNSHIP	RANGE	COUNTY	BOX DIMENSIONS - FEET		
							Length	Width	Depth
EME	C-11 EOL boot	R	2	21S	36E	Lea	Moved 34 ft South

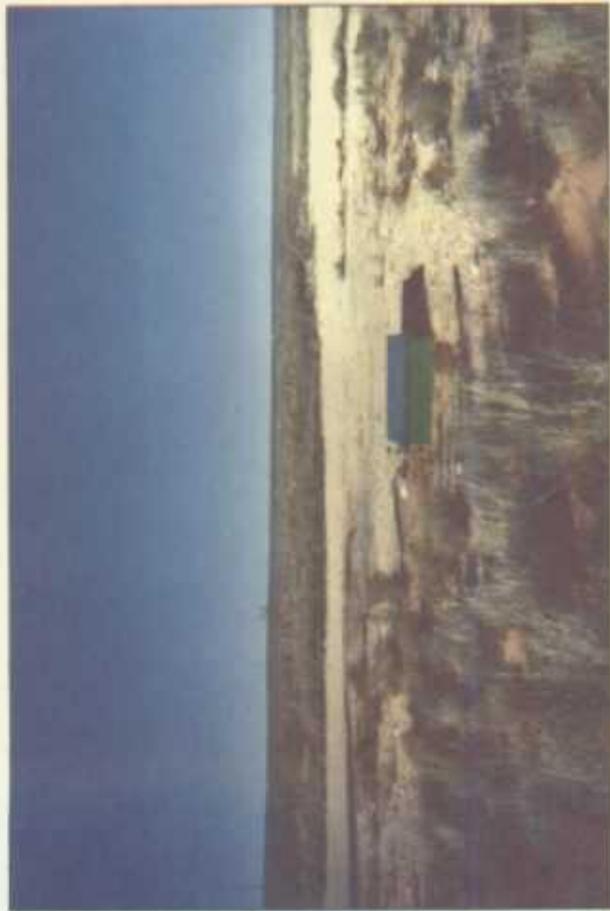
11/19/2003

Undisturbed box

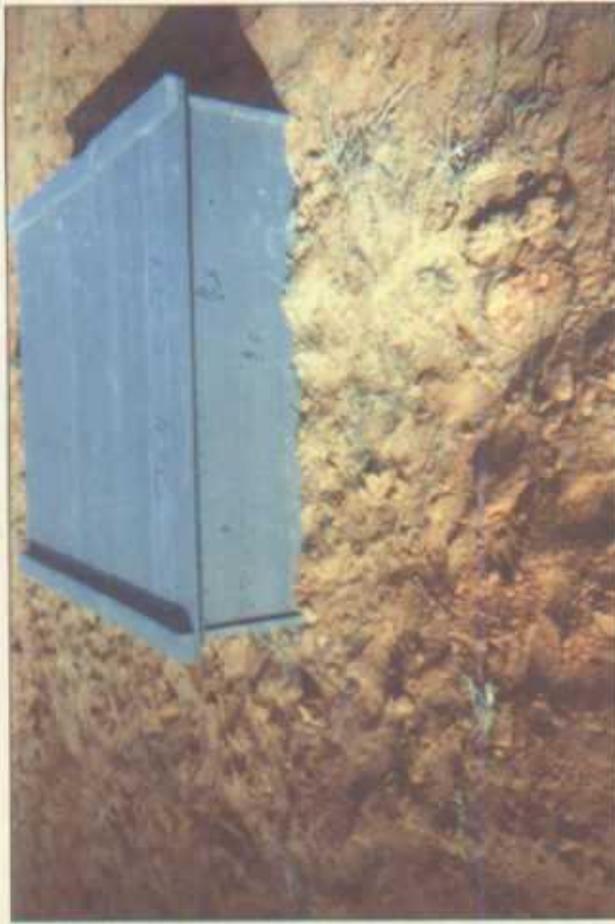
1/22/2004

Completed new junction box 34 ft south

General Description of Remedial Action: This junction box was located off a dirt lease road. A vertical delineation trench was made using a backhoe and samples were field-tested for chloride and VOC's. Chloride concentrations exhibited a conclusive trend of declination (see graph). All PID readings were 0.0 ppm and TPH lab results confirmed concentrations well below NMOCD guidelines. The excavated soil was blended on-site and then backfilled into the location. The disturbed surface will be re-seeded with a blend of native vegetation and is expected to return to productive capacity at a normal rate. A new watertight junction box has been built 34 ft south of this site.

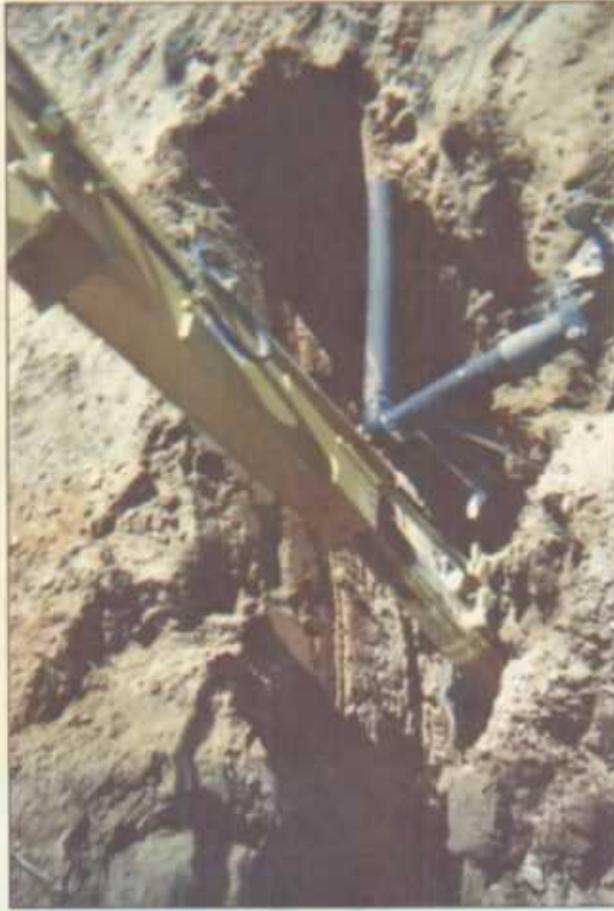
3/16/2004

Vertical delineation at old junction

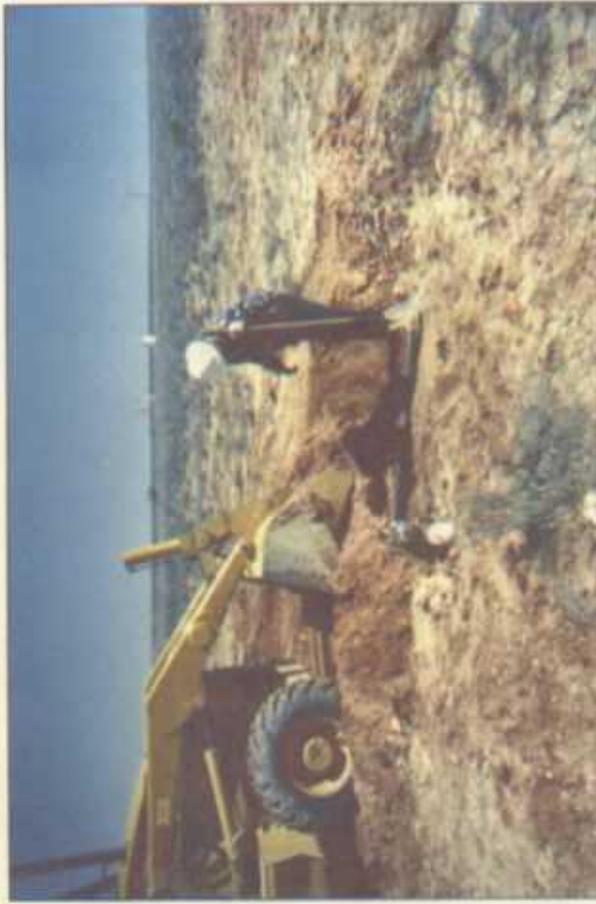
3/16/2004

Backfilling excavation

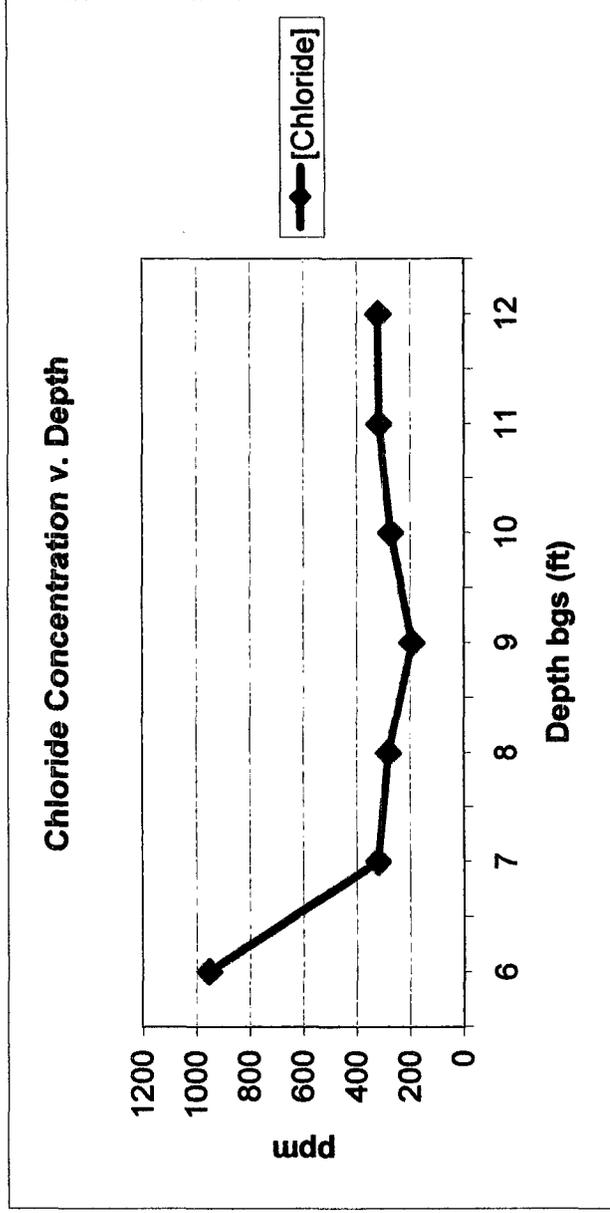
Vertical Delineation at Source

Depth bgs (ft)	[Cl] ppm
6	954
7	320
8	281
9	193
10	273
11	317
12	320

Groundwater = >100 ft
