EME 0-35 South

FINAL REPORT

**RICE OPERATING COMPANY
JUNCTION BOX FINAL REPORT**

EME jct. O-35 South
T20S, R36E

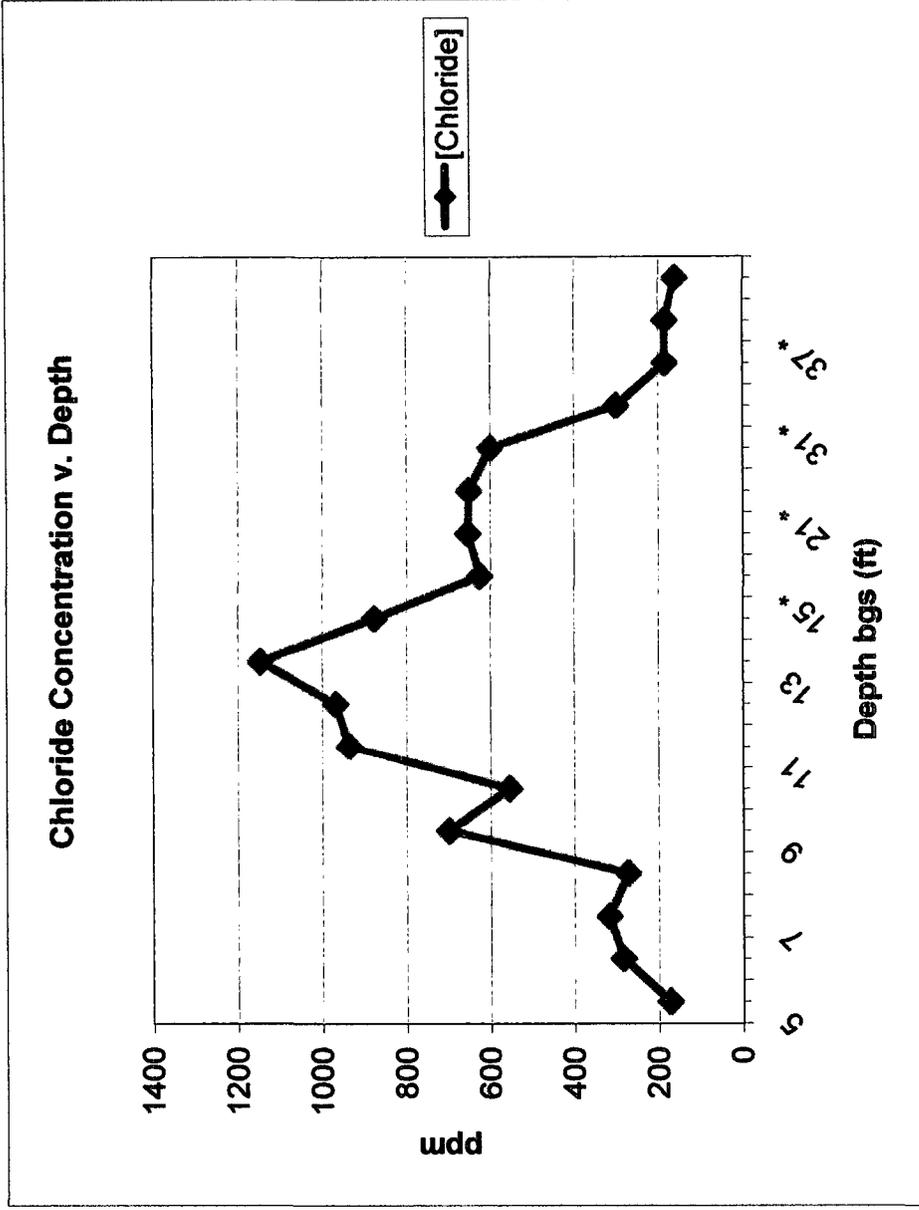
Vertical Delineation at Source

Depth bgs (ft)	[Cl] ppm
5	174
6	285
7	318
8	273
9	699
10	554
11	936
12	968
13	1147
14	876
15 *	626
20 *	654
21 *	652
26 *	600
31 *	300
36 *	184
37 *	184
38 *	161

* Soil bore samples

Groundwater = 122 ft

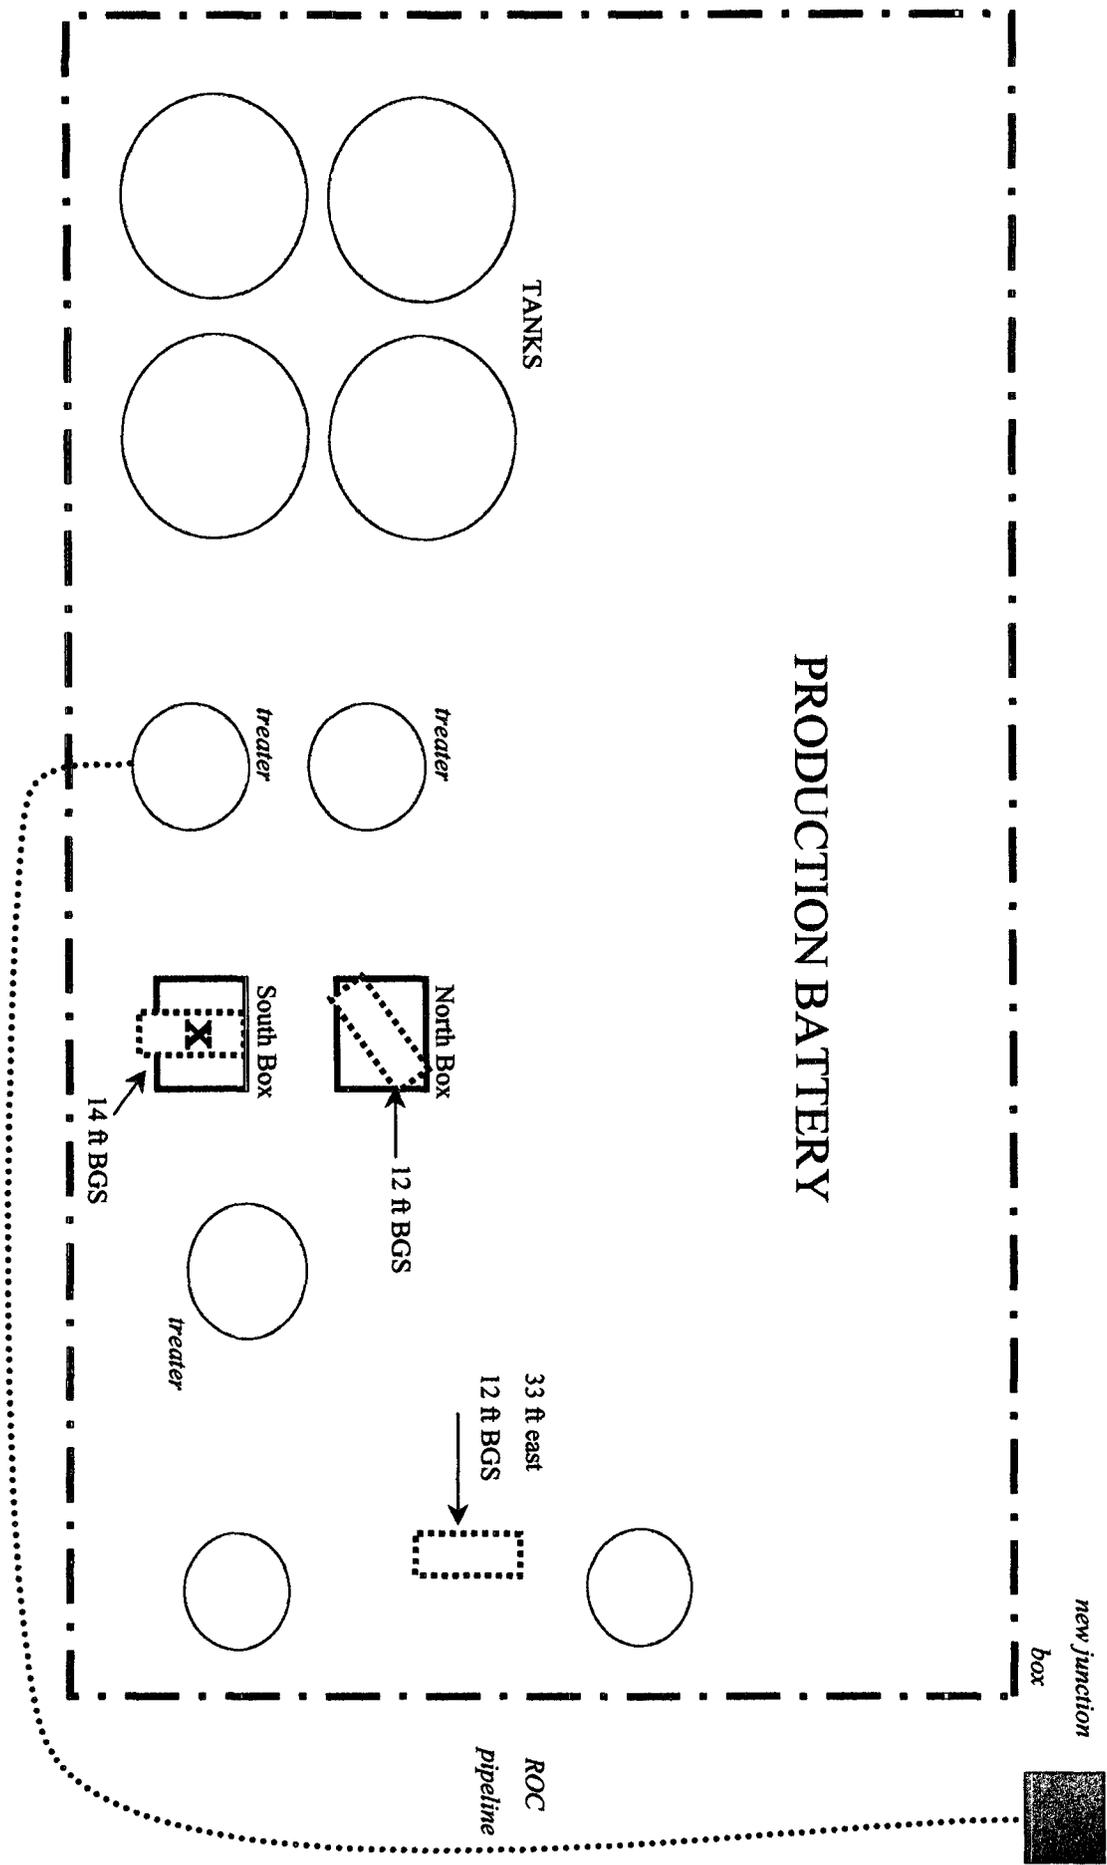
EME jet. O-35 North & South

Unit 'O', Sec. 35, T20S, R36E

= Excavation trench

= Soil Bore Location

PRODUCTION BATTERY

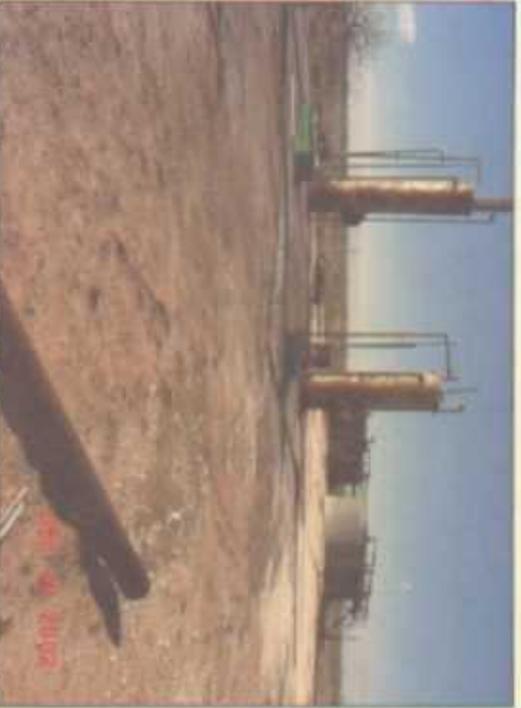
Boxes inside battery (looking SW); South box on left 12/30/02

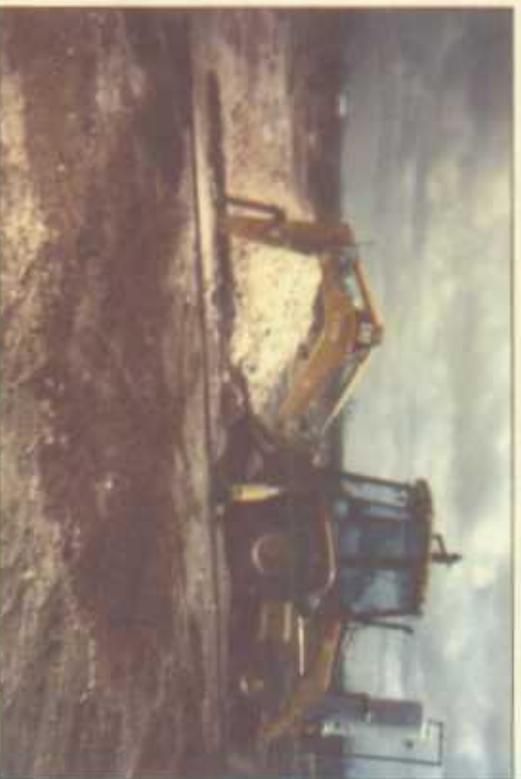
Vertical delineation with backhoe 3/22/04

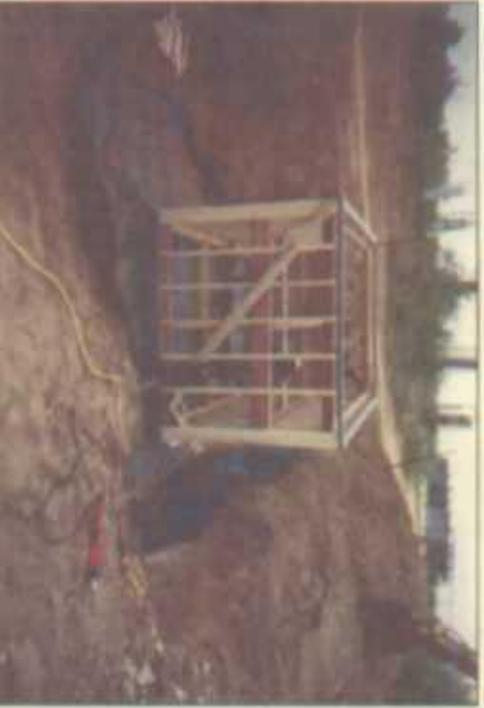
Construction of new junction box 200 ft NE 9/26/03

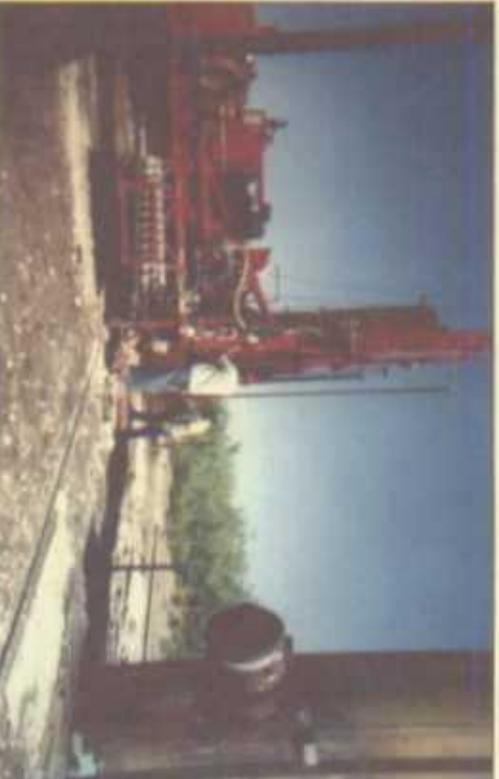
Soil bore at south box 6/1/04
