EME A-12 Boot

FINAL REPORT

**RICE OPERATING COMPANY
JUNCTION BOX FINAL REPORT**

unit 'A', Sec. 12, T20S, R36E

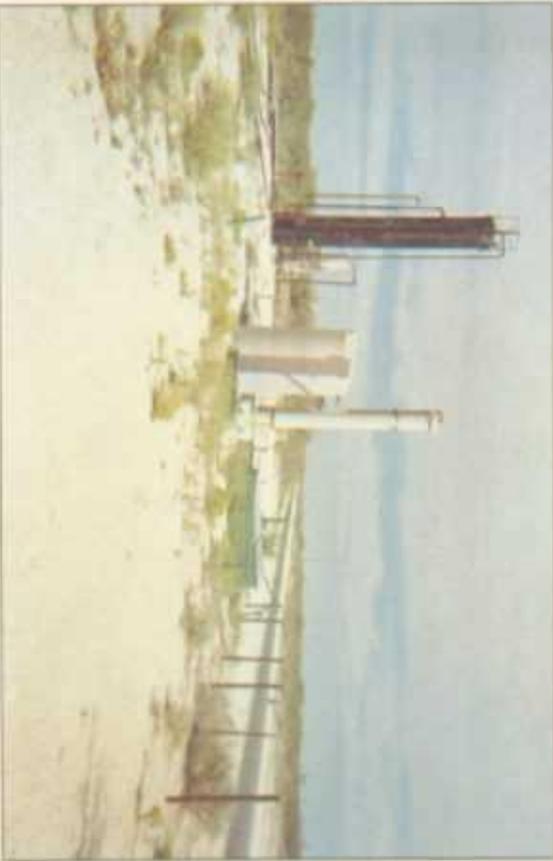
4/22/2003

undisturbed junction box with boot

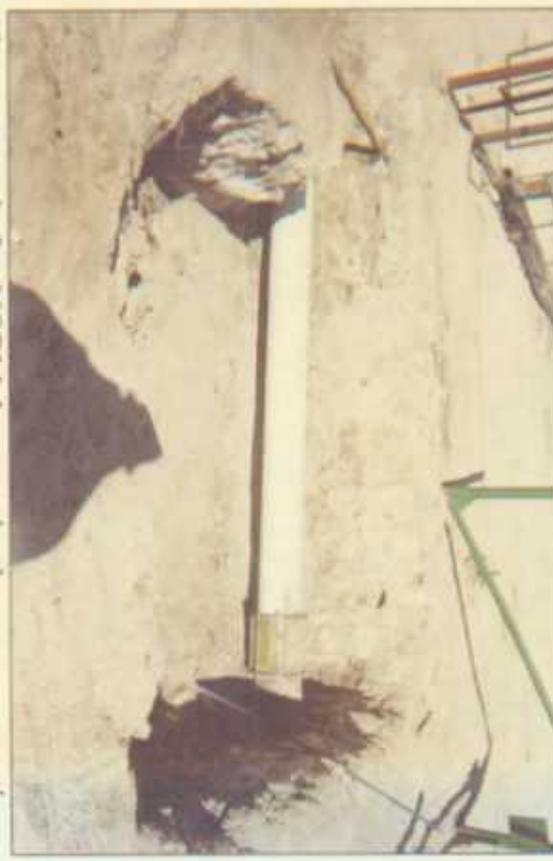
box removed after NORM decontamination; new connection
1/8/2004

General Description of Remedial Action: This junction box contained a boot and was located inside an active production battery. The junction was re-plumbed and the new boot and box were relocated 80 ft west of the old one, still inside the facility. There was no physical indications of chloride or hydrocarbon impact and chloride field testing was performed using a hand auger to collect samples. Sample concentrations were similar to background chloride levels and TPH lab results yielded concentrations well below NMOCD guidelines. BTEX concentrations were non-detect and met NMOCD guidelines. 6 cubic yards of clean soil was imported to fill the hole caused by NORM decontamination. The backfill was contoured to mimic the surrounding surface at the battery.

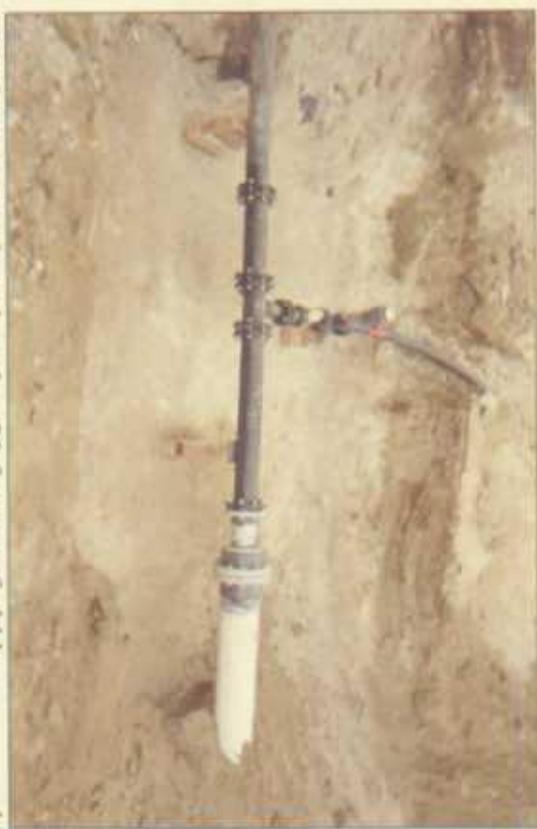
1/8/2004

new connections at new junction site, 80 ft west of old box

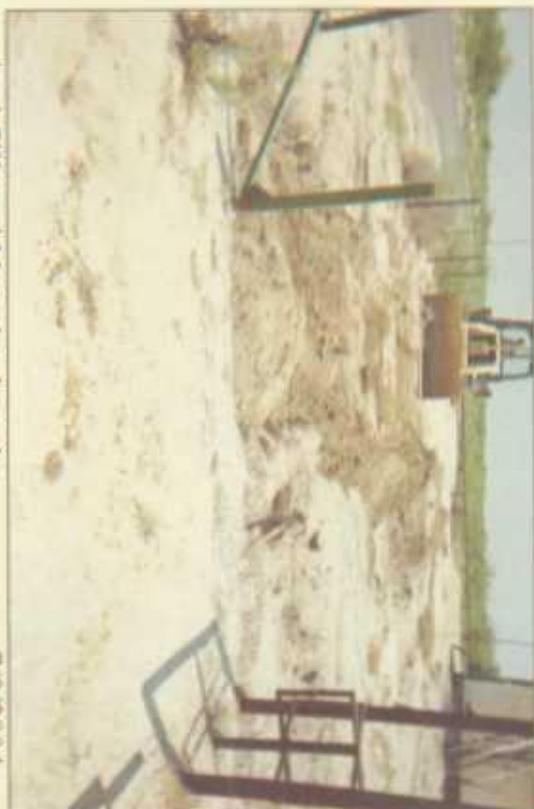
7/8/2004

backfilling old junction box site

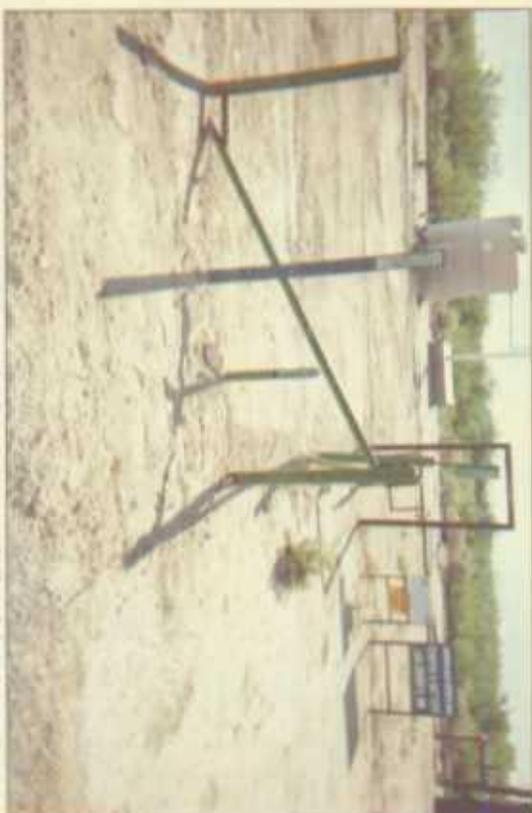
8/13/2004

backfilled box site with new box and boot in background (looking west)

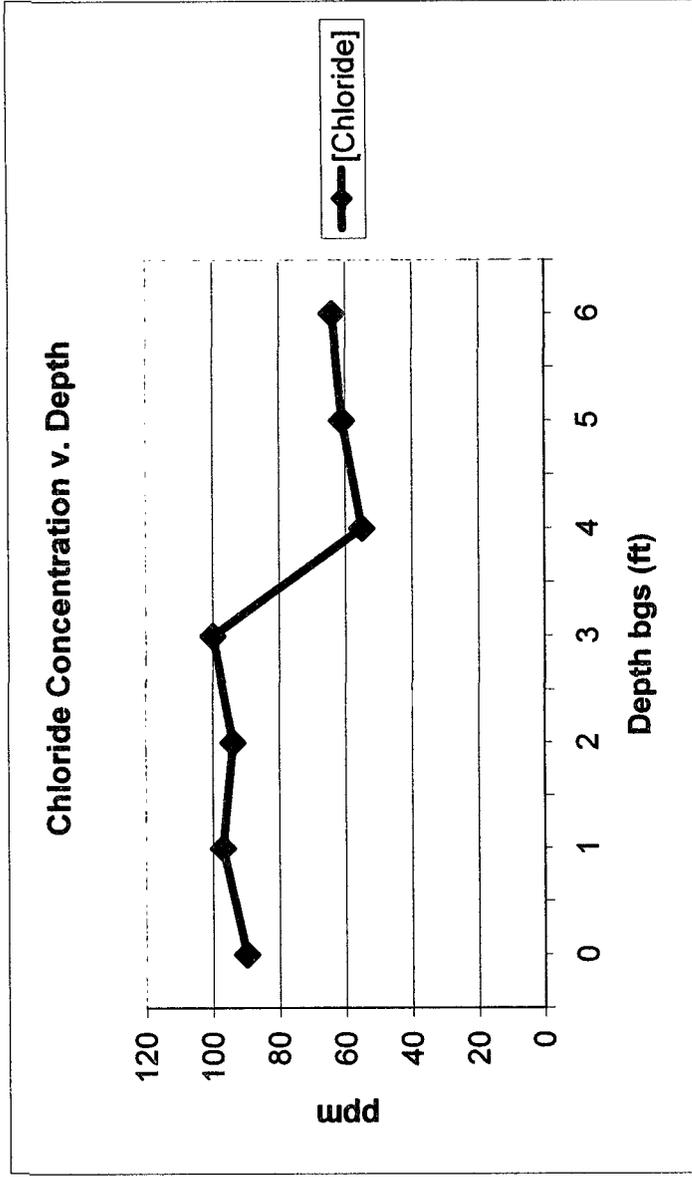
Vertical Delineation at Source

Depth bgs (ft)	[Cl] ppm
0	90
1	97
2	94
3	100
4	55
5	61
6	64

Groundwater = 27 ft
