EME Jct. Q-6-2

# FINAL REPORT

**RICE OPERATING COMPANY  
JUNCTION BOX FINAL REPORT**

unit 'Q', sec. 6, T21S, R36E

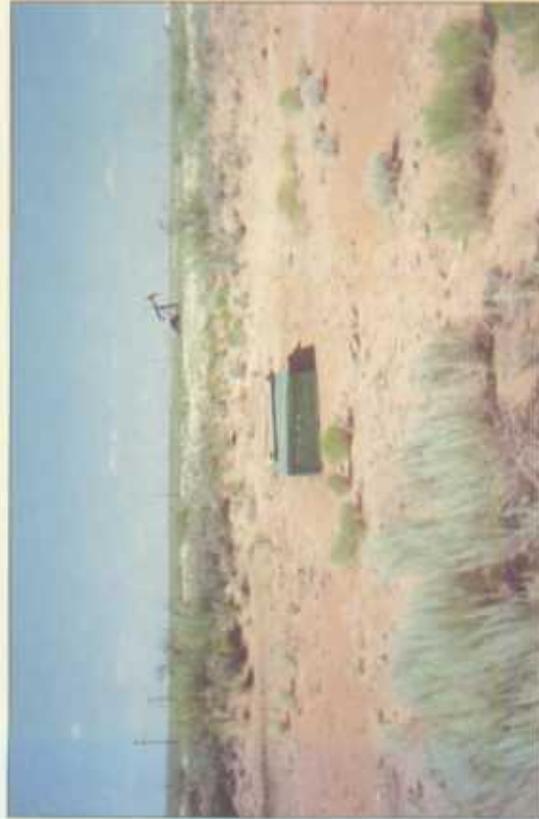
7/22/2003

undisturbed junction box

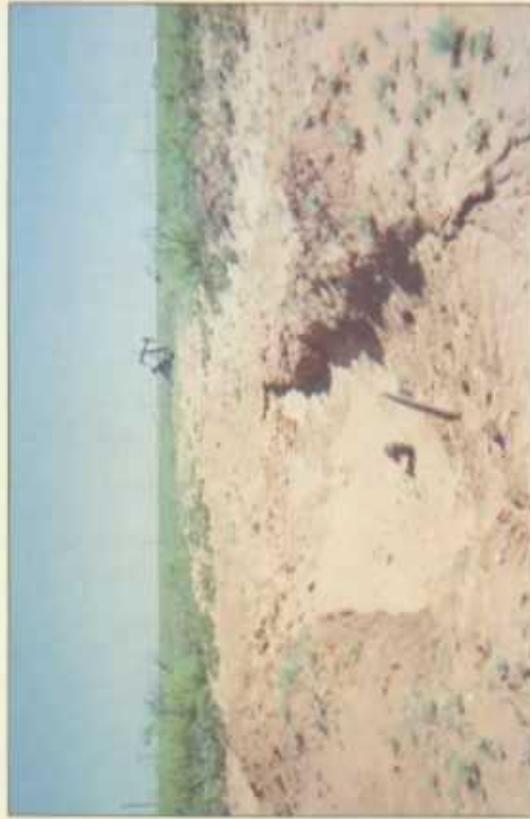
5/5/2004

junction box removed

**General Description of Remedial Action:** The lumber from this box was removed during the NORM survey and the junction was removed as the new pipeline was plumbed straight through at this location. Upon environmental observation, there was no physical evidence of TPH or chloride impact. Samples were collected using a hand auger and field tested for chloride. All tests indicated low concentrations. Lab results yielded NMOCD TPH and BTEX guidelines were met and very low chloride was confirmed. The hole where the box had been was backfilled with 60 yds of clean, imported soils. On 8/5/2004, the disturbed surface was seeded with a blend of native vegetation.

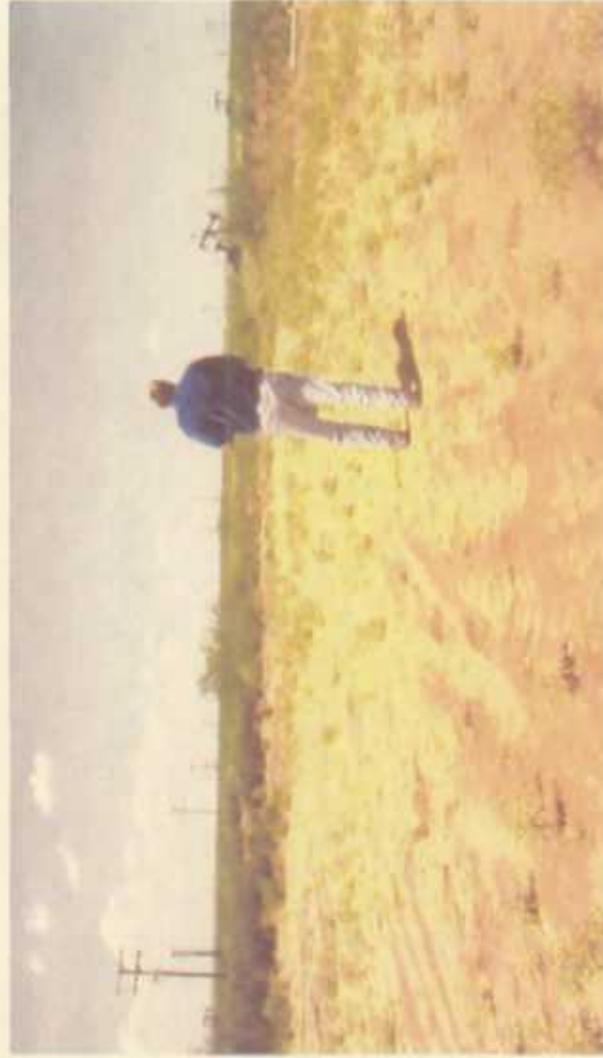
8/5/2004

seeding backfilled site
