EME Gullally "A" EOL

**RICE OPERATING COMPANY  
JUNCTION BOX FINAL REPORT**

# EME Gullyully 'A' EOL

unit 'O', sec. 24, T20S, R36E

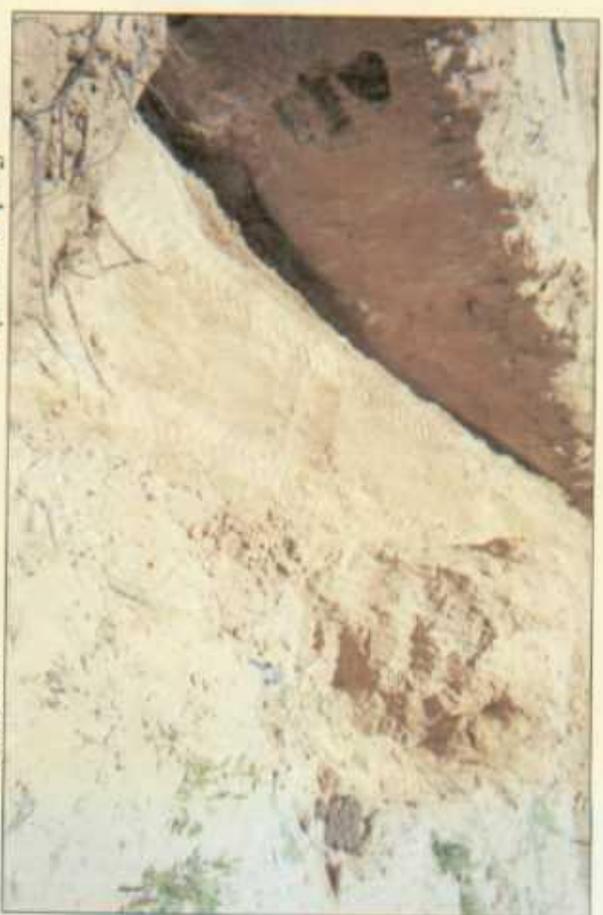
5/24/2004

final excavation

General Description of Remedial Action: This end-of-line (EOL) box was located west of an active production facility. Delineation and excavation were performed with a backhoe as chloride tests and PID readings were conducted at regular intervals. The source at the box yielded a conclusive trend of declination to a depth of 12 ft BGS (see graph), indicative of non-saturated conditions in the vadose zone below the box. All PID field screenings were 0.0 ppm and lab results confirmed TPH concentrations well below NMOCD guidelines. The excavated soil from the 10 x 20 x 12-ft deep hole was blended on site and then backfilled. The disturbed surface was contoured and seeded with a blend of native vegetation. This EOL has been eliminated with a new pipeline re-plumbed straight through. No excavation was conducted east of the box due to proximity of the battery.

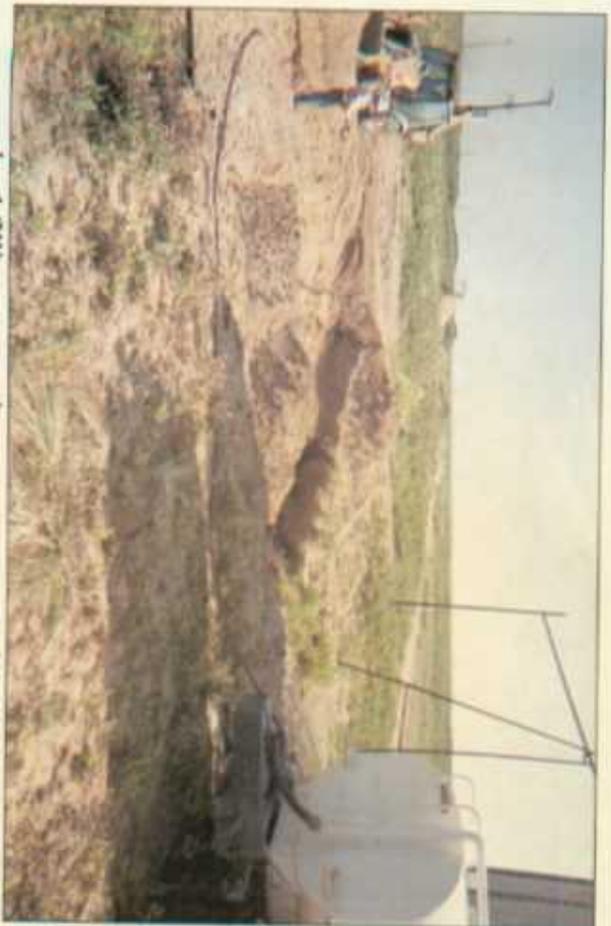
6/16/2004

backfilling excavation

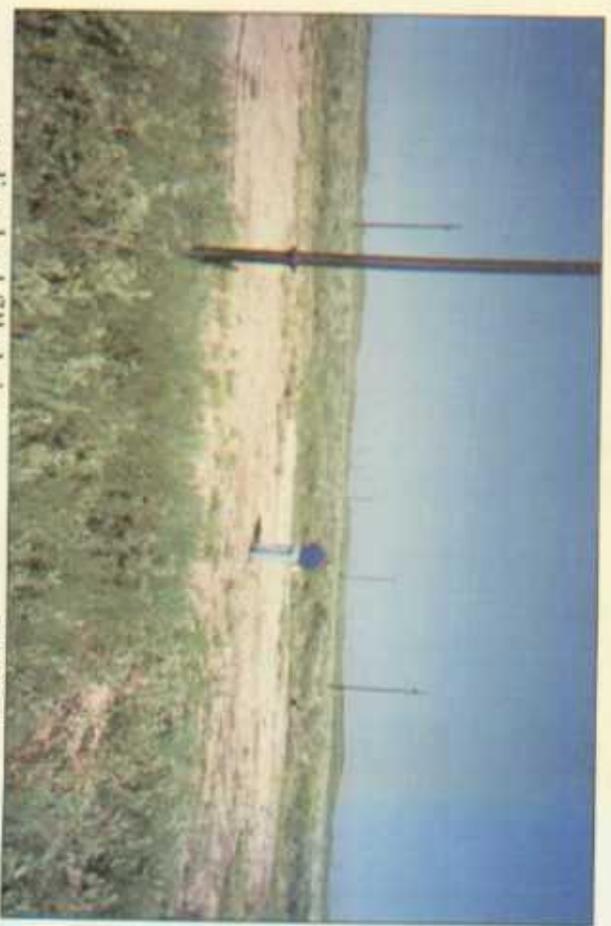
8/4/2004

seeding backfilled site

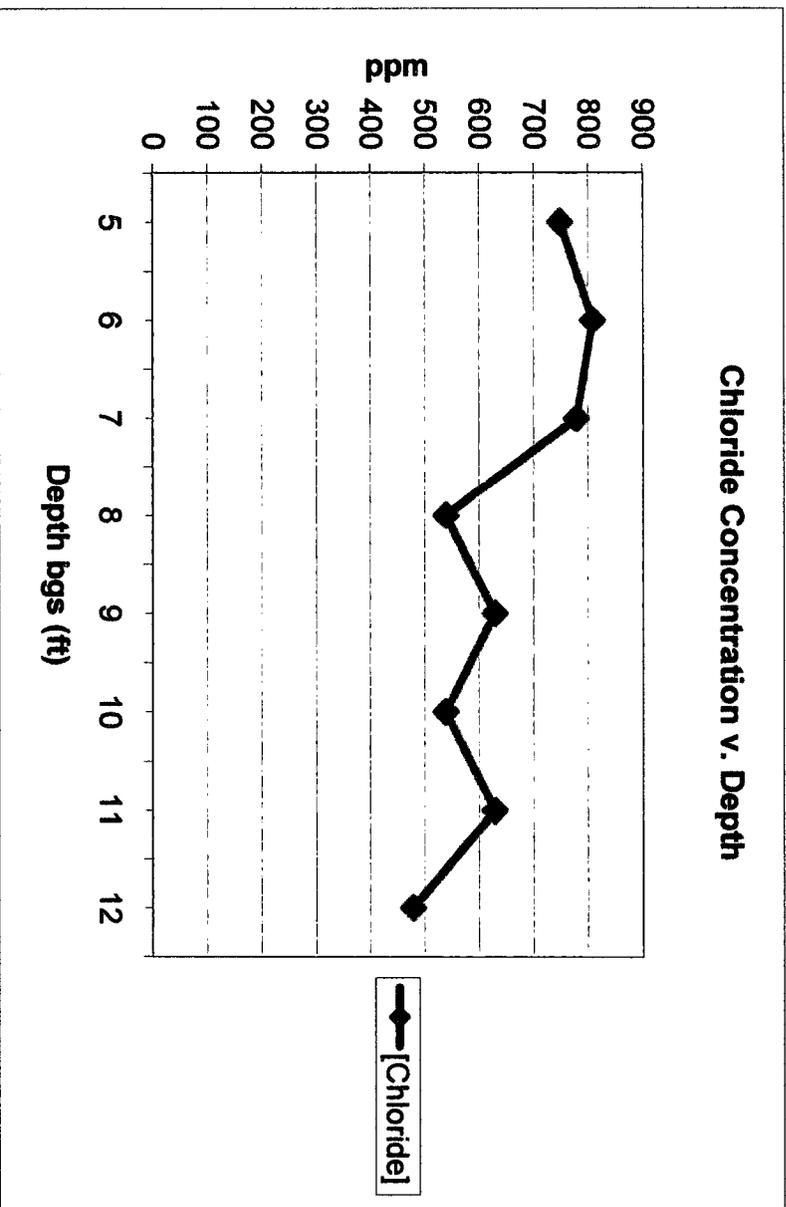
*Vertical Delineation at Source*

**CHLORIDE CONCENTRATION CURVE**

Depth bgs (ft)	[Cl <sup>-</sup> ] ppm
5	749
6	809
7	779
8	539
9	629
10	539
11	629
12	479

Depth to groundwater here is ambiguous. USGS maps indicate that the site is located on a hydrogeologic boundary line to the north of which groundwater depth is ~36 ft and 117 ft to the south.

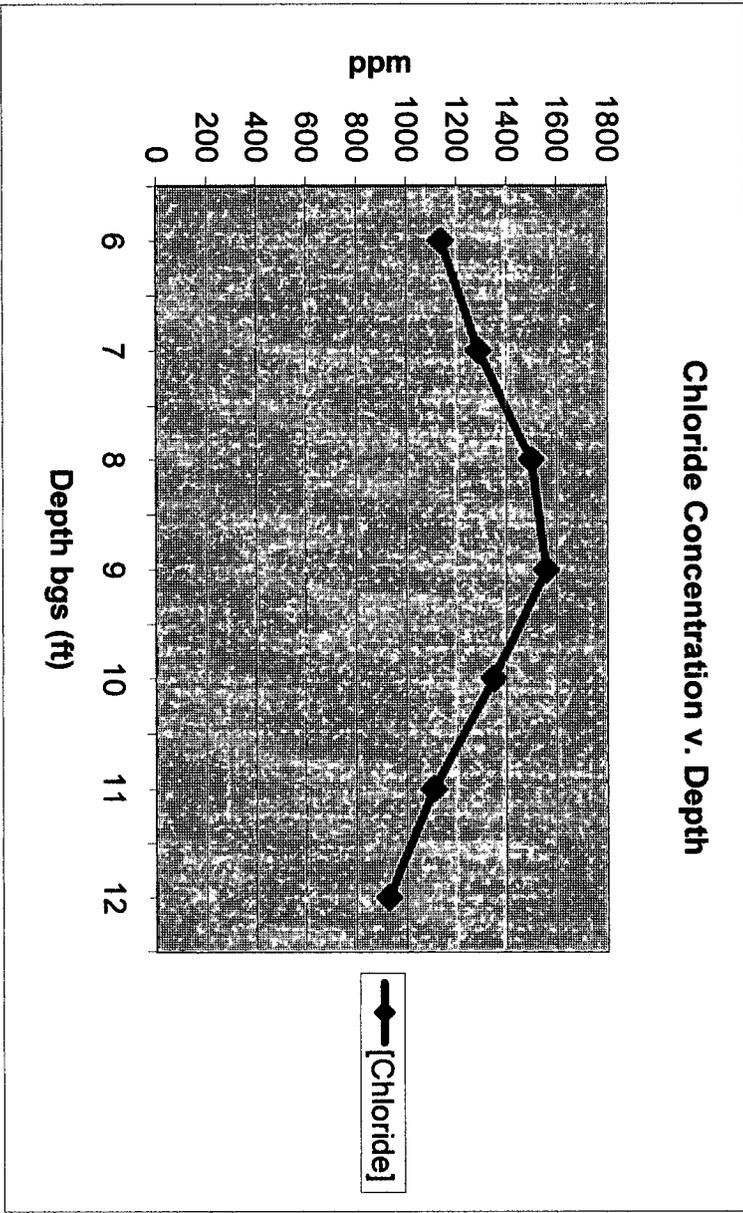
*15 ft West of box*

**CHLORIDE CONCENTRATION CURVE**

Depth bgs (ft)	Cl <sup>-</sup> ppm
6	1139
7	1289
8	1499
9	1559
10	1349
11	1109
12	929

Depth to groundwater here is ambiguous. USGS maps indicate that the site is located on a hydrogeologic boundary line to the north of which groundwater depth is ~36 ft and 117 ft to the south.

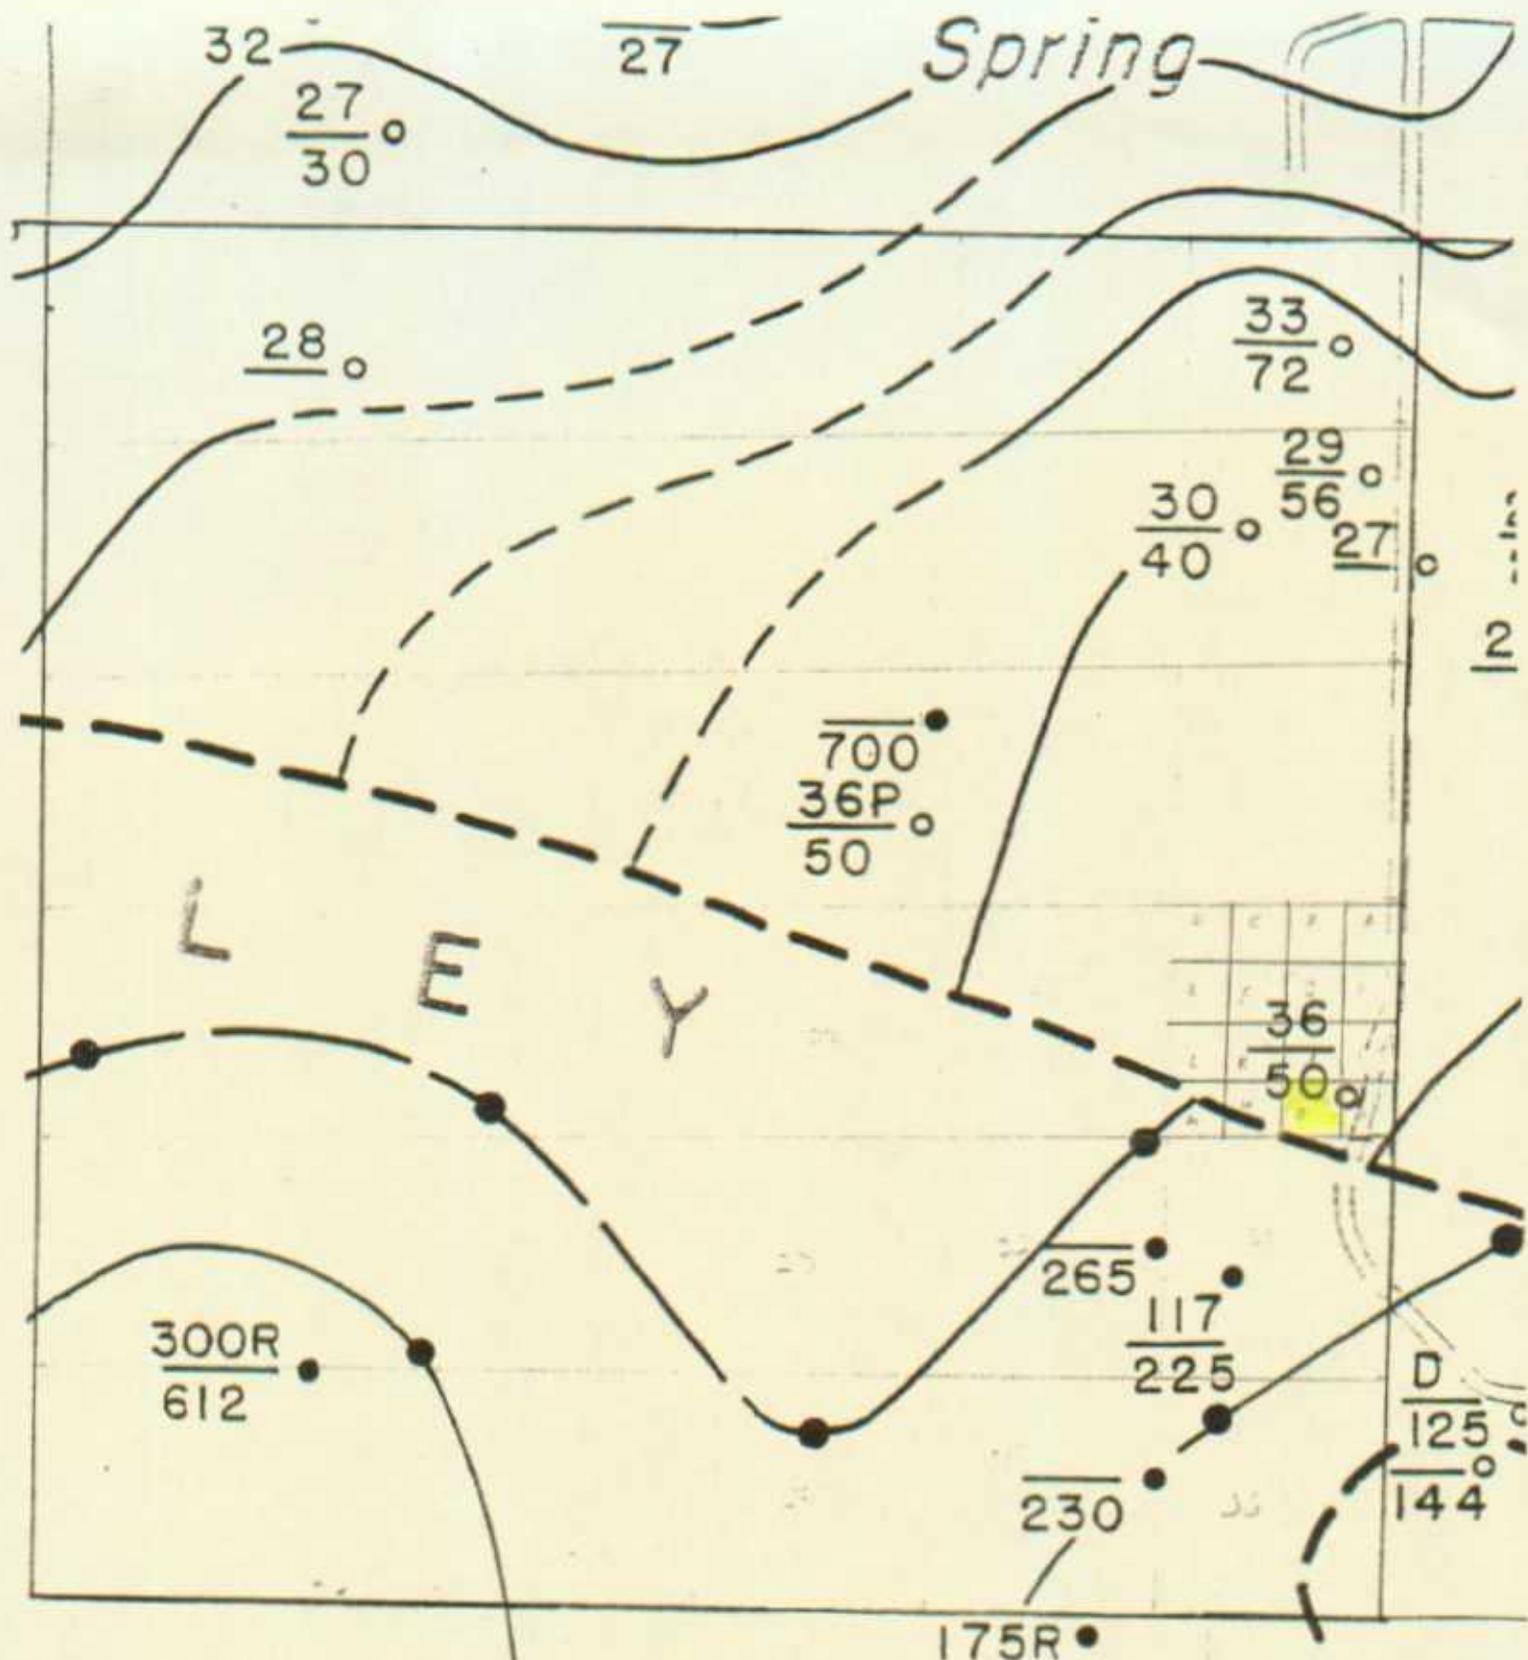
\* Depth to groundwater here is ambiguous. USGS maps indicate that the site is located on a hydrogeologic boundary north of which groundwater is around 36 ft but is 117 ft to the south.

enlarged from Plate 2 "Groundwater Map of Southern  
Map Lea County, New Mexico"
