# Final Report

**RICE OPERATING COMPANY  
JUNCTION BOX FINAL REPORT**

# EME jct. K-4

Unit 'K', Sec. 4, T20S, R37E

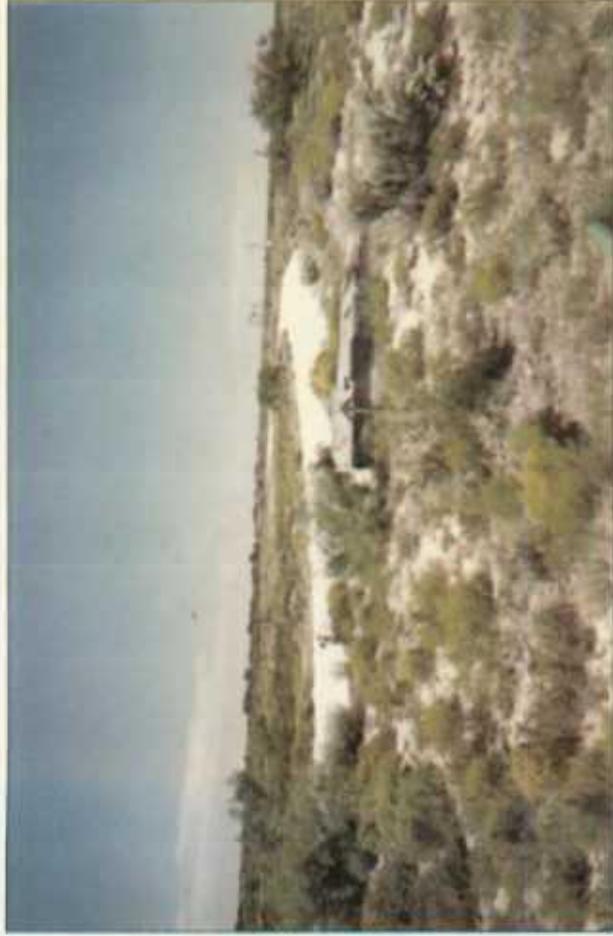
8/27/2004

undisturbed junction box

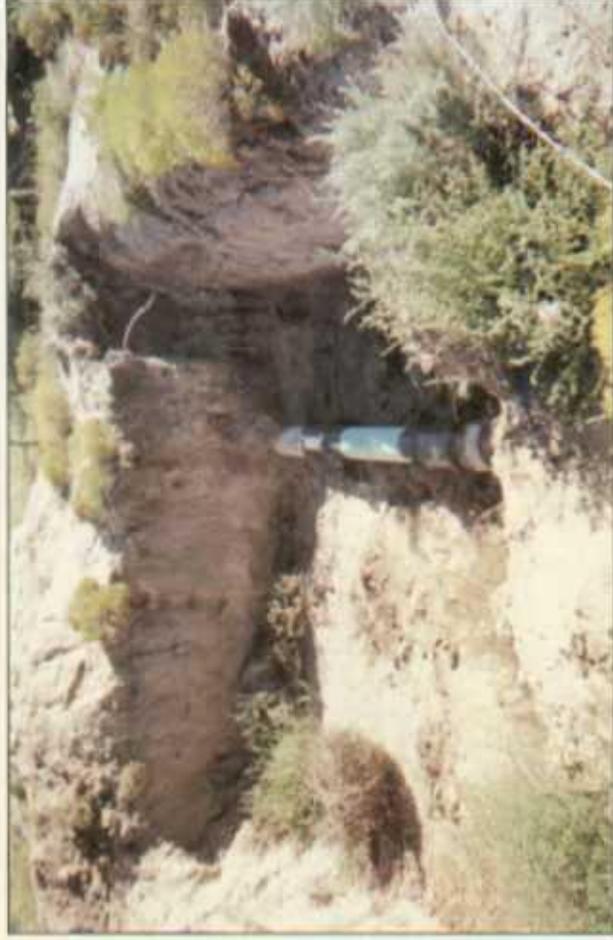
10/25/2004

junction box removed

This junction was eliminated with the pipeline replacement program. After the box materials were removed, an initial investigation of the site was conducted. The soils and surrounding surface did not exhibit any indications of adverse impacts from the junction box. Soil samples were collected below ground surface using a hand auger. Chloride field tests performed on these samples yielded very low concentrations similar to background level. Lab analysis of these samples confirmed the chloride field tests. TPH concentrations were not present within the lab's detection limit (<10.0 ppm), meeting NMOCD guidelines. The former junction box site was backfilled with the excavated soil and contoured to the surrounding terrain. The disturbed surface was seeded with a blend of native vegetation on 11/2/2005 and is expected to return to productive capacity at a normal rate. Since this junction has been eliminated, a new box is not required.

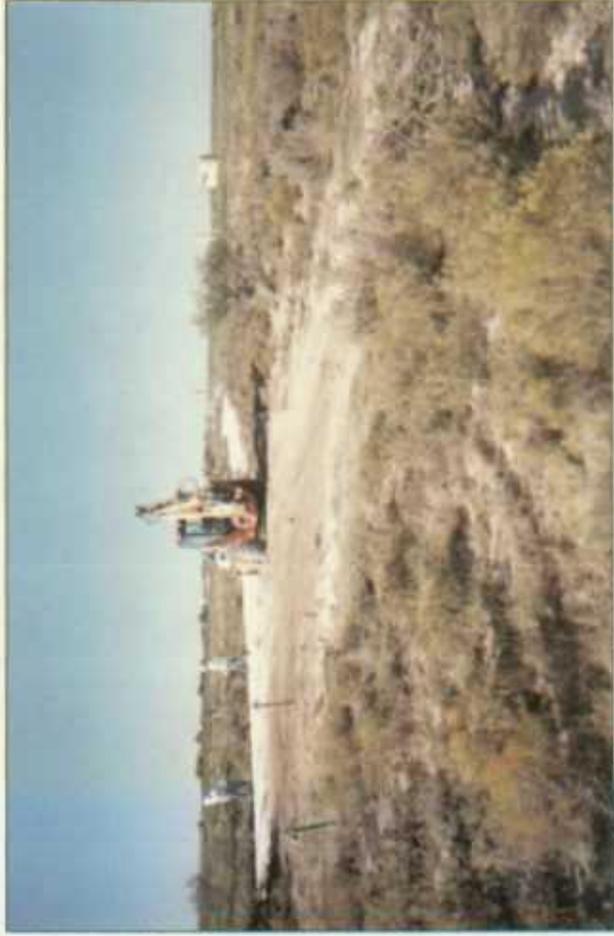
11/01/2005

backfilling and leveling

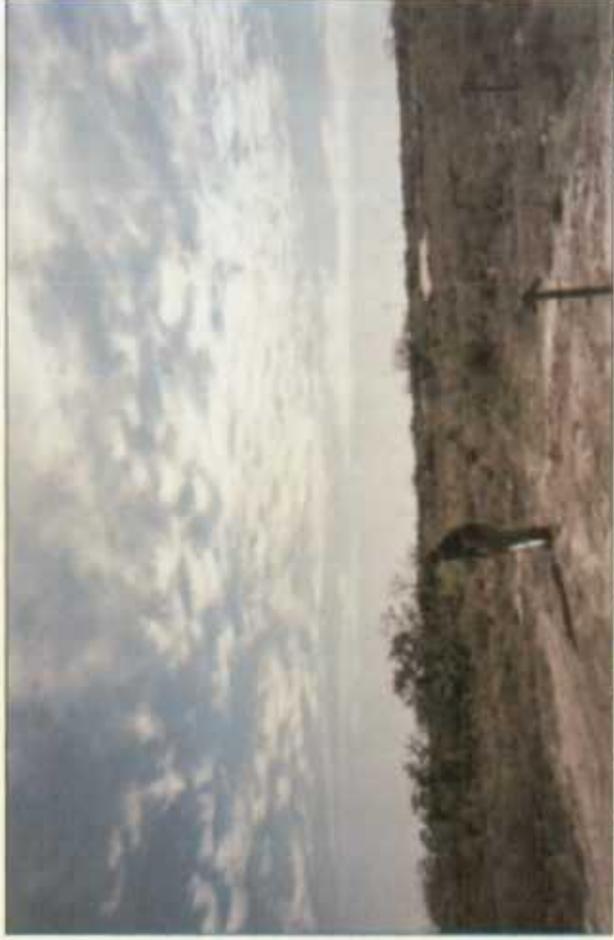
11/02/2005

seeding disturbed surface
