# Final Report

**RICE OPERATING COMPANY  
JUNCTION BOX FINAL REPORT**

# EME jct. A-3

Unit 'A', Section 3, T20S, R37E

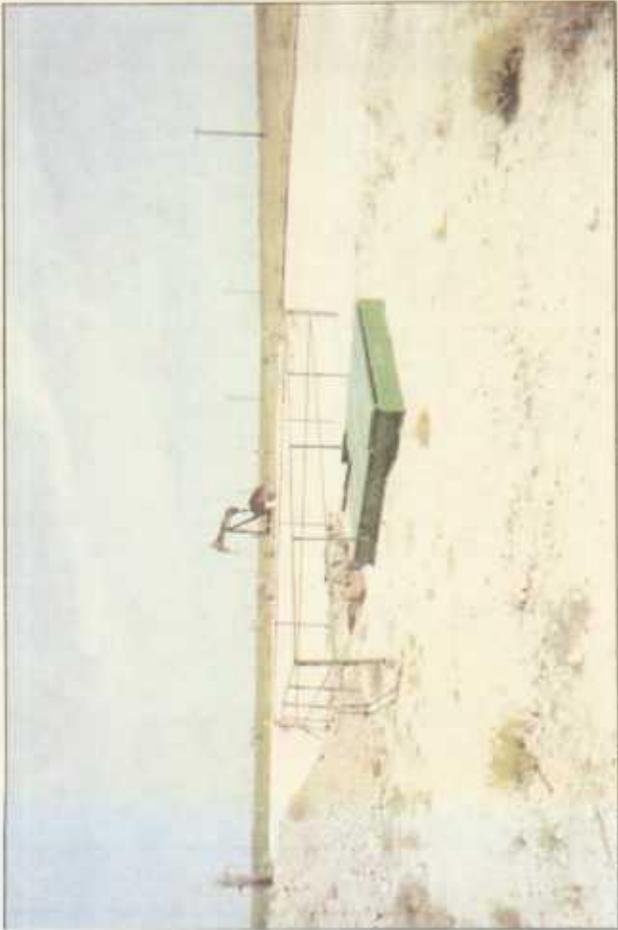
8/19/2003

old junction box prior to excavation

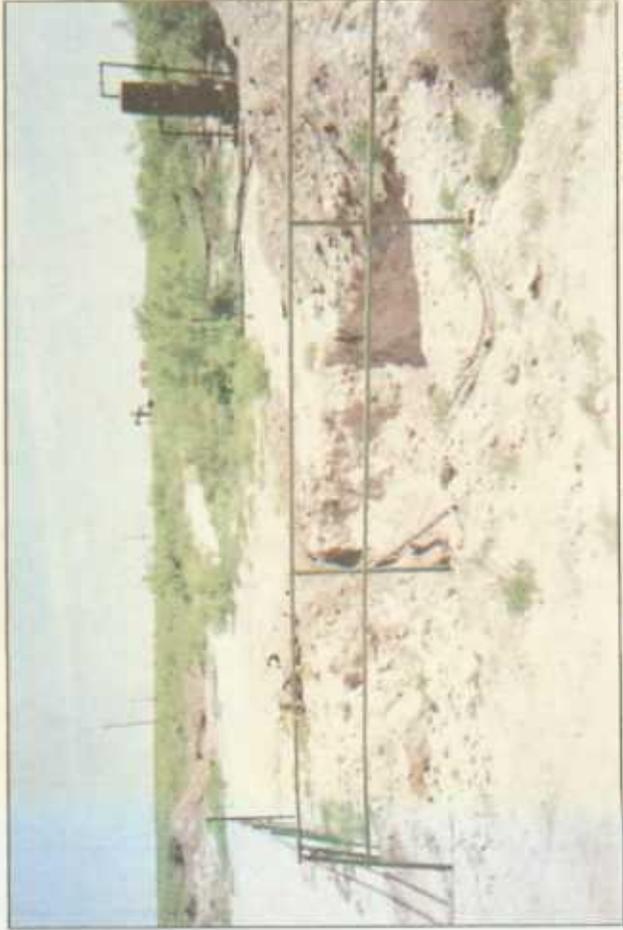
12/17/2003

box removed; prior to excavation

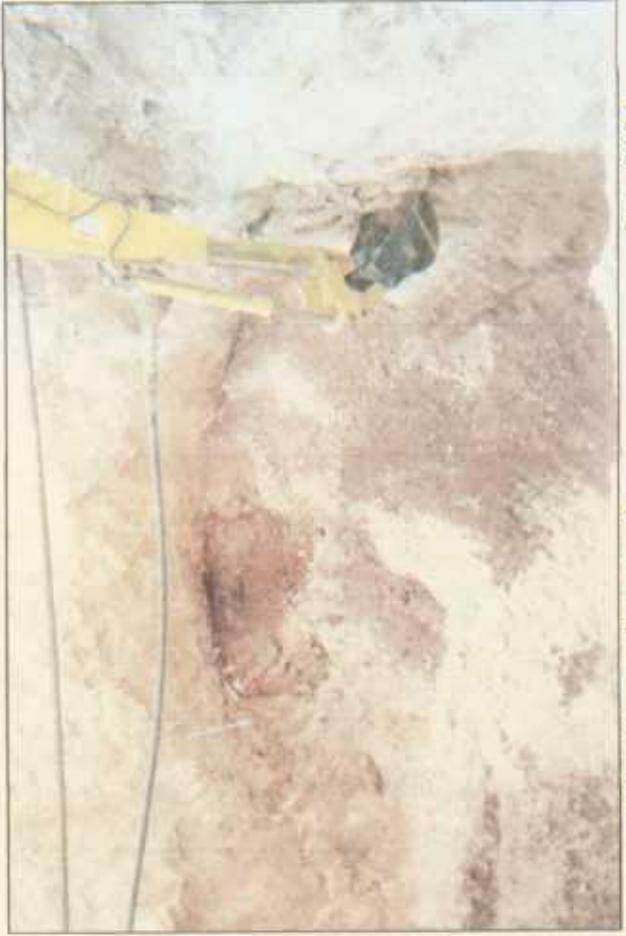
June 2004

delineation and excavation

This junction box was addressed with pipeline replacement program. A new replacement junction was built 100 ft southeast of this site. Depth to groundwater was estimated to be 21 ft or shallower. The former junction site was delineated using a backhoe while PID screenings and chloride field tests were performed at regular intervals producing a 30 x 25 x 20-ft-deep excavation. Indigenous red clay was encountered at 16 ft to 24.5 ft BGS and no moisture or groundwater was encountered above the clay. 110 cubic yards of the excavated soil was transported to an offsite facility and 170 yds of clean imported material was brought onto the site. The clean imported soil was blended with the remaining excavated soil and then backfilled into the excavation on top of the clay and contoured to the surrounding surface. A new watertight junction box was built 100 ft southeast of this site. The disturbed surface resulting from these activities was not seeded and restored because it is part of a well pad. Remaining constituents do not pose a threat to groundwater because there is no groundwater is present beneath this location.

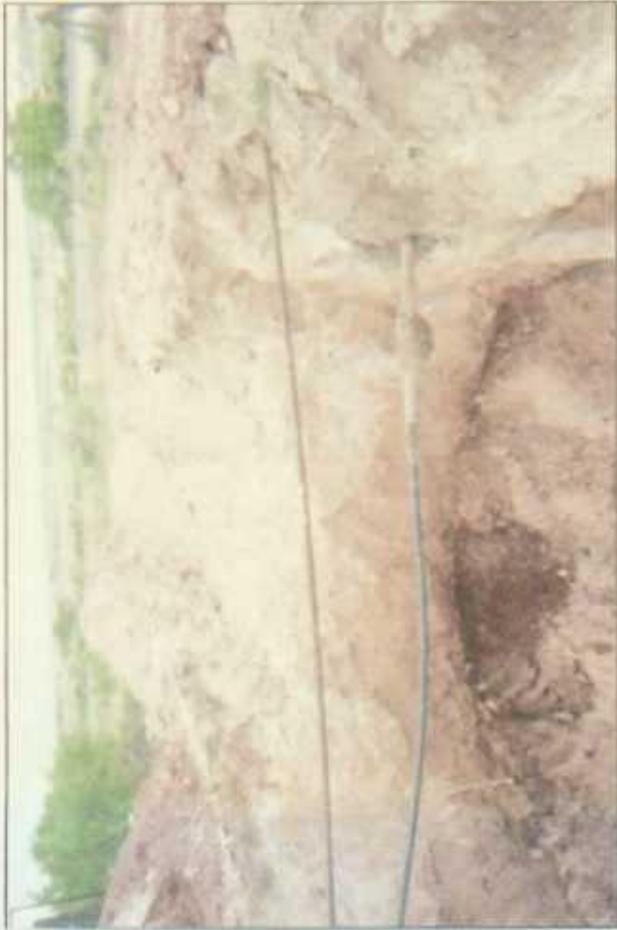
June 2004

20 ft deep excavation

Soil Excavated 555 cubic yards Excavation Length 30 Width 25 Depth 20 feet

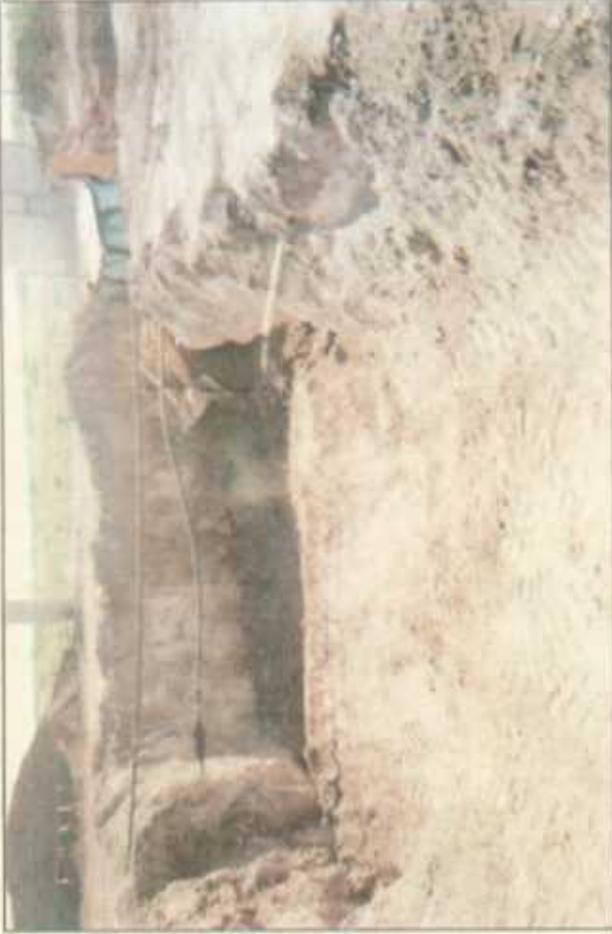
6/11/2004

beginning backfill

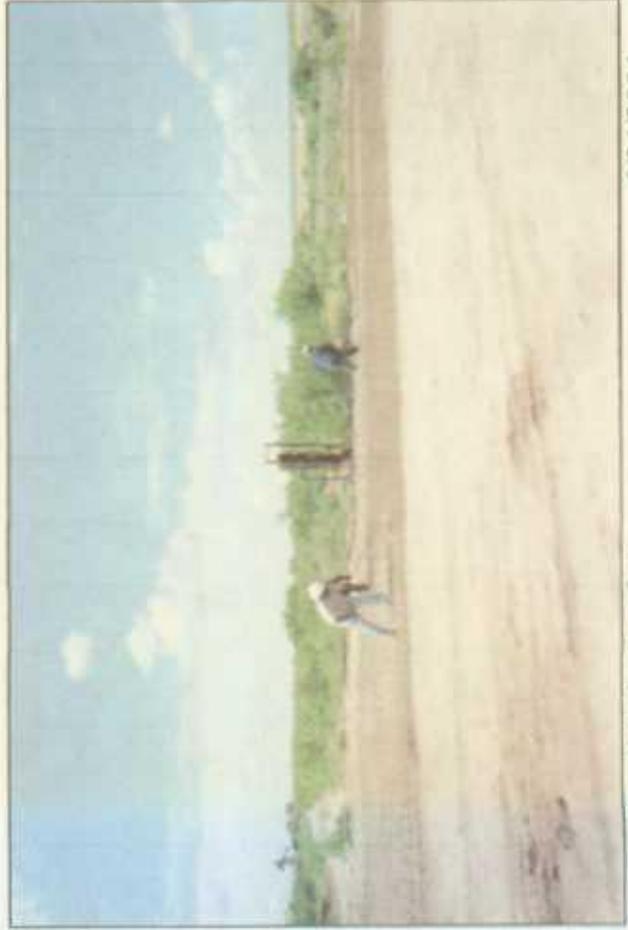
6/24/2004

seeding disturbed surface

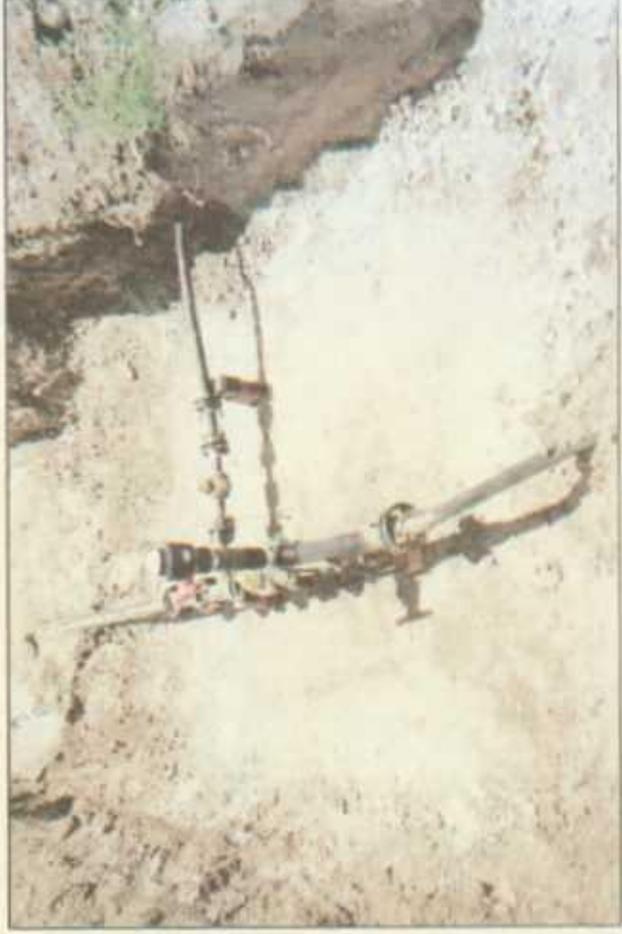
7/20/2004

new junction 100 ft southeast
