EME SCI I-19  
1R0427-198

**RICE OPERATING COMPANY  
JUNCTION BOX FINAL REPORT**

# EME jct. I-19

unit 'I', sec. 19, T20S, R37E

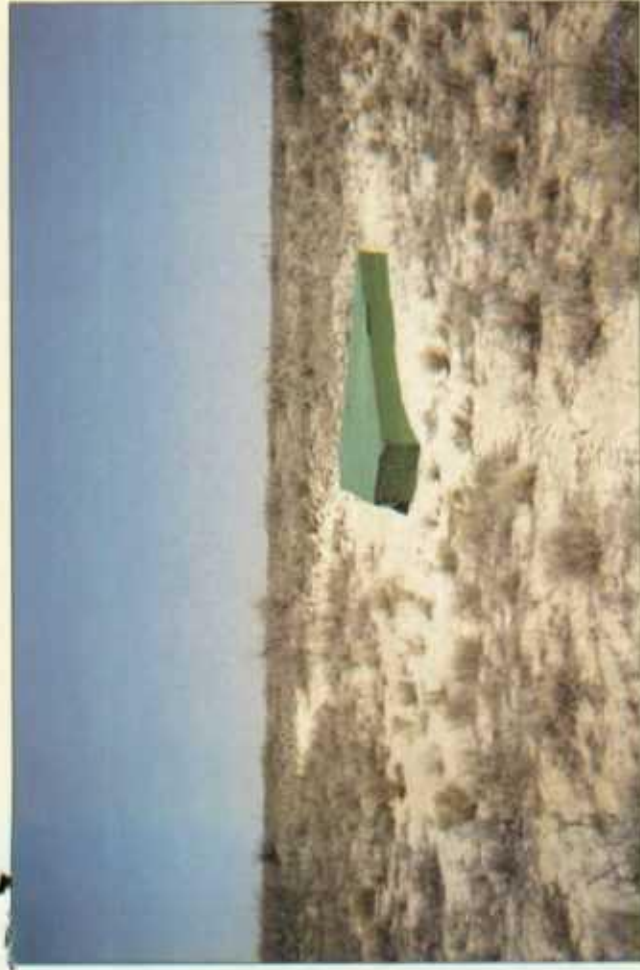
1/7/2004

undisturbed junction box

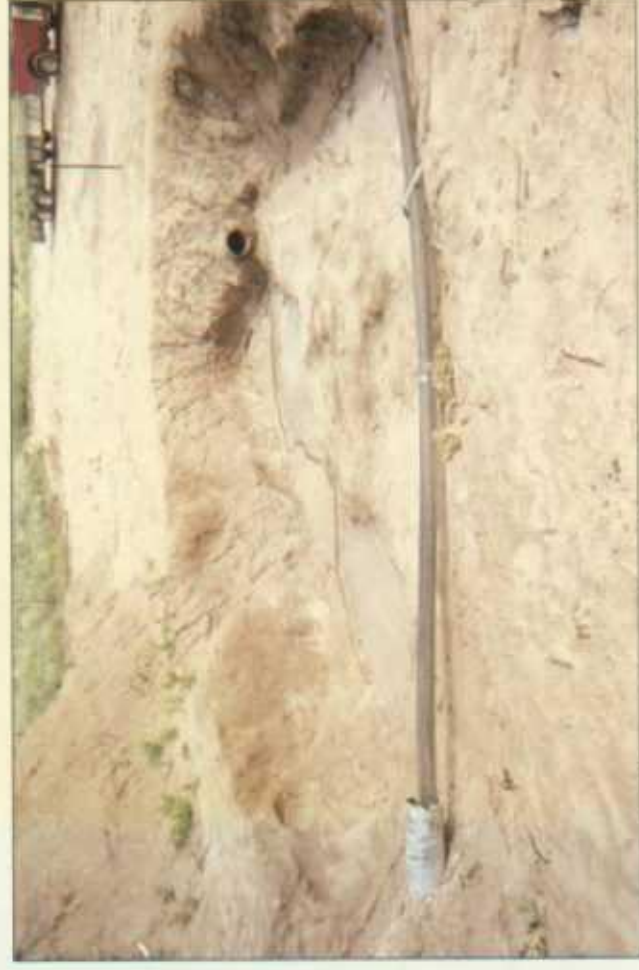
8/16/2004

new plumbing at former junction site

**General Description of Remedial Action:** This junction box was addressed with the pipeline replacement program. The junction was moved ft North and the old pipeline was replaced with a 4-in. polyethylene pipeline. The lumber was removed from the former box site and the location was delineated using a backhoe while PID screenings and chloride field tests were performed at regular intervals. All PID readings yielded 0.1 ppm and lab results confirmed TPH concentrations well below NMOCD guidelines within the 15 x 15 x 12-ft-deep excavation. Chloride concentrations were also relatively low and are not considered threatening to groundwater quality. The excavated soil was blended on site and then backfilled into the hole. The disturbed surface has been seeded with a blend of native vegetation and is expected to return to productive capacity at a normal rate. A new junction box was built 44 ft East of this location.

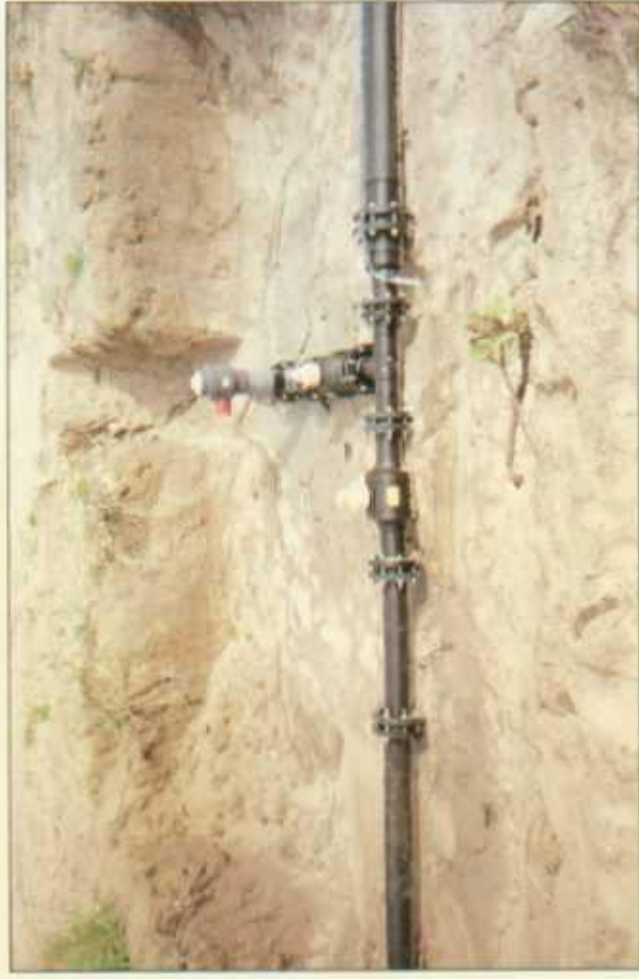
8/16/2004

new junction 44 ft west of former

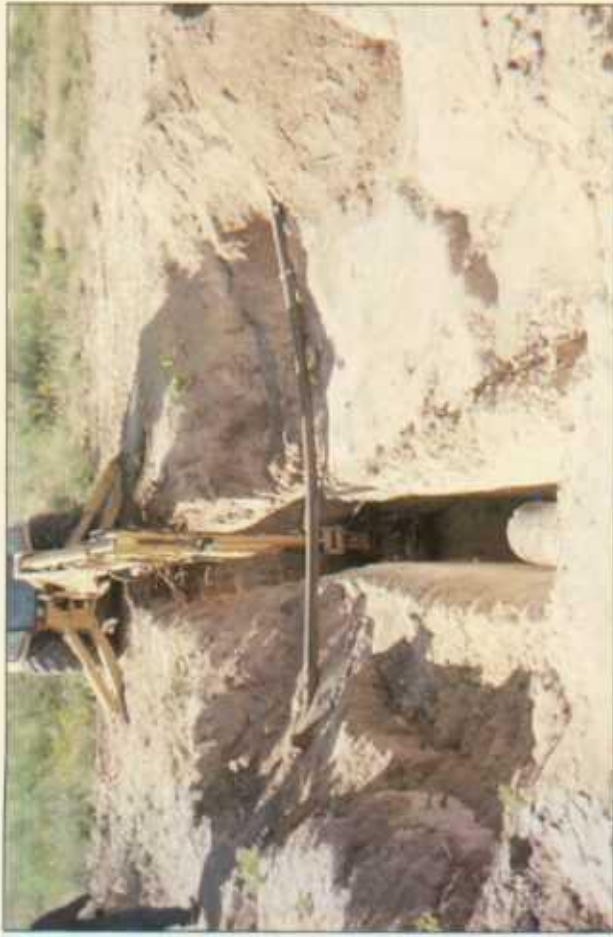
8/27/2004

delineation at former junction

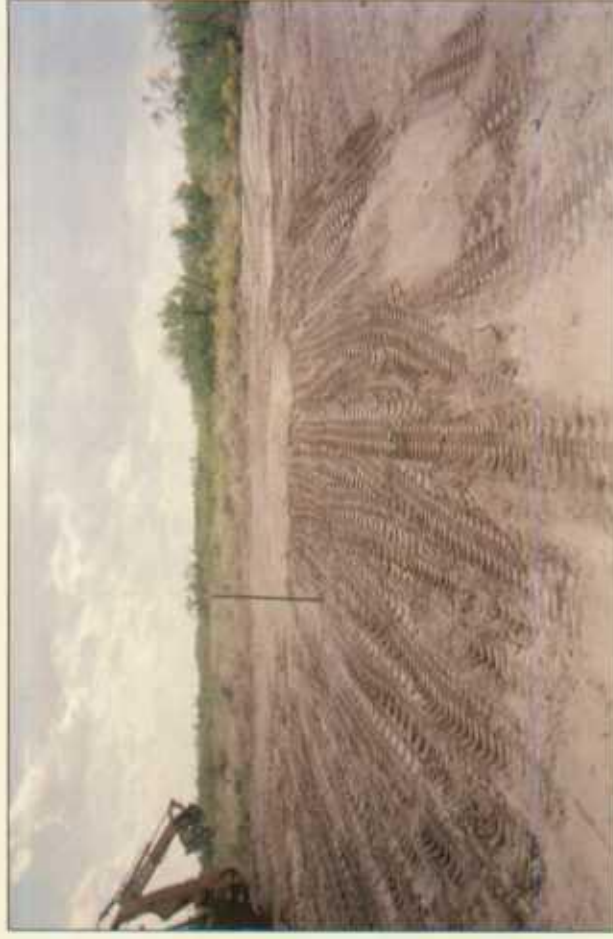
9/16/2004

backfilled excavation

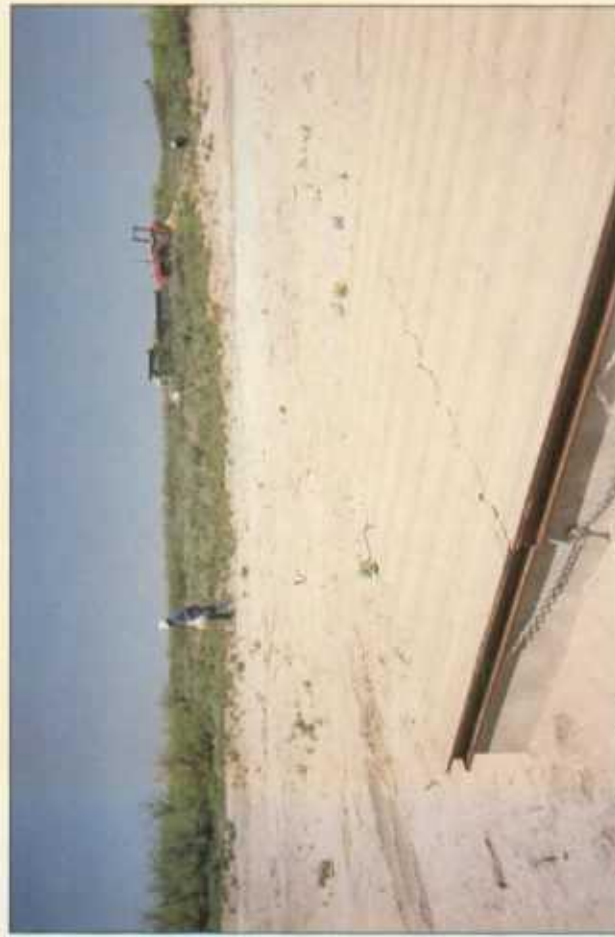
5/9/2005

seeding disturbed area; new junction box in foreground

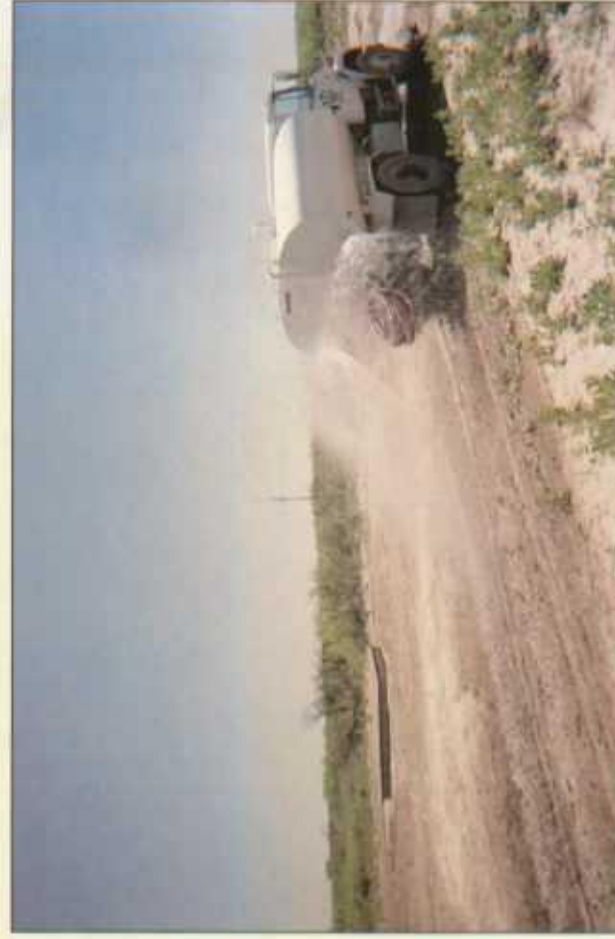
5/9/2005

watering seed; new junction box in background
