**RICE OPERATING COMPANY  
JUNCTION BOX FINAL REPORT**

SWD SYSTEM	JUNCTION	UNIT	SECTION	TOWNSHIP	RANGE	COUNTY	BOX DIMENSIONS - FEET		
							Length	Width	Depth
Vacuum	jct. B-36	B	36	17S	34E	Lea	no box--System abandonment

# Vacuum jct. B-36

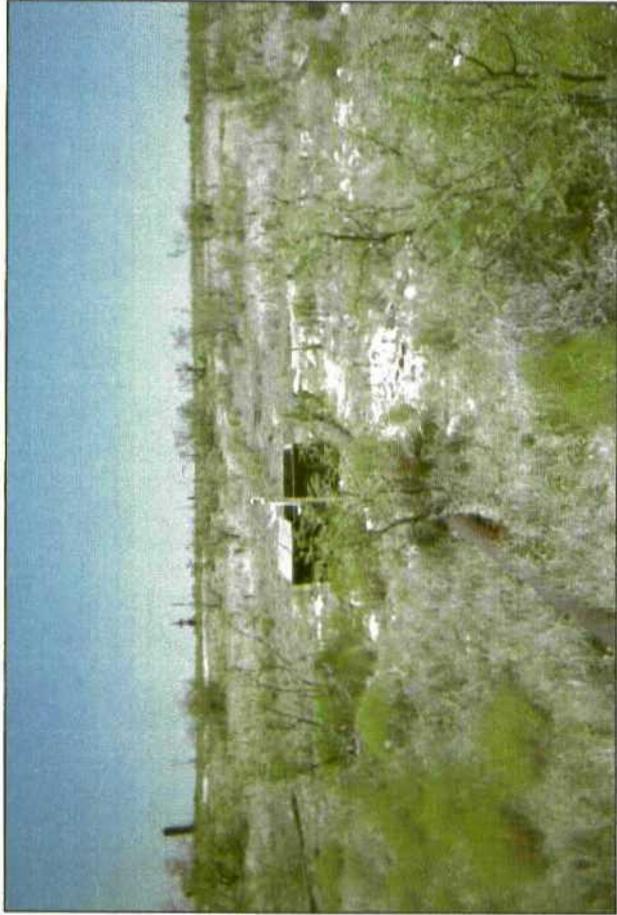
6/23/2005

undisturbed junction box

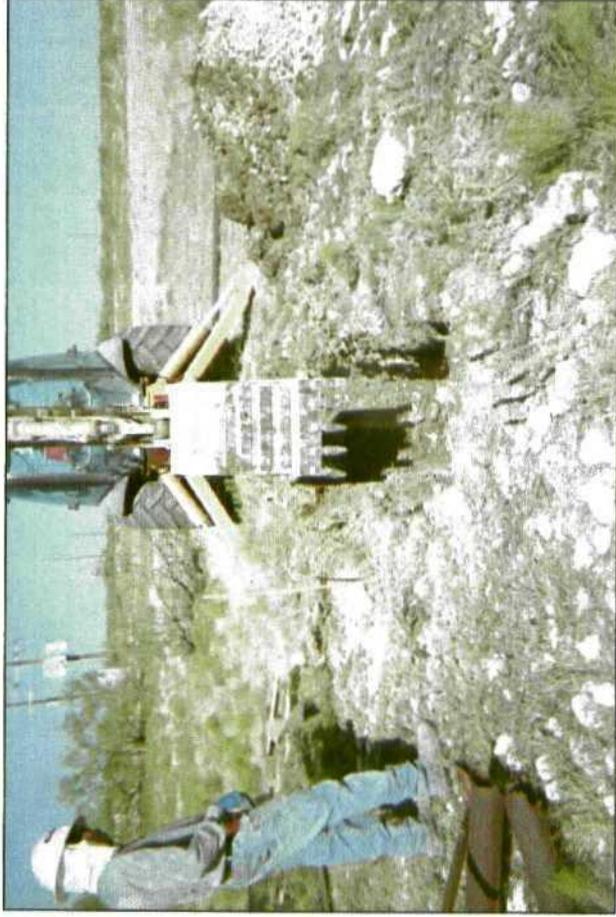
7/19/2005

delineation trench at former junction box site

as part of the Vacuum SWD System abandonment. The surrounding surface did not exhibit any signs of impact. After the box was removed, a delineation trench was made at the junction using a backhoe while soil samples were collected every ft of depth from 3 to 9 ft BGS. Chloride field tests performed on the samples were considerably low and all were less than 250 ppm. PID screenings also yielded very low VOC concentrations. A grab sample at 9 ft BGS was analyzed at a laboratory and confirmed the field tests. TPH was not present within the lab's detection limits (<10.0 ppm), meeting NMOCD guidelines. The excavated soil was blended on site and then backfilled into the trench and contoured to the surrounding surface. The disturbed surface was seeded on 11/23/2005 with a blend of native vegetation and is expected to return to productive capacity at a normal rate. Since the Vacuum SWD System is not longer active, a new junction box is not required.

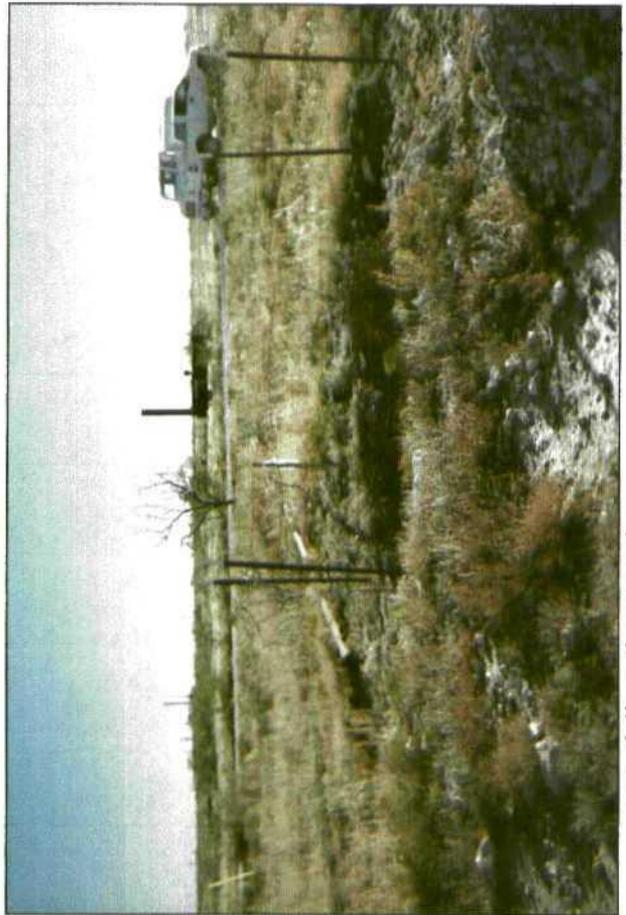
11/21/2005

open delineation trench

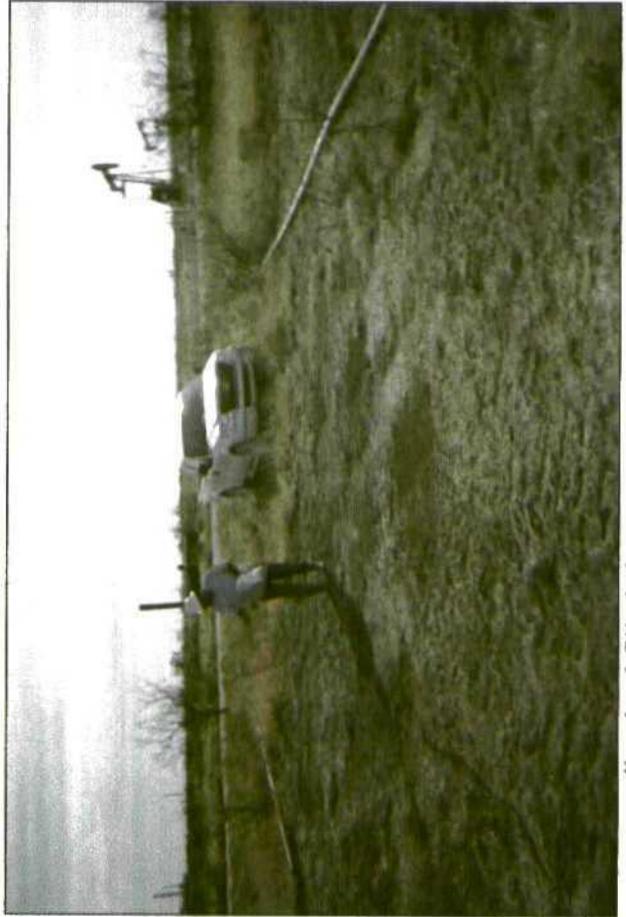
11/23/2005

seeding backfilled site
