EME E-35

**FINAL
REPORT**

**RICE OPERATING COMPANY
JUNCTION BOX FINAL REPORT**

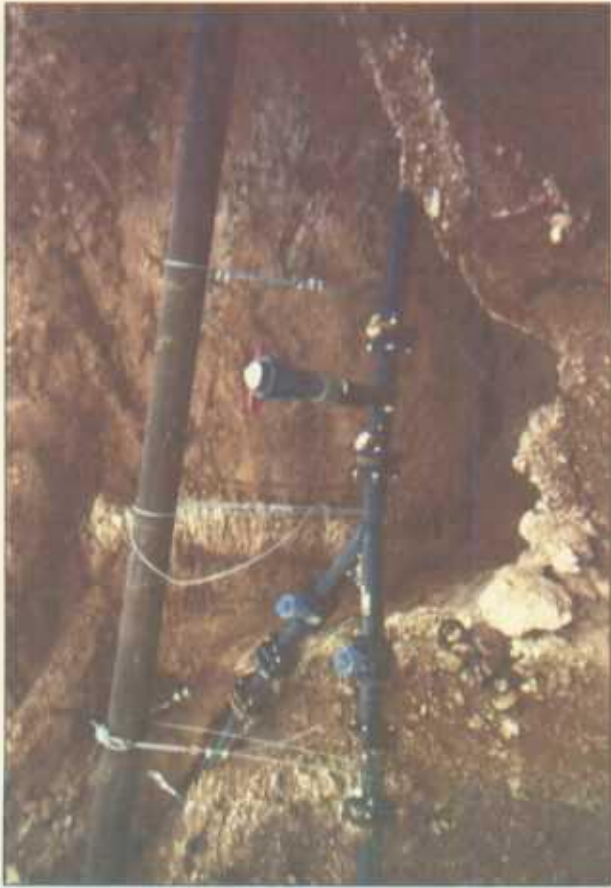
Backhoe Excavation May 2003

General Description of Remedial Action: The junction site was delineated vertically and laterally producing a 20' x 15' x 12'bgs excavation. Although TPH concentrations were well below NMOCD guidelines, chlorides did not significantly decrease vertically or laterally. The excavation was backfilled to 3 ft BGS with the soil that was blended on site. At 3 ft, a 20 mil poly liner was installed in a convex manner as illustrated in the attached diagram. The remaining soil was backfilled and contoured on top of the liner on 6/3/2003. The surface was seeded with a blend of native vegetation. On 1/13/2004, a soil bore was conducted at this site to determine the vertical extent of chloride impact. The bore was advanced to 20 ft BGS when a conclusive decline trend of chloride concentrations was observed (see graph). The bore hole was backfilled with cuttings and a bentonite seal was placed at 0-9 ft to maintain the integrity of the poly liner. A new watertight junction box has been built 100' west of this location.

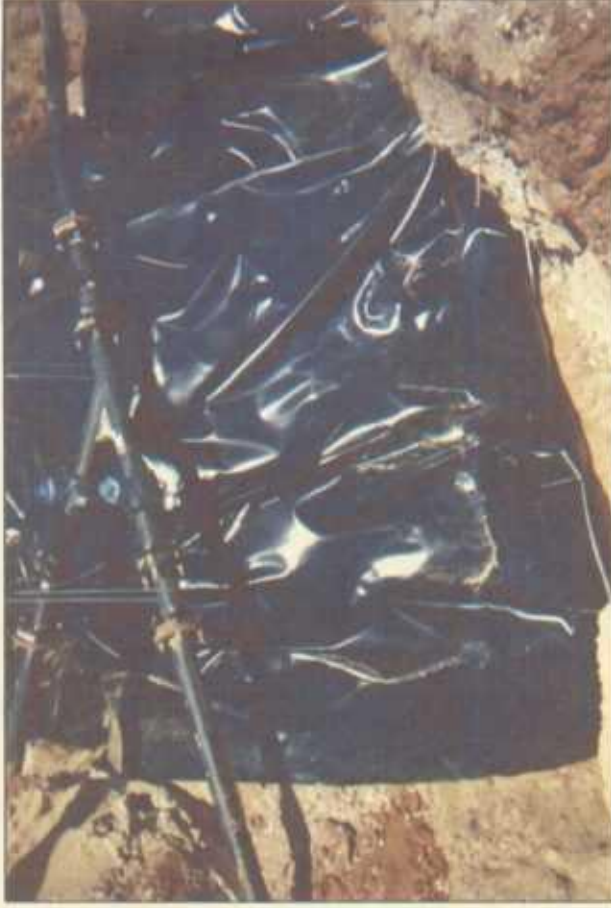
Installing 20 mil Poly Liner

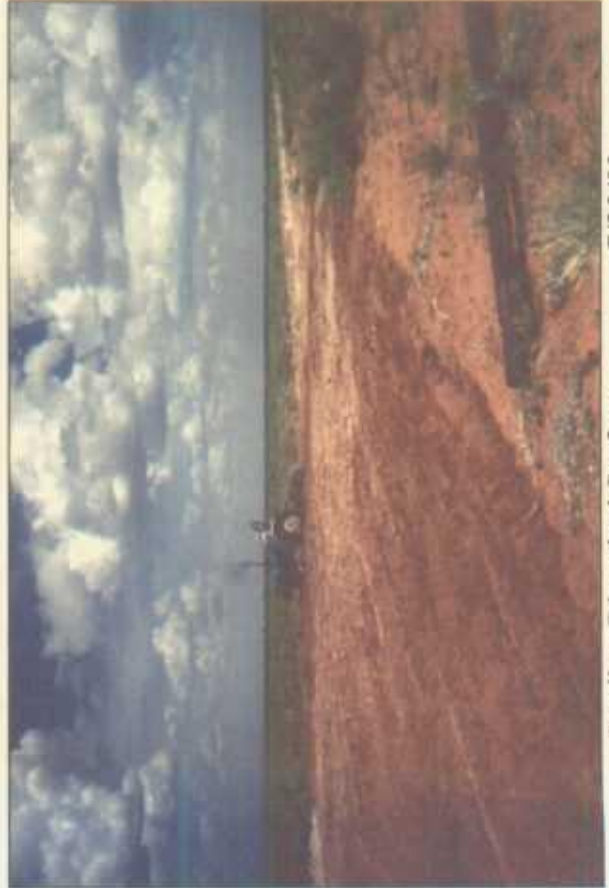
7/29/03

Seeding Disturbed Surface

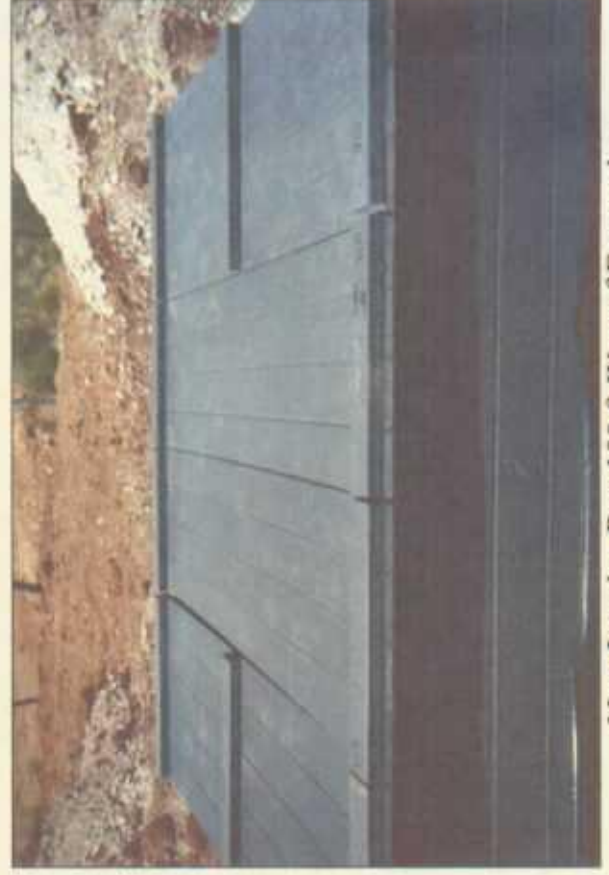
New Junction Box 100 ft West of Excavation

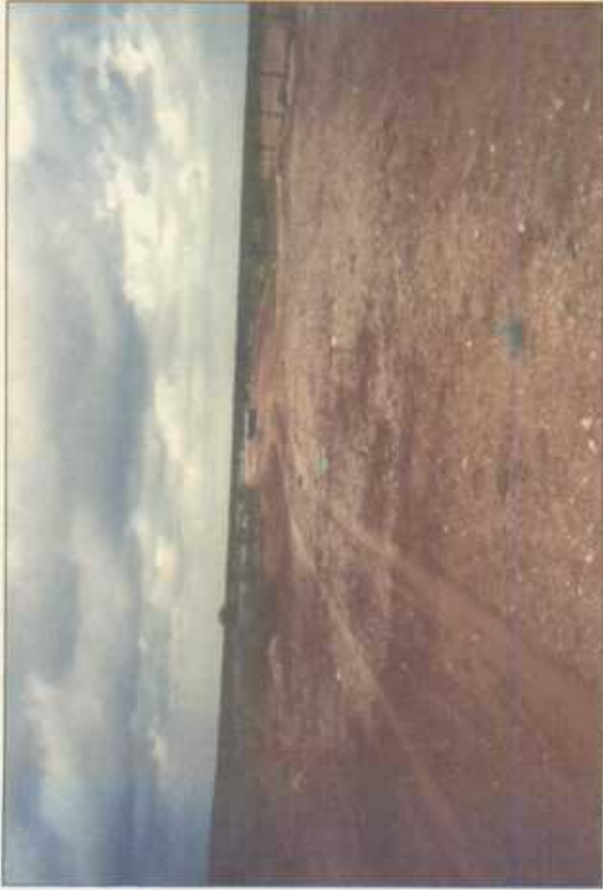
Backfilled Site with ID plate in center and new box in background

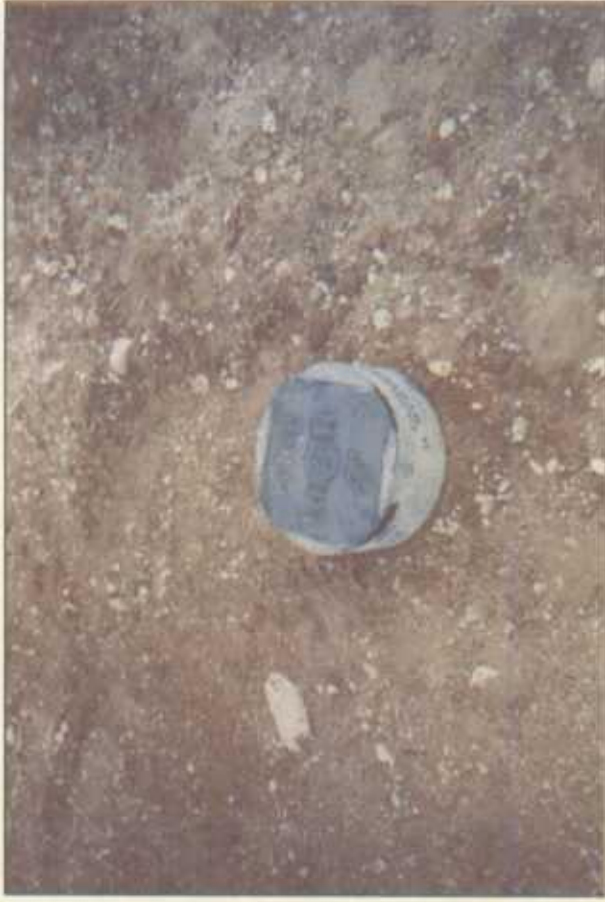
Close-up of ID plate " POLY LINER 3' "

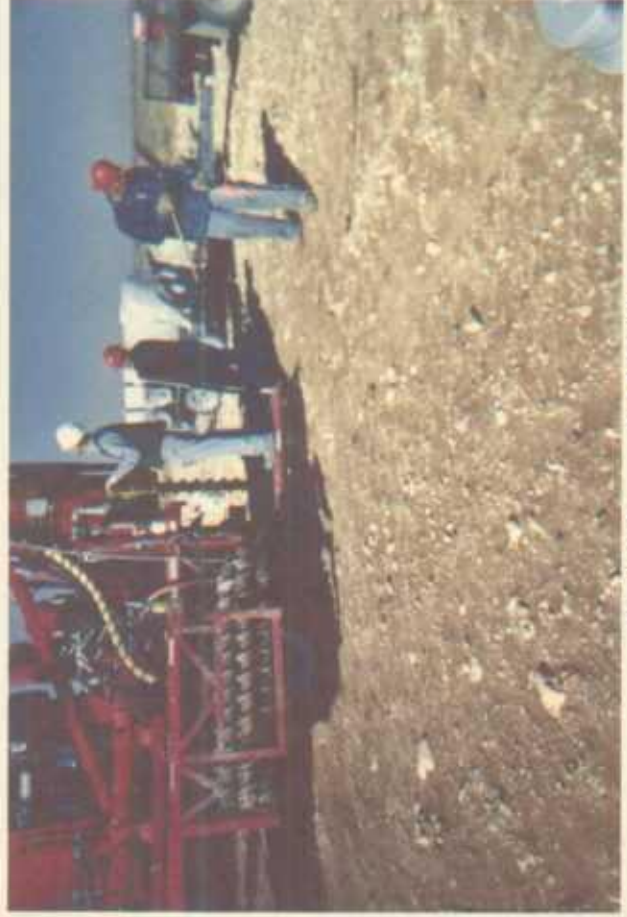
Soil Bore 1/13/2004

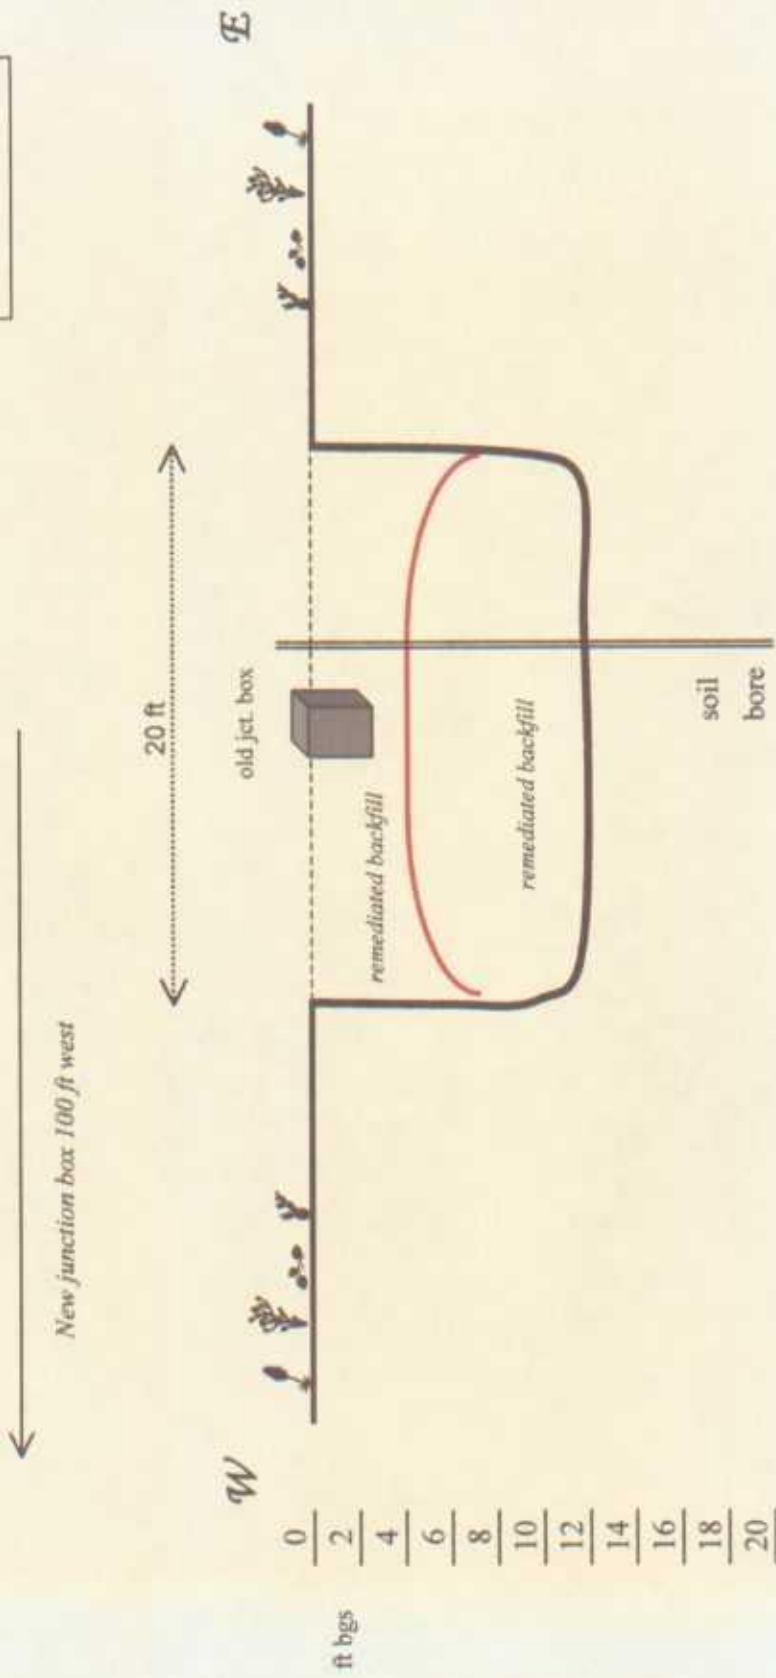
**EME jct. E-35
Impact Excavation
Cross-Section**

Excavation Boundary
 	20 mil Poly

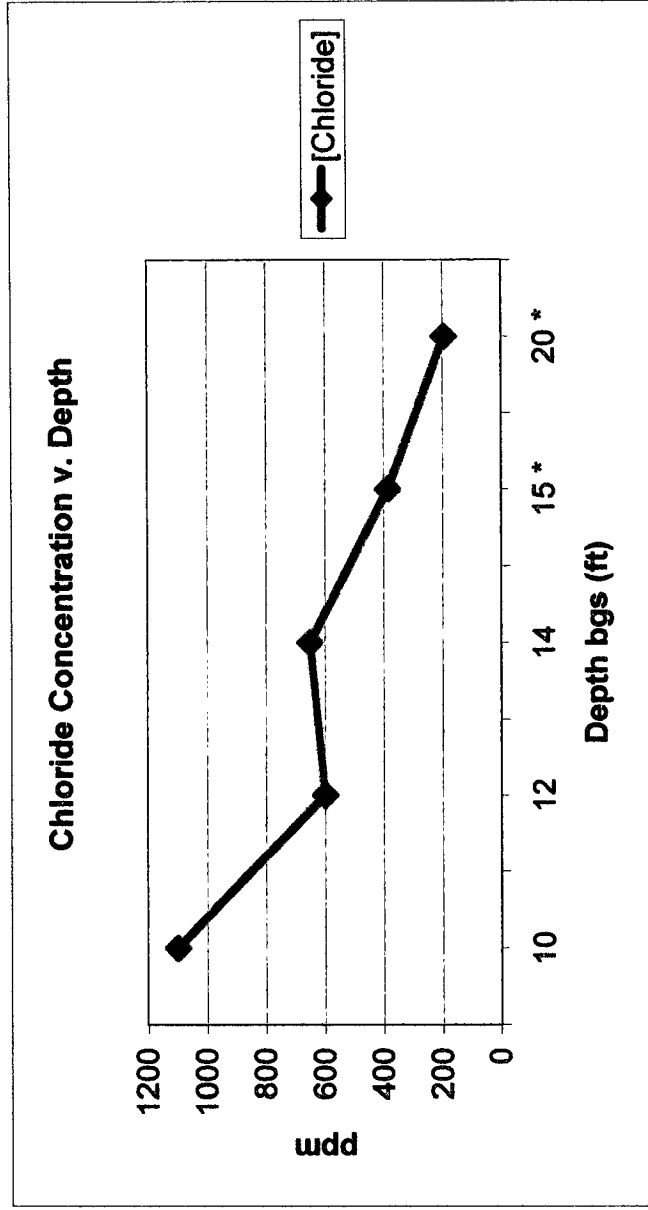
CHLORIDE CONCENTRATION CURVE

Vertical Delineation at Source

Depth bgs (ft)	[Cl ⁻] ppm
10	1100
12	600
14	650
15 *	386
20 *	195

Groundwater = 122 ft
