**1R - 427 - 50**

# FINAL REPORT

**RICE OPERATING COMPANY  
JUNCTION BOX FINAL REPORT**

## EME jct. I-9

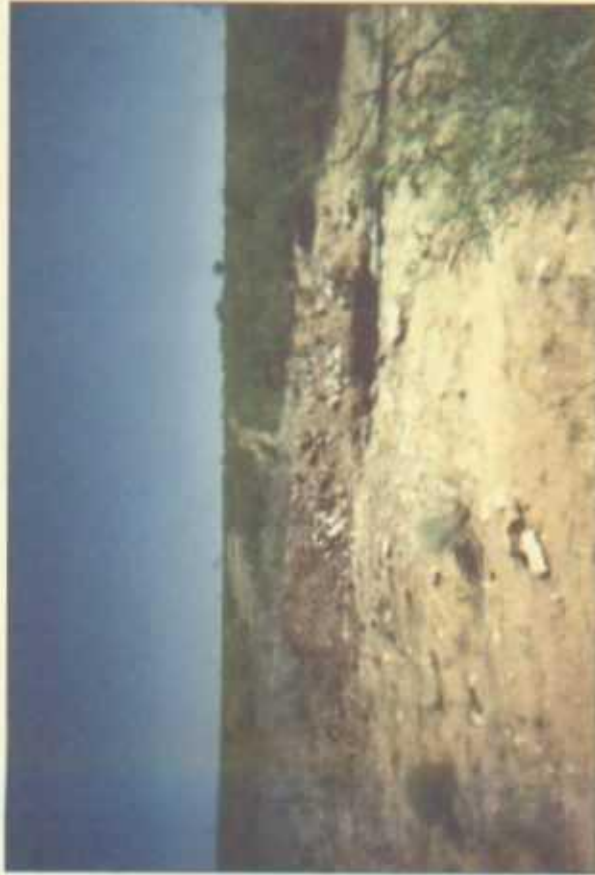
Box removed; prior to excavation

8/21/2003

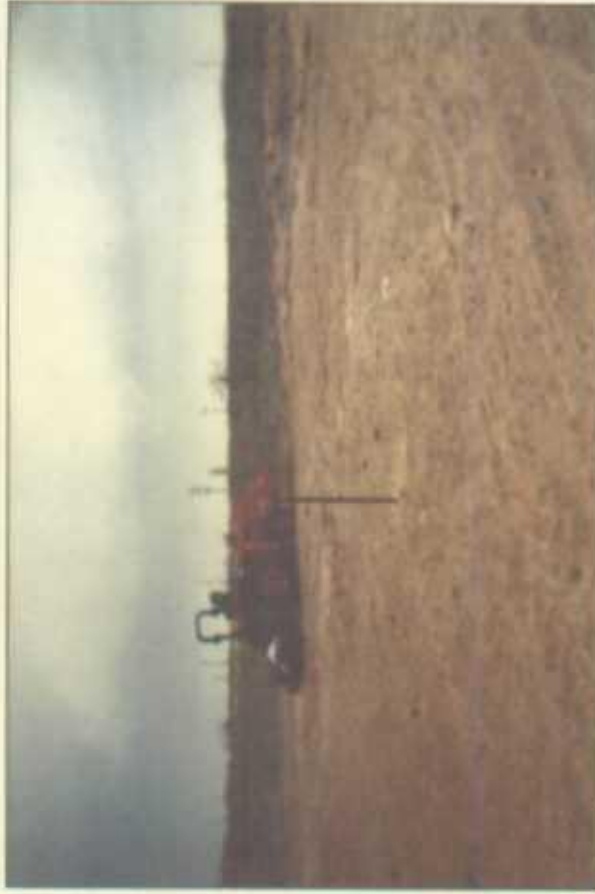
Seeding disturbed surface at backfilled site

12/12/2003

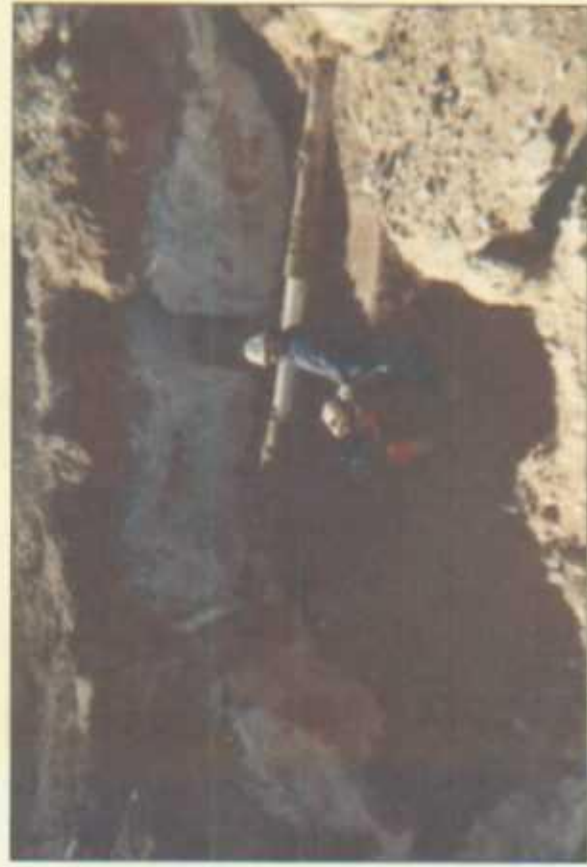
Compacting clay

Nov. 2003

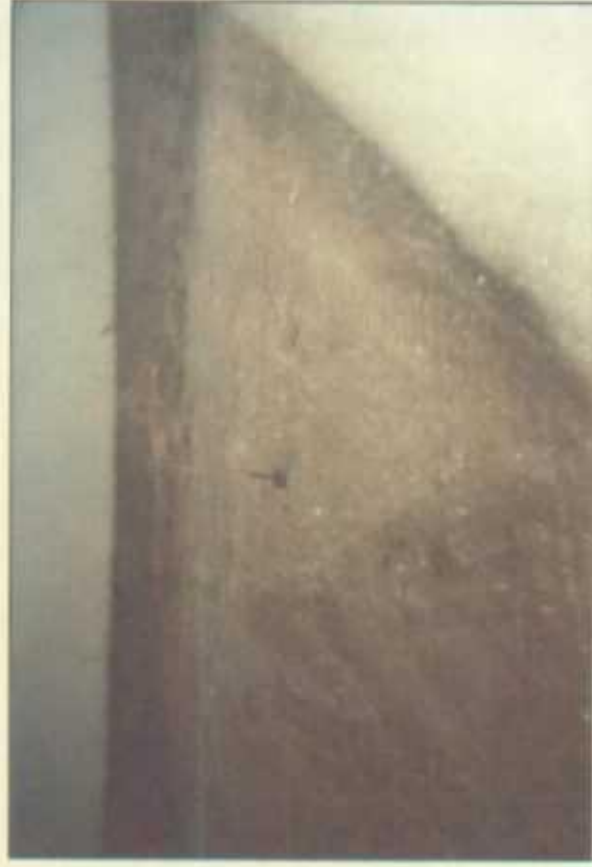
Shovel marking plate to identify clay barrier below

12/15/2003
