# FINAL REPORT

# RICE OPERATING COMPANY JUNCTION BOX FINAL REPORT

## EME M-34 Junction Box Upgrade

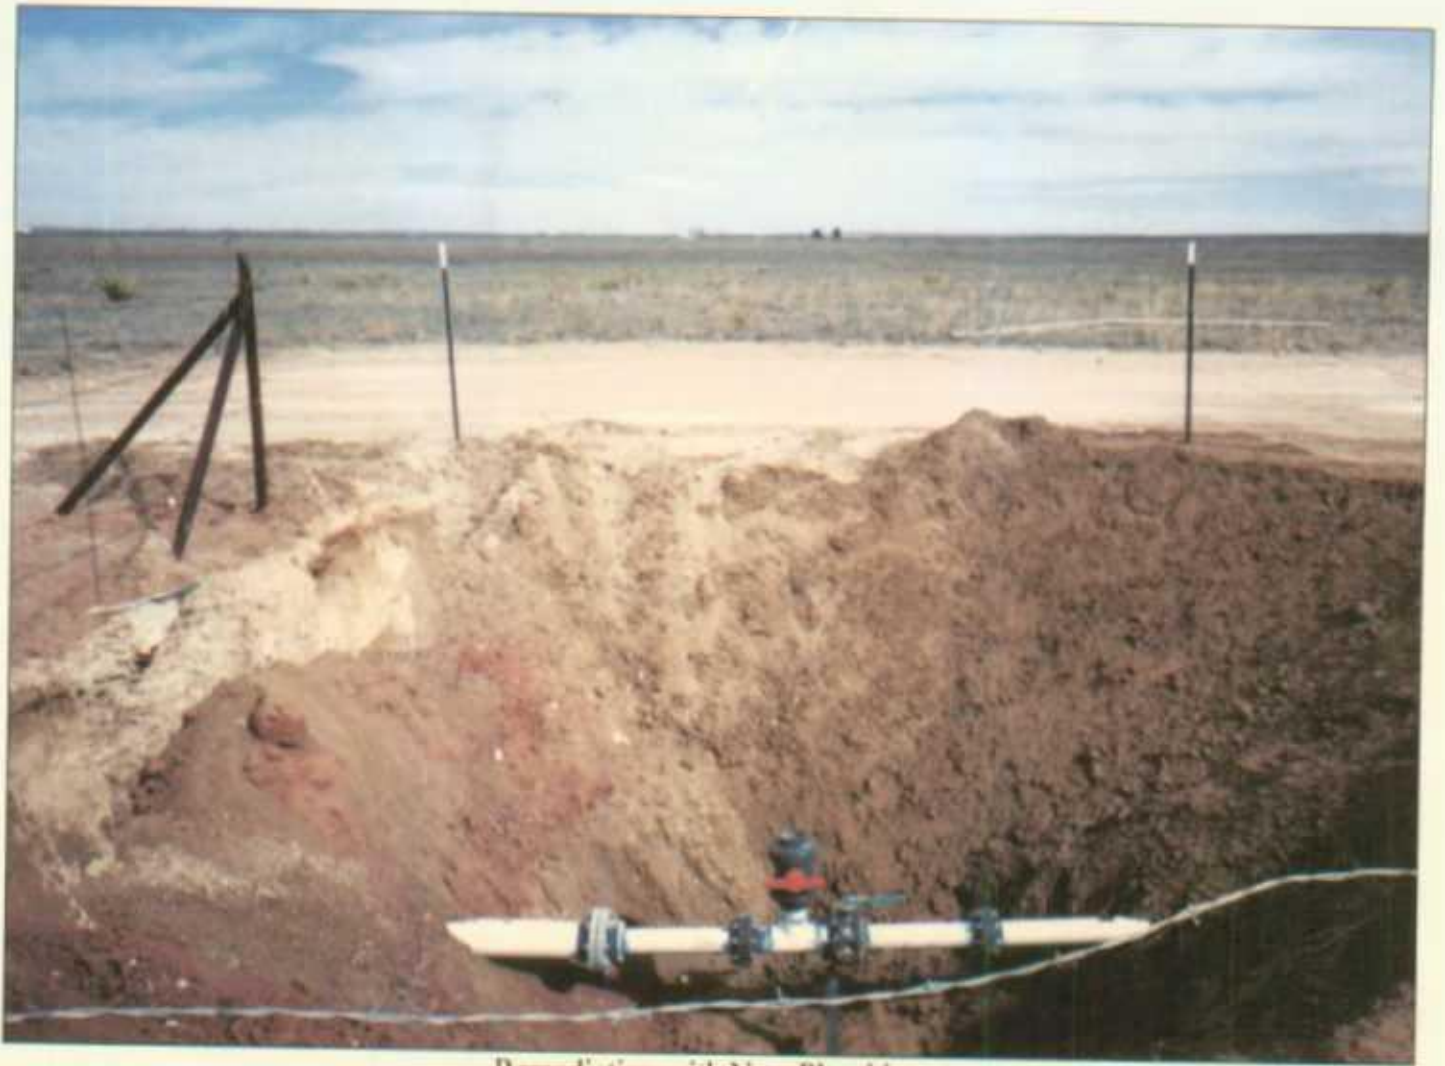
Remediation with New Plumbing

from 950 ppm @ 20' to 71 ppm @ 35' bgs. This demonstrates that impact stopped before reaching groundwater. A compacted clay barrier and water tight junction box was installed

and backfilled. High impacted soil was hauled to a permitted disposal facility. Natural attenuation will remediate the remaining hydrocarbon.
