BD Vent C-2

**RICE OPERATING COMPANY  
JUNCTION BOX FINAL REPORT**

# BD C-2 vent

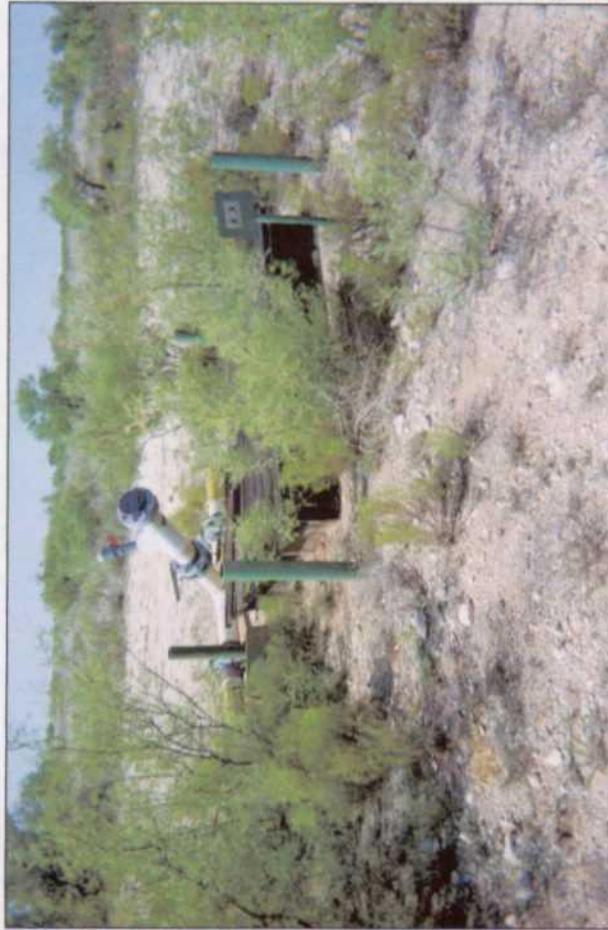
Old junction box before replumbing 7/14/2003

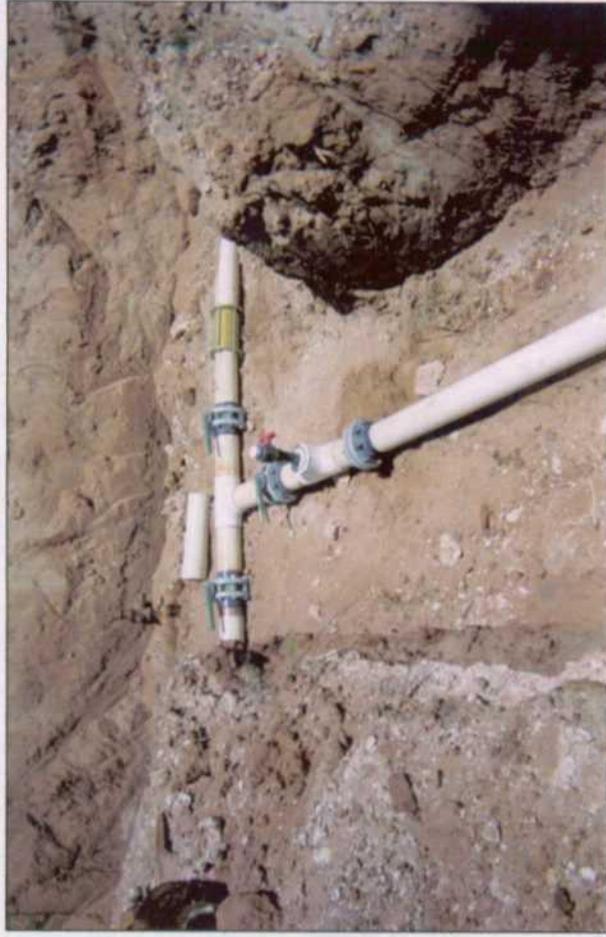
New plumbing at junction 7/16/2003

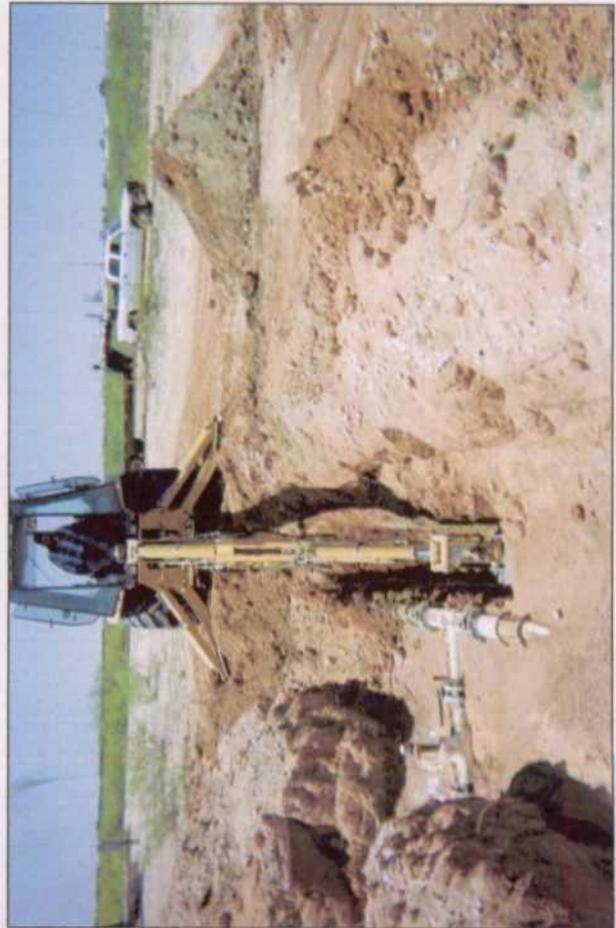
Delineation 4/22/04

The site was delineated with a backhoe while chloride field tests and PID screenings were conducted at regular intervals. Vertical chloride delineation was extended to 20 ft BGS where a conclusive trend was not observed. PID concentrations were generally minimal throughout the 30 x 30 x 6-ft-deep excavation. NMOCD TPH guidelines were met. To inhibit downward migration of residual chloride, a 1-ft thick clay barrier was installed at the bottom of the hole at 6 ft. The excavation was backfilled with the blended, excavated soils because the junction had to be put back into service with a new watertight junction box. On 7/15/2004, a soil bore was initiated at the site to delineate chloride further. The bore was advanced to 38 ft BGS where a conclusive trend of decline was observed as concentrations fell to background levels (see graph). The bottom of the bore hole was plugged with bentonite and the remainder was filled with drill cutting. The disturbed surface was seeded with a blend of native vegetation on 5/25/04 and will be monitored for growth.

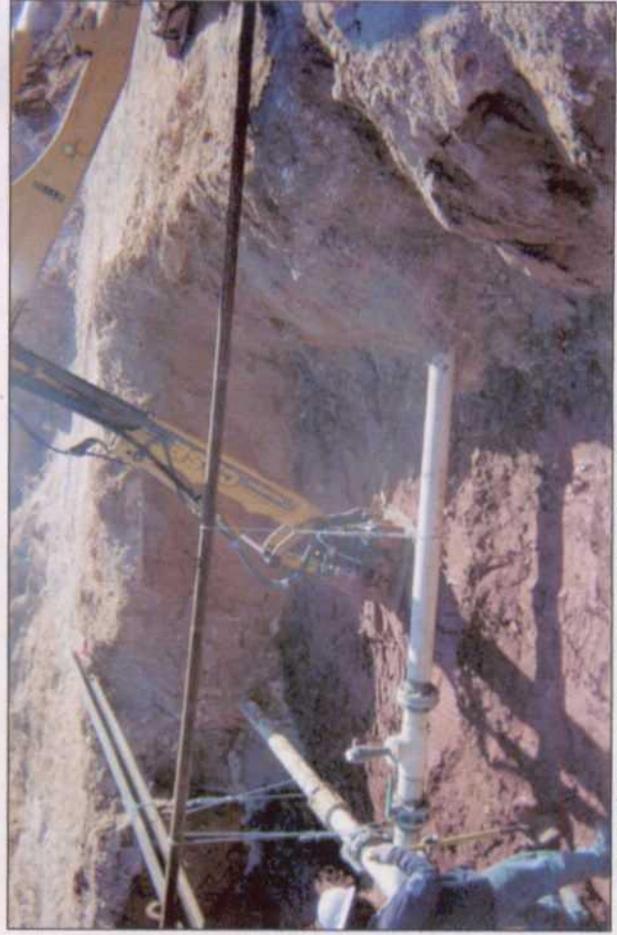
Installing and compacting clay barrier

5/4/2004

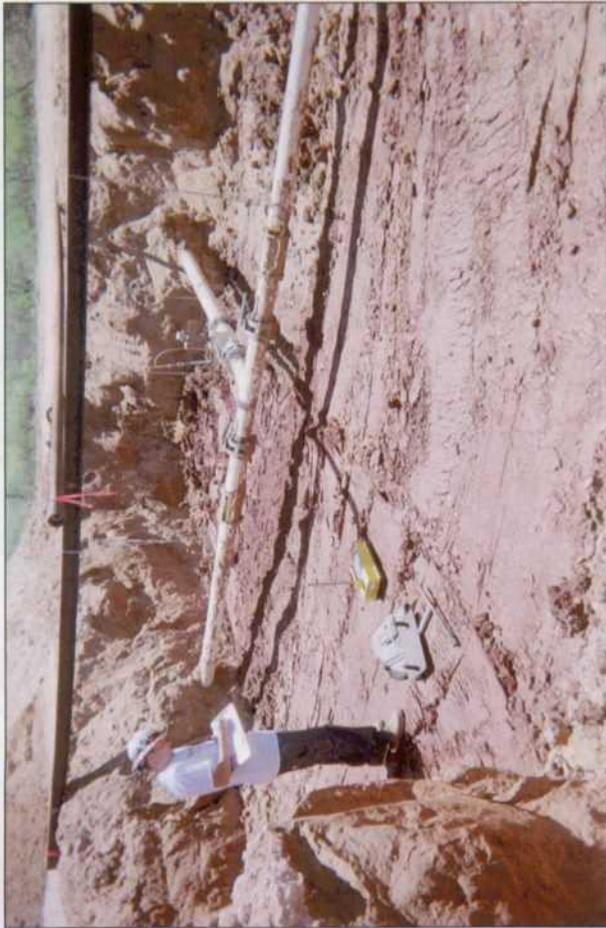
testing clay

5/4/2004

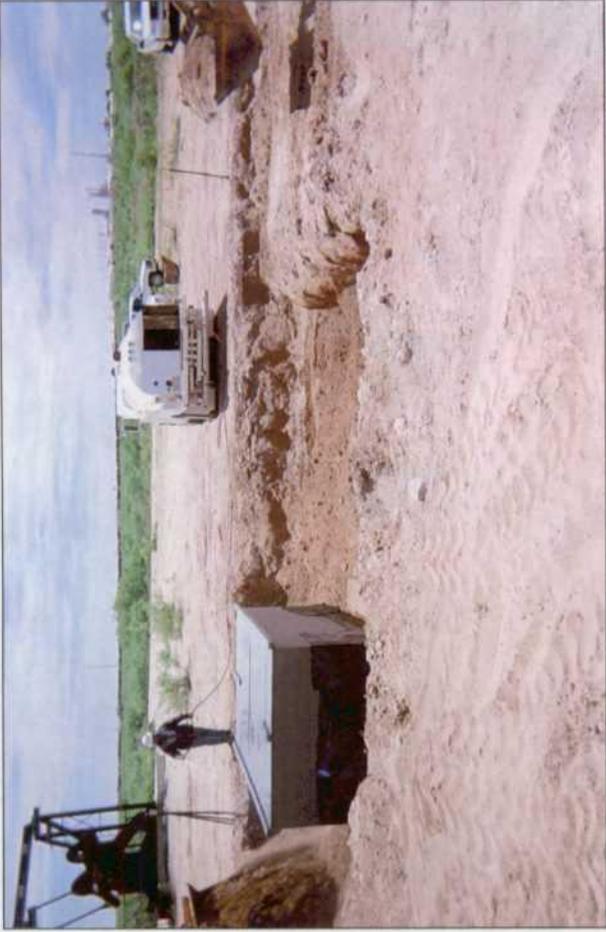
completing junction box; compacting surrounding soils

5/25/2004

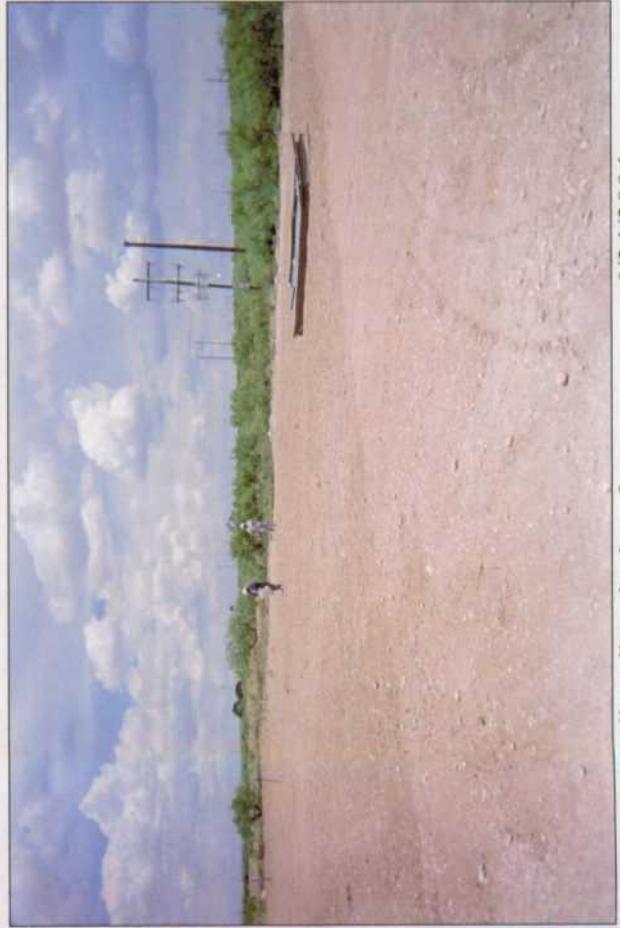
seeding disturbed surface

6/24/2004

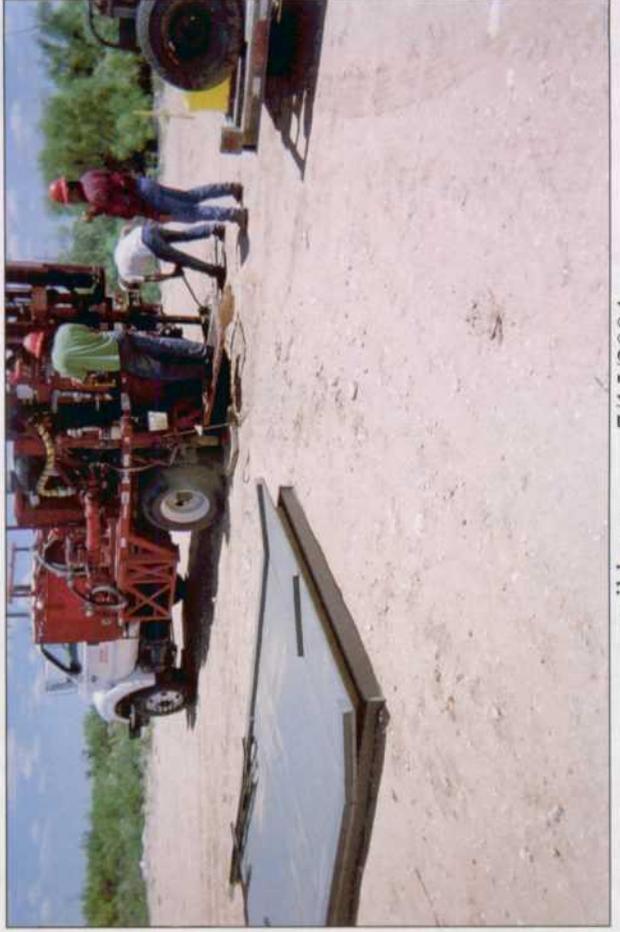
soil bore

7/15/2004

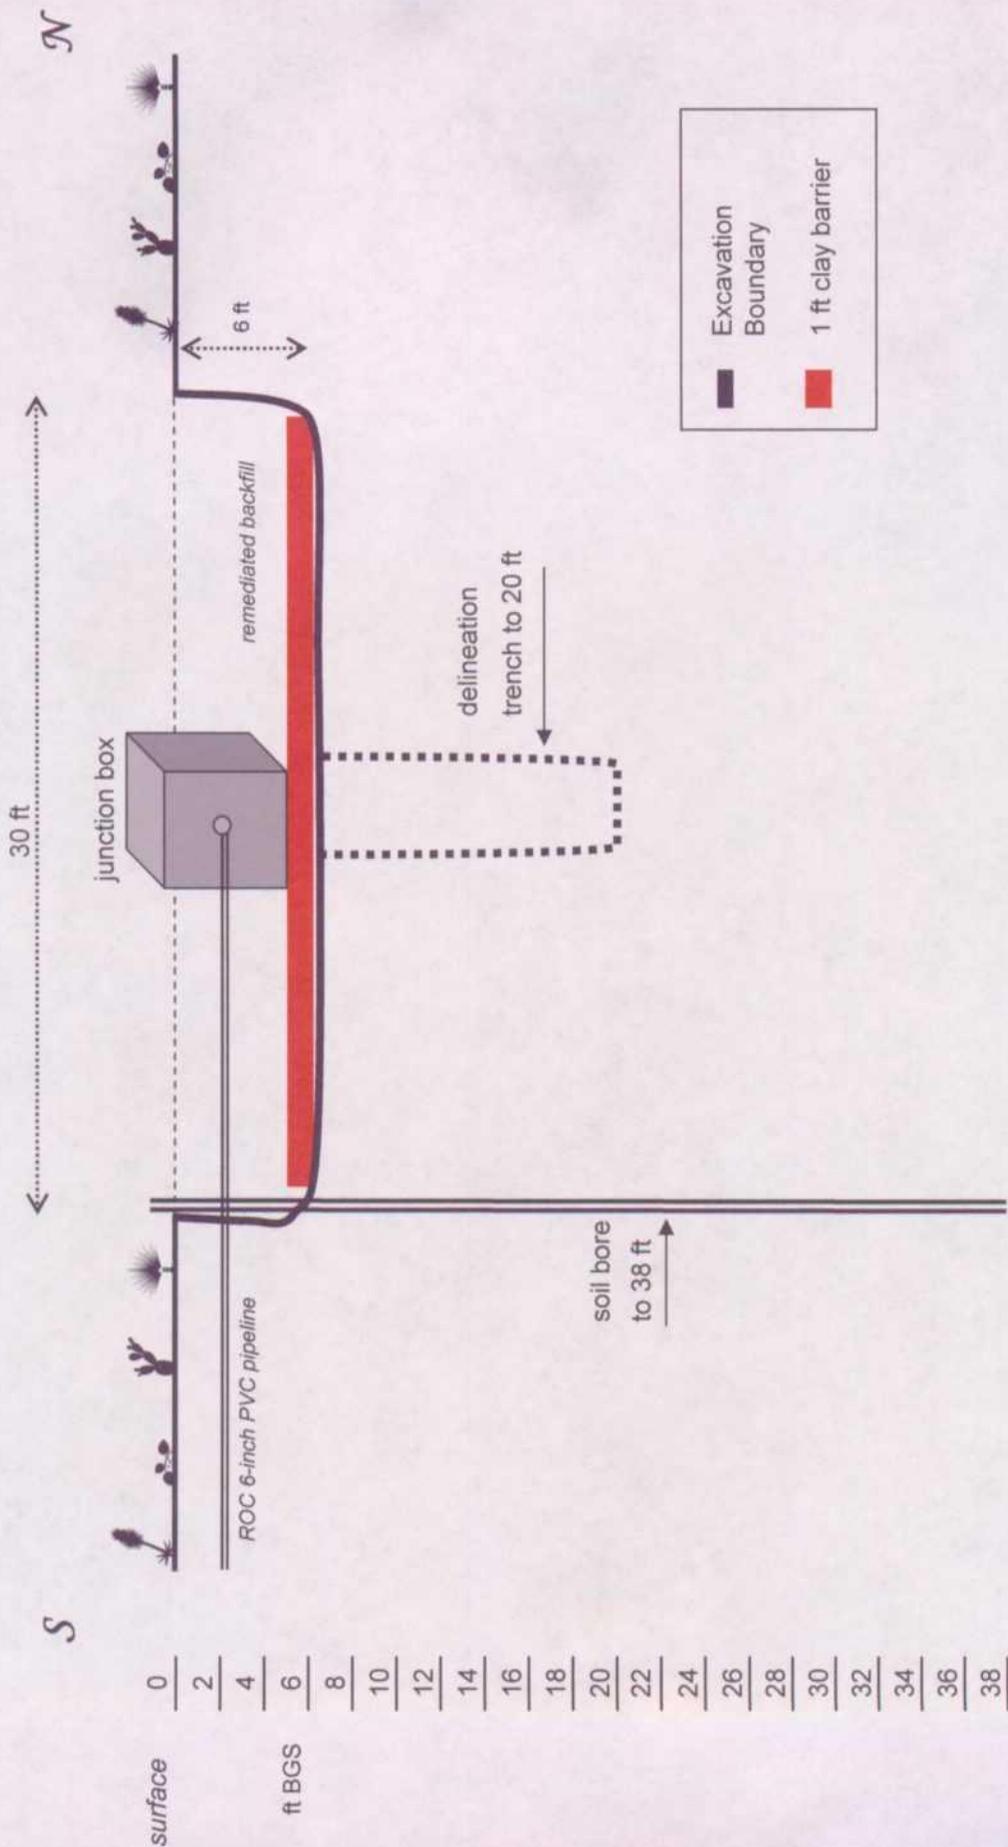
### Excavation Cross-Section

A delineation trench was extended down to 20 ft BGS; not included in the 6 ft bottom composite sample.

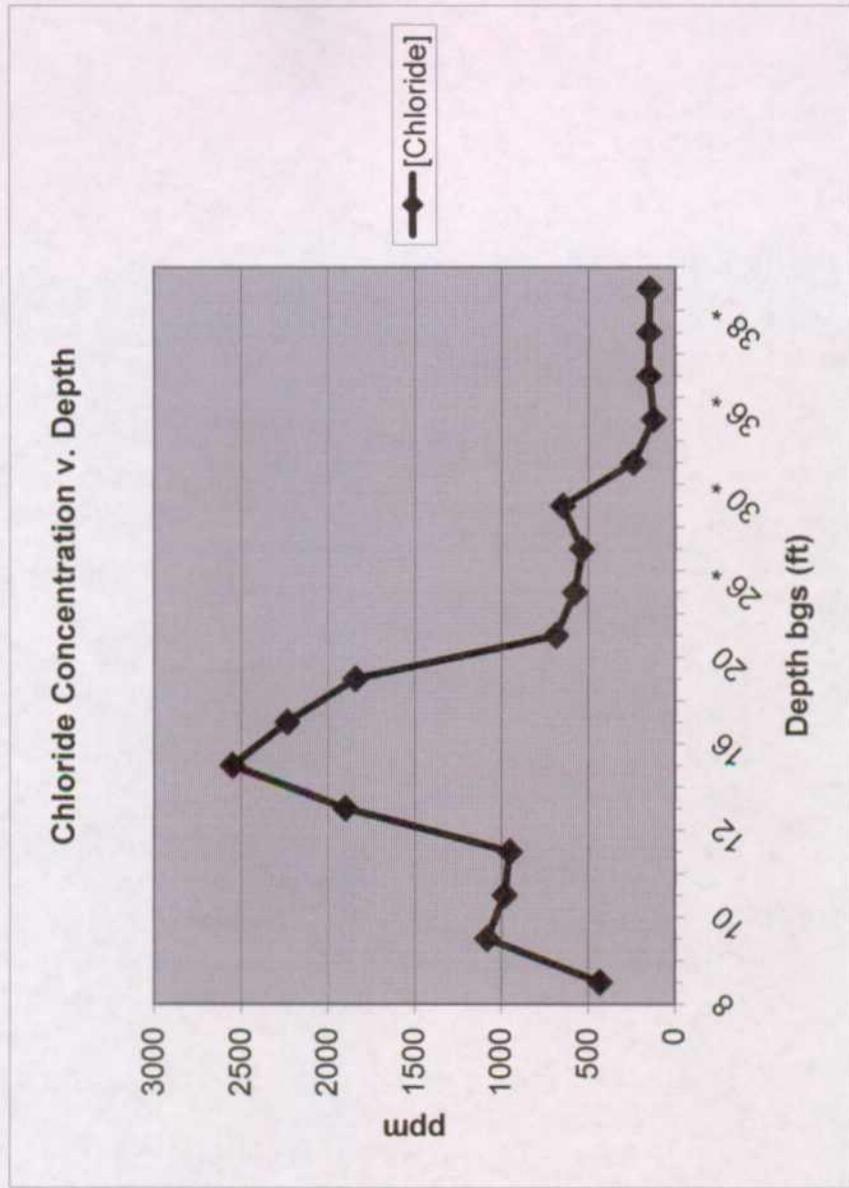
Vertical Delineation at Source

Depth bgs (ft)	[Cl <sup>-</sup> ] ppm
8	434
9	1083
10	982
11	950
12	1899
14	2550
16	2234
18	1841
20	685
25 *	575
26 *	536
27 *	646
30 *	239
35 *	123
36 *	150
37 *	150
38 *	146

\* Soil bore samples

Groundwater = 50 ft

LOCATION	DEPTH (ft)	ppm
4-wall comp.	1-5 ft	308
bottom comp.	6 ft	1015
remed. backfill	n/a	578
Vertical	8	434
at jct.	9	1083
	10	982
	11	950
	12	1899
	14	2550
	16	2234
	18	1841
	20	685
Soil Bore	25	575
	26	536
	27	646
	30	239
	35	123
	36	150
	37	150
	38	146
