**RICE OPERATING COMPANY
JUNCTION BOX DISCLOSURE* REPORT**

SWD SYSTEM	JUNCTION	UNIT	SECTION	TOWNSHIP	RANGE	COUNTY	BOX DIMENSIONS - FEET		
							Length	Width	Depth
Vacuum	E-2	E	2	18S	35E	Lea	7	5	4

Vacuum jct. E-2

unit 'E', sec. 2, T18S, R35E

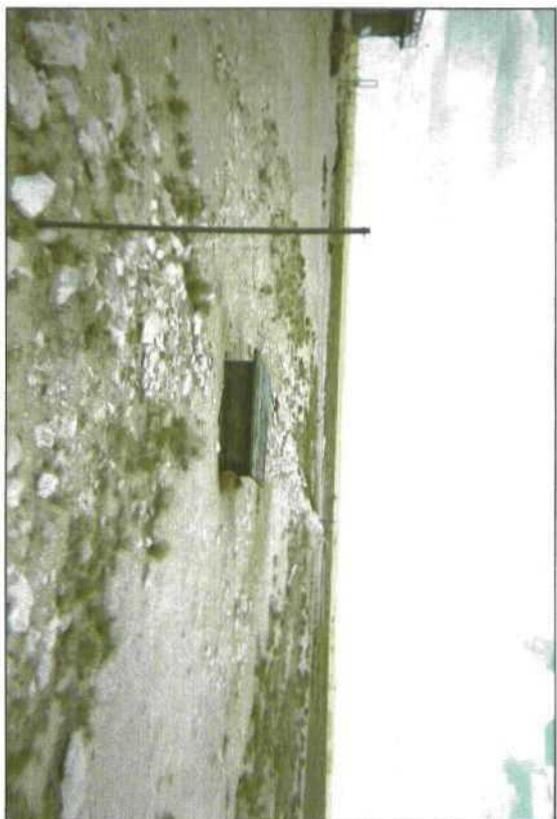
8/4/2003

undisturbed junction box

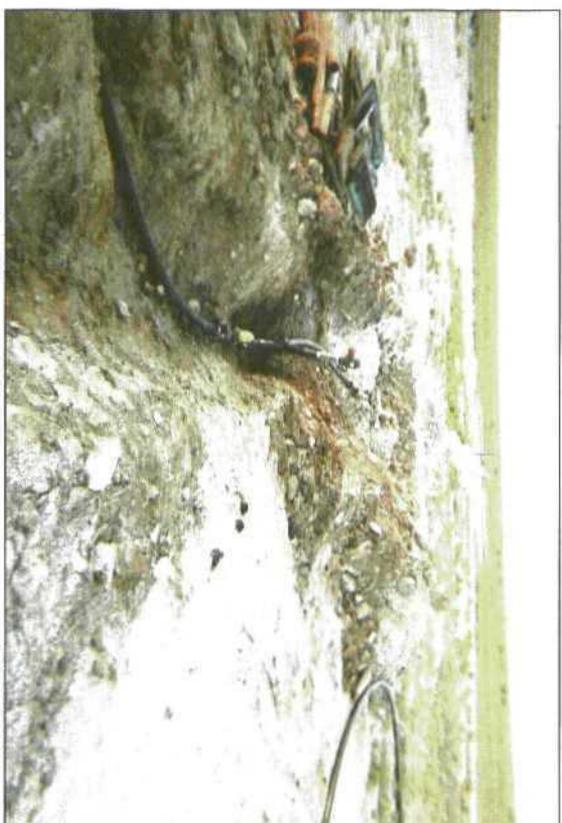
8/12/2003

new poly plumbing; old box removed

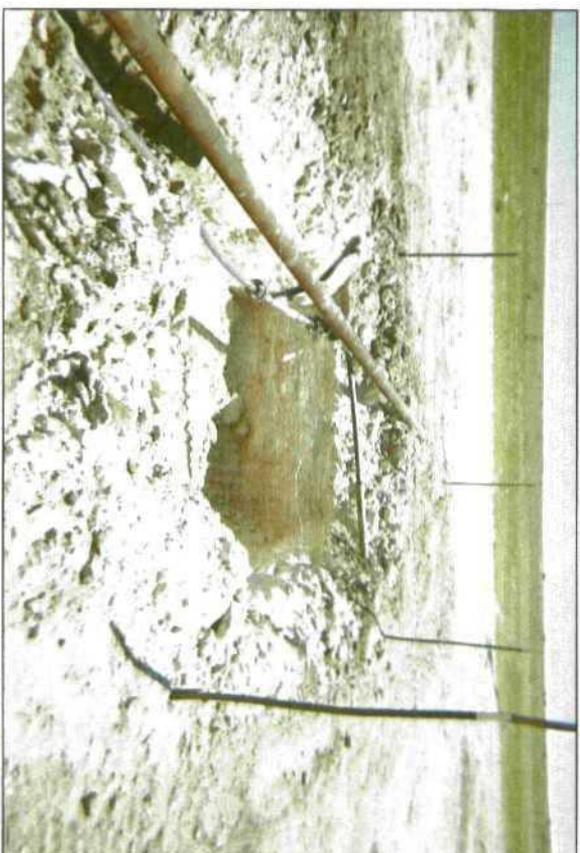
9/2/2004

12 x 15 x 7-ft-deep excavation

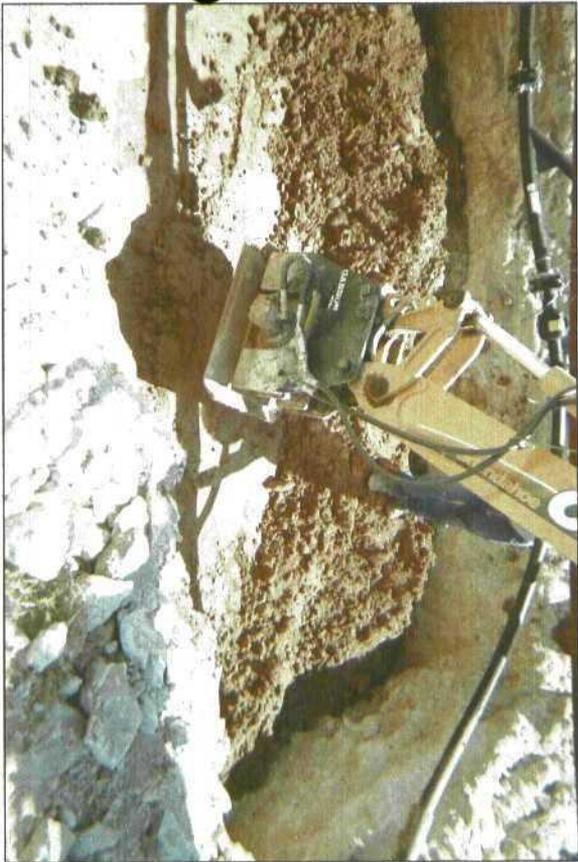
9/14/2004

compacting clay barrier at 6 ft BGS

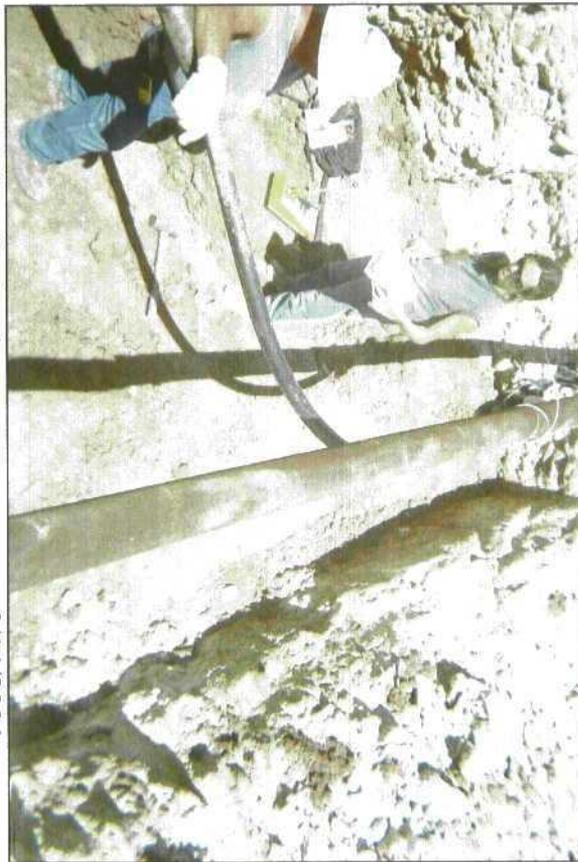
9/14/2004

testing clay barrier

Test No.	Location	Dry Density % Maximum	% Moisture	Depth
SG-1	Center of Pit	97.2	19.3

Control Density: 106.2
ASTM: D 698

Optimum Moisture: 17.3

Required Compaction: 95%

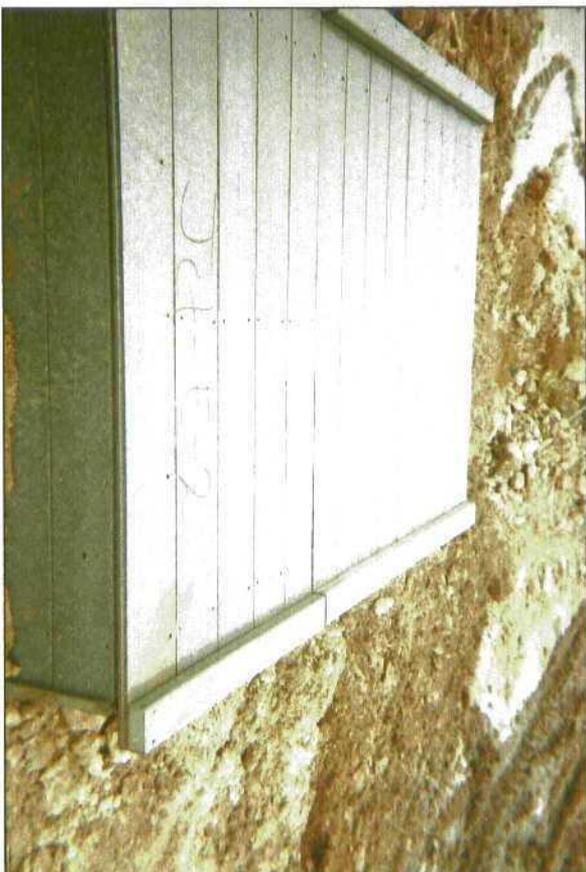
9/30/2004

completed junction box

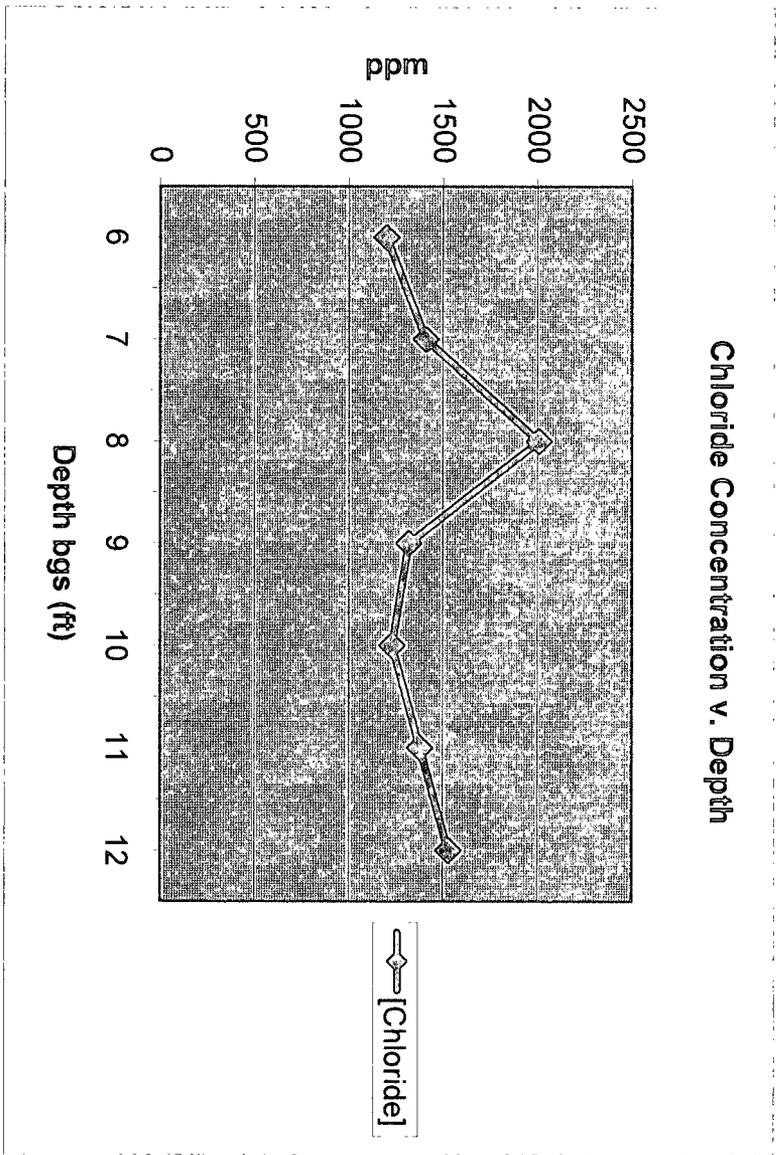
CHLORIDE CONCENTRATION CURVE

Vertical Delineation at Source

Depth bgs (ft)	[Cl] ppm
6	1200
7	1409
8	2009
9	1319
10	1230
11	1379
12	1529

Groundwater = 52 ft

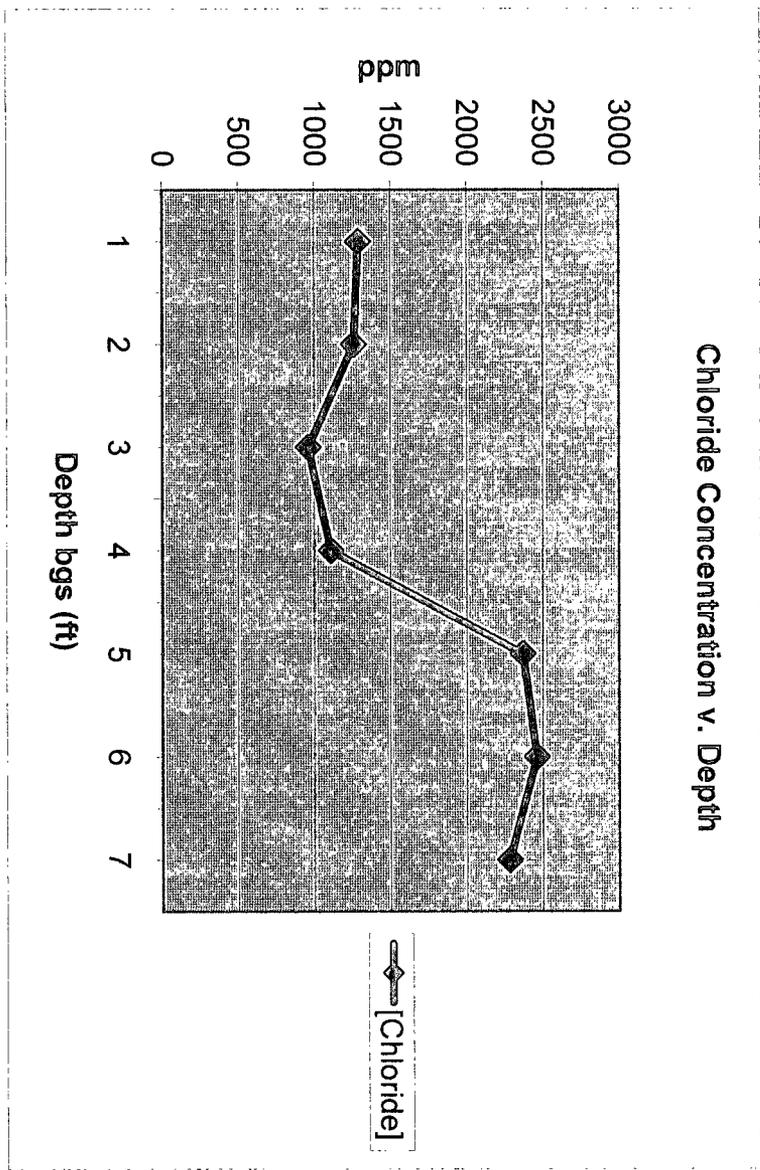
CHLORIDE CONCENTRATION CURVE

5 ft EAST of junction

Depth bgs (ft)	[Cl] ppm
1	1290
2	1259
3	960
4	1110
5	2369
6	2459
7	2280

Groundwater = 52 ft

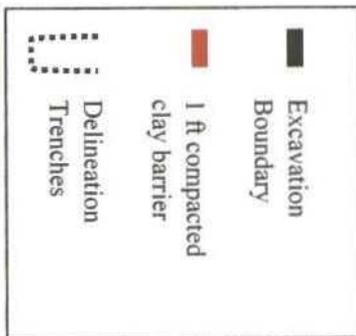
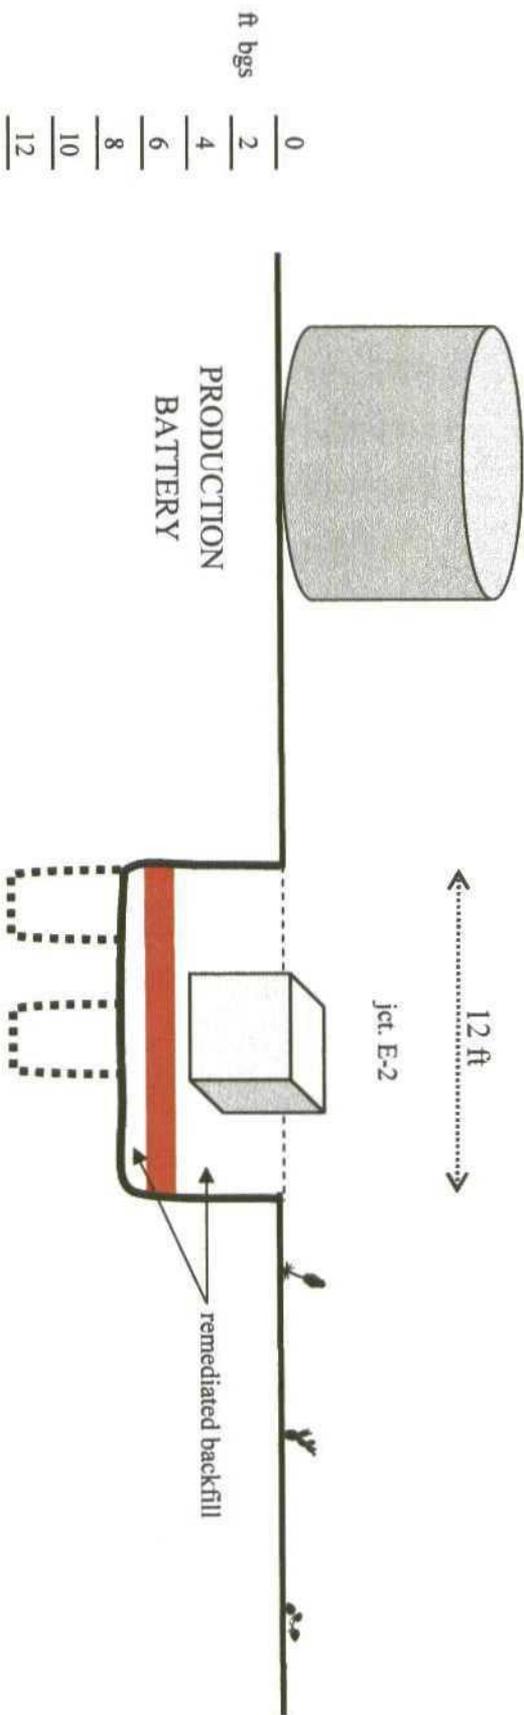
unit 'E', section 2, T18S, R35E
Excavation Cross-Section

15 x 12 x 7 ft deep
