**RICE OPERATING COMPANY  
JUNCTION BOX FINAL REPORT**

| SWD SYSTEM | JUNCTION | UNIT | SECTION | TOWNSHIP | RANGE | COUNTY | BOX DIMENSIONS - FEET | | |
|---|---|---|---|---|---|---|---|---|---|
| EME | P-13 | P | 13 | 21S | 35E | LEA | Length<br>10 | Width<br>8 | Depth<br>4 |

## EME P-13 Jet. Box Upgrade

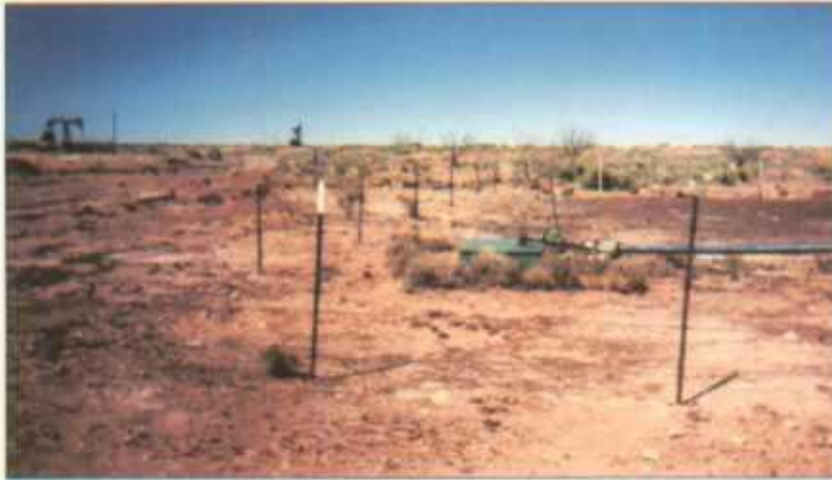
Old Junction Box

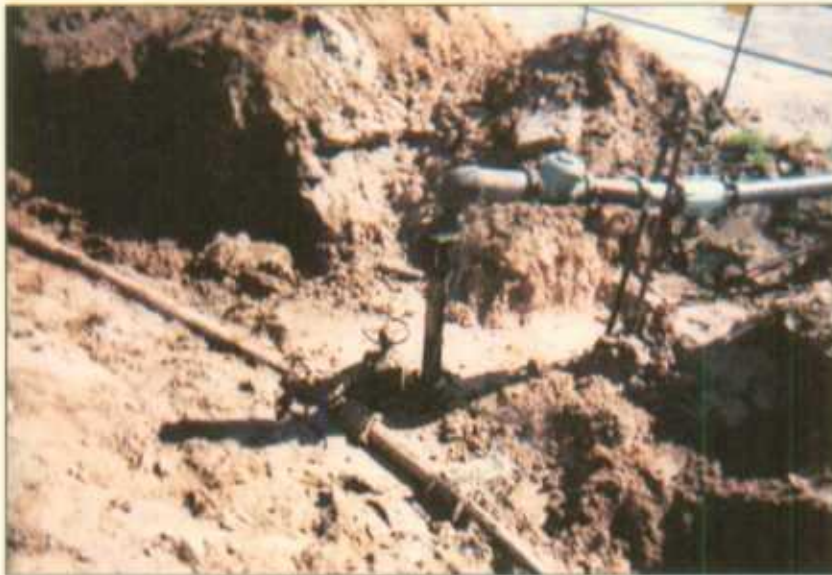
NORM Removal

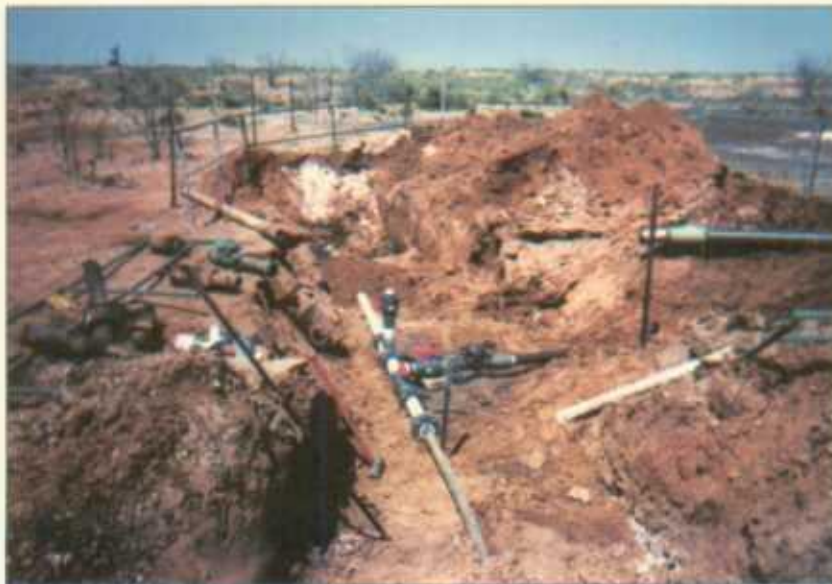
New Plumbing

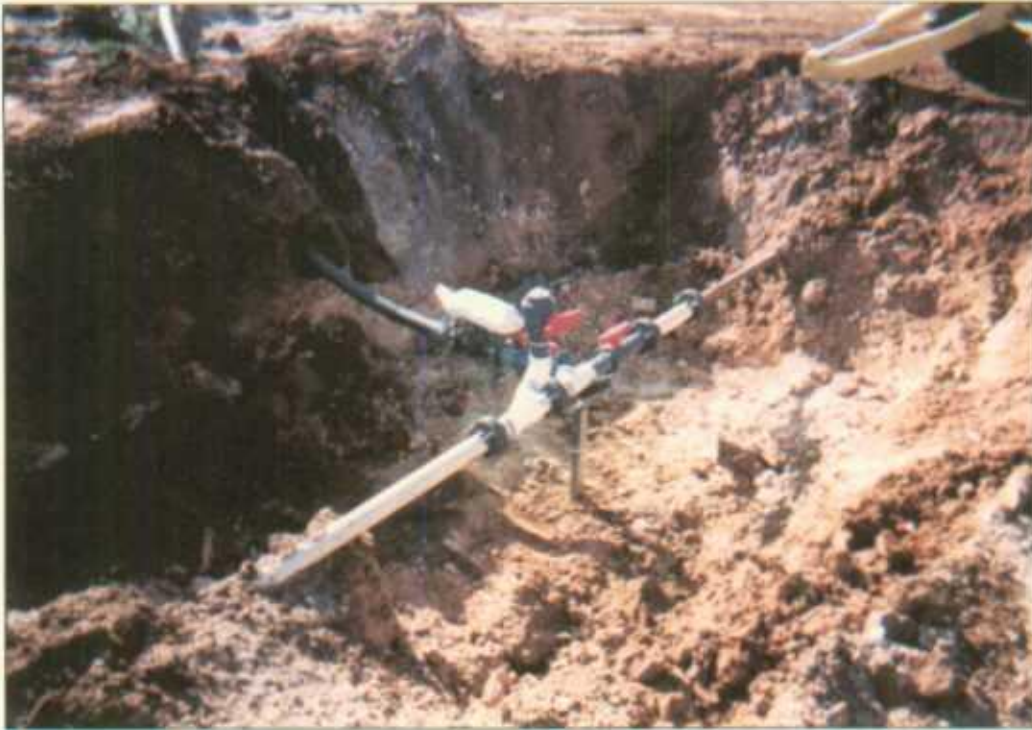
Remediation

**General Description of Remedial Action:** Delineated vertical and lateral extent.

Found all readings under NMOCD TPH guidelines. Installed compacted clay barrier and water proof junction box. Blended soil and backfilled. Natural attenuation will remediate the remaining hydrocarbon.

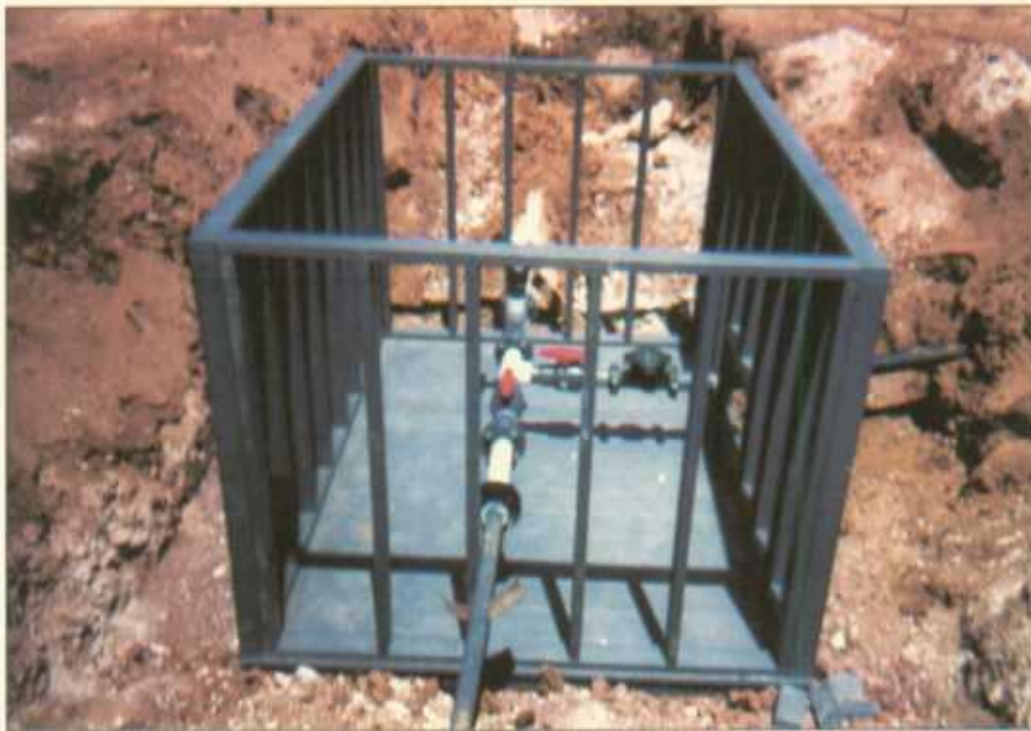
New Junction Box Construction
