Phase III ESA
Site Monitoring Report

Mattie Price Tank Battery

Lea County, New Mexico

Kane Environmental Engineering, Inc.
5307 Oakdale Creek Court
Spring, Texas 77379
Project No. 04-631

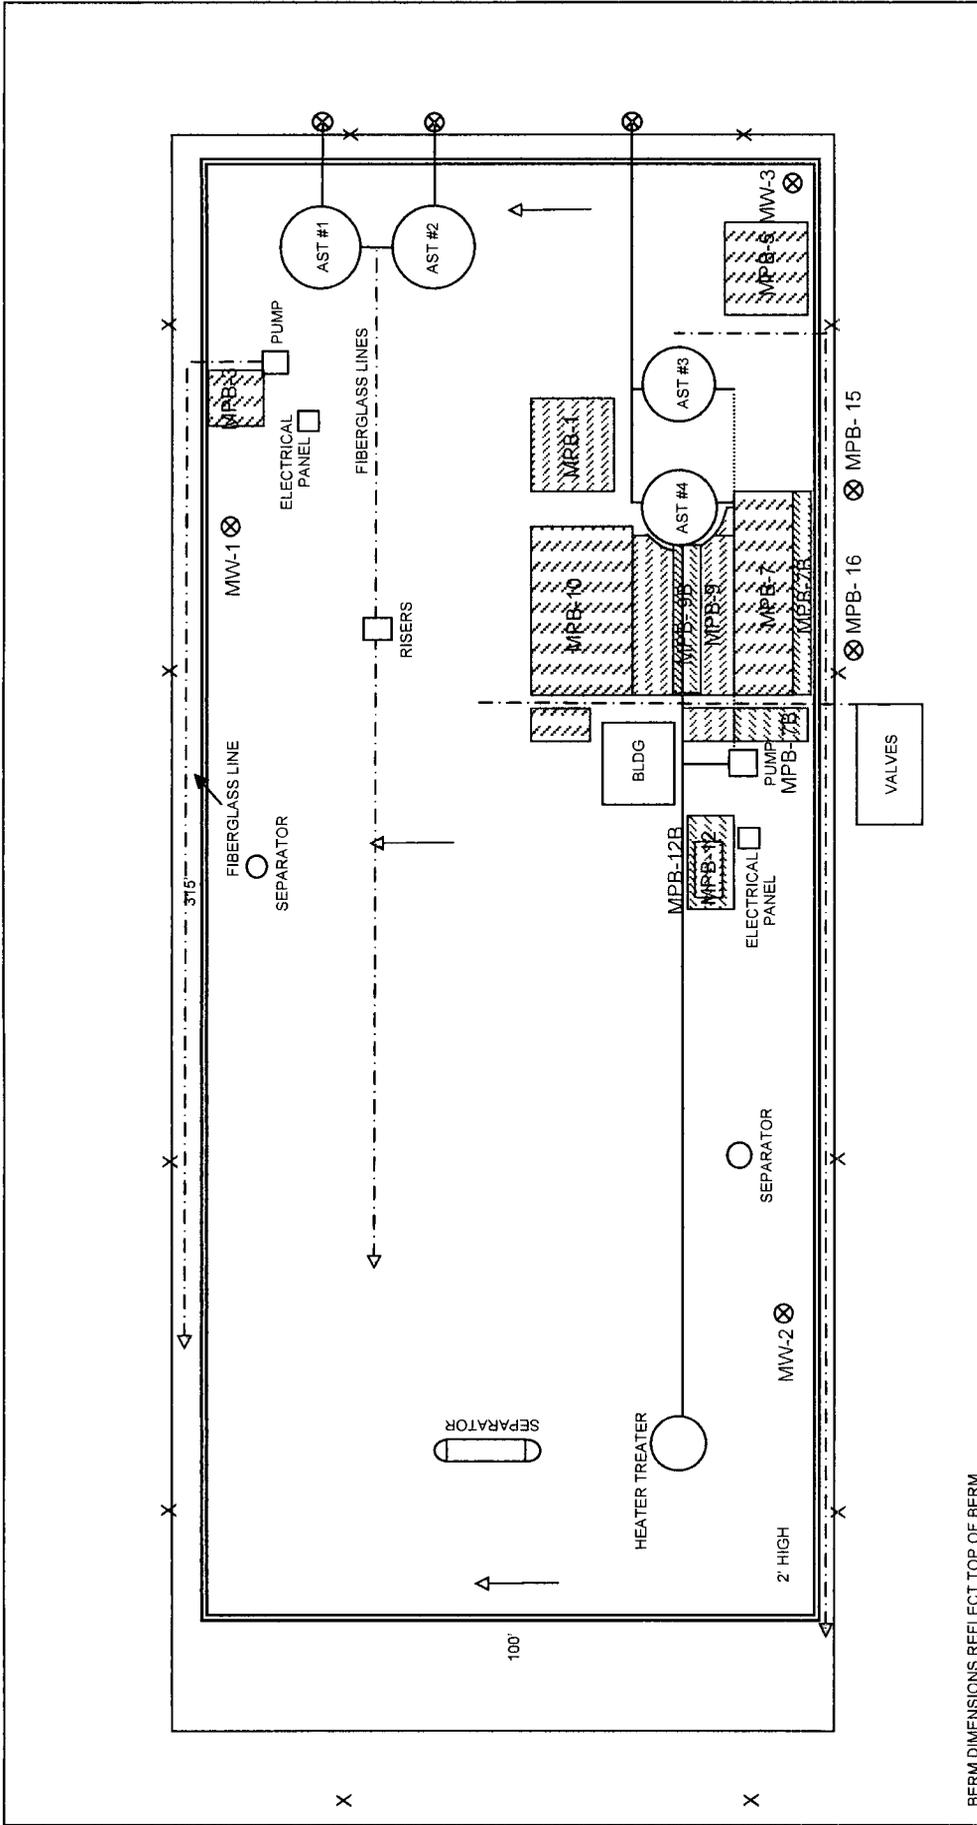
Figure 3	
Soil Excavation Plot	
Lea County, New Mexico	
DRAWN BY: SMH	PROJECT: 04-631
DATE: 2/28/2006	APPROVED BY: DCP
REVISED: 11/30/06	NOT TO SCALE

TANK LEGEND	
—	SURFACE DRAINAGE
X	FENCE
▭	EARTHEN BERM
▨	INITIAL EXCAVATION AREA
▩	'B' EXCAVATION AREA
—	SURFACE PIPING
- - -	SUBSURFACE PIPING
.....	PIPING REMOVED FOR EXCAVATION

Three monitoring wells were installed (shown on **Figures 3 and 4**). Well northing and easting, ground surface elevations, static water levels and groundwater elevations are shown in **Table 2**. Groundwater flow has been determined to be to the east-southeast.

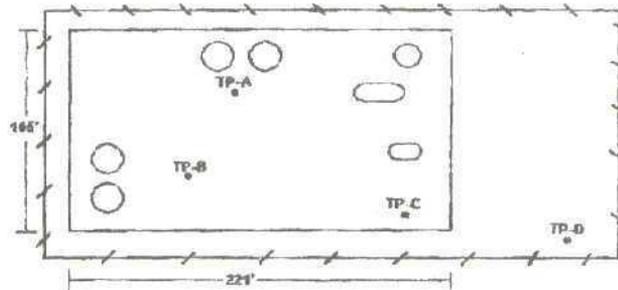
Hydrocarbon & Chloride Test Results

Test Point	Results
A	16,860ppm @ 6' 25,900ppm @ 7 ½' 2,160ppm @ 10' 516ppm @ 14'
B	3,130ppm @ 6'
C	460ppm @ 6'
D	18ppm @ 4'
Chlorides	<250ppm

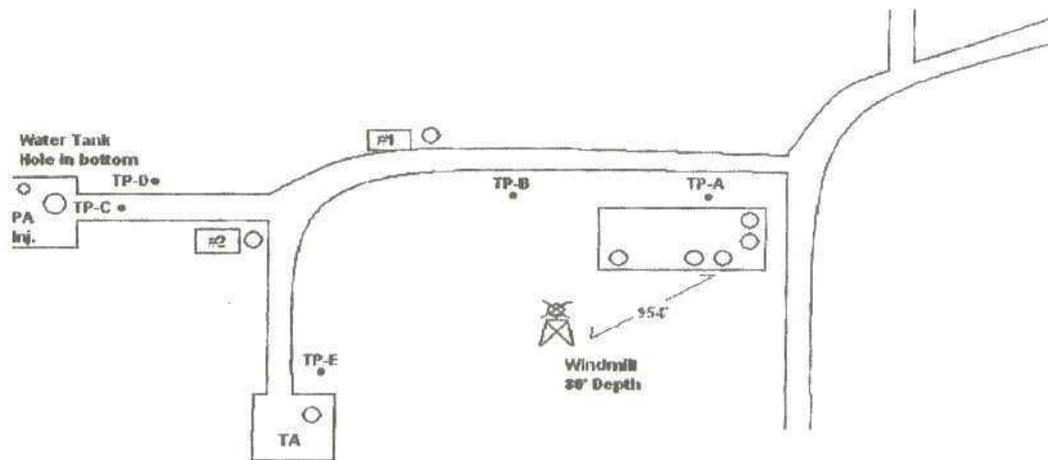
Chloride Test Results

Test Point	Results
A.	100ppm @ Surface
B.	100ppm @ Surface
C.	100ppm @ Surface
D.	300ppm @ Surface
E.	150ppm @ Surface

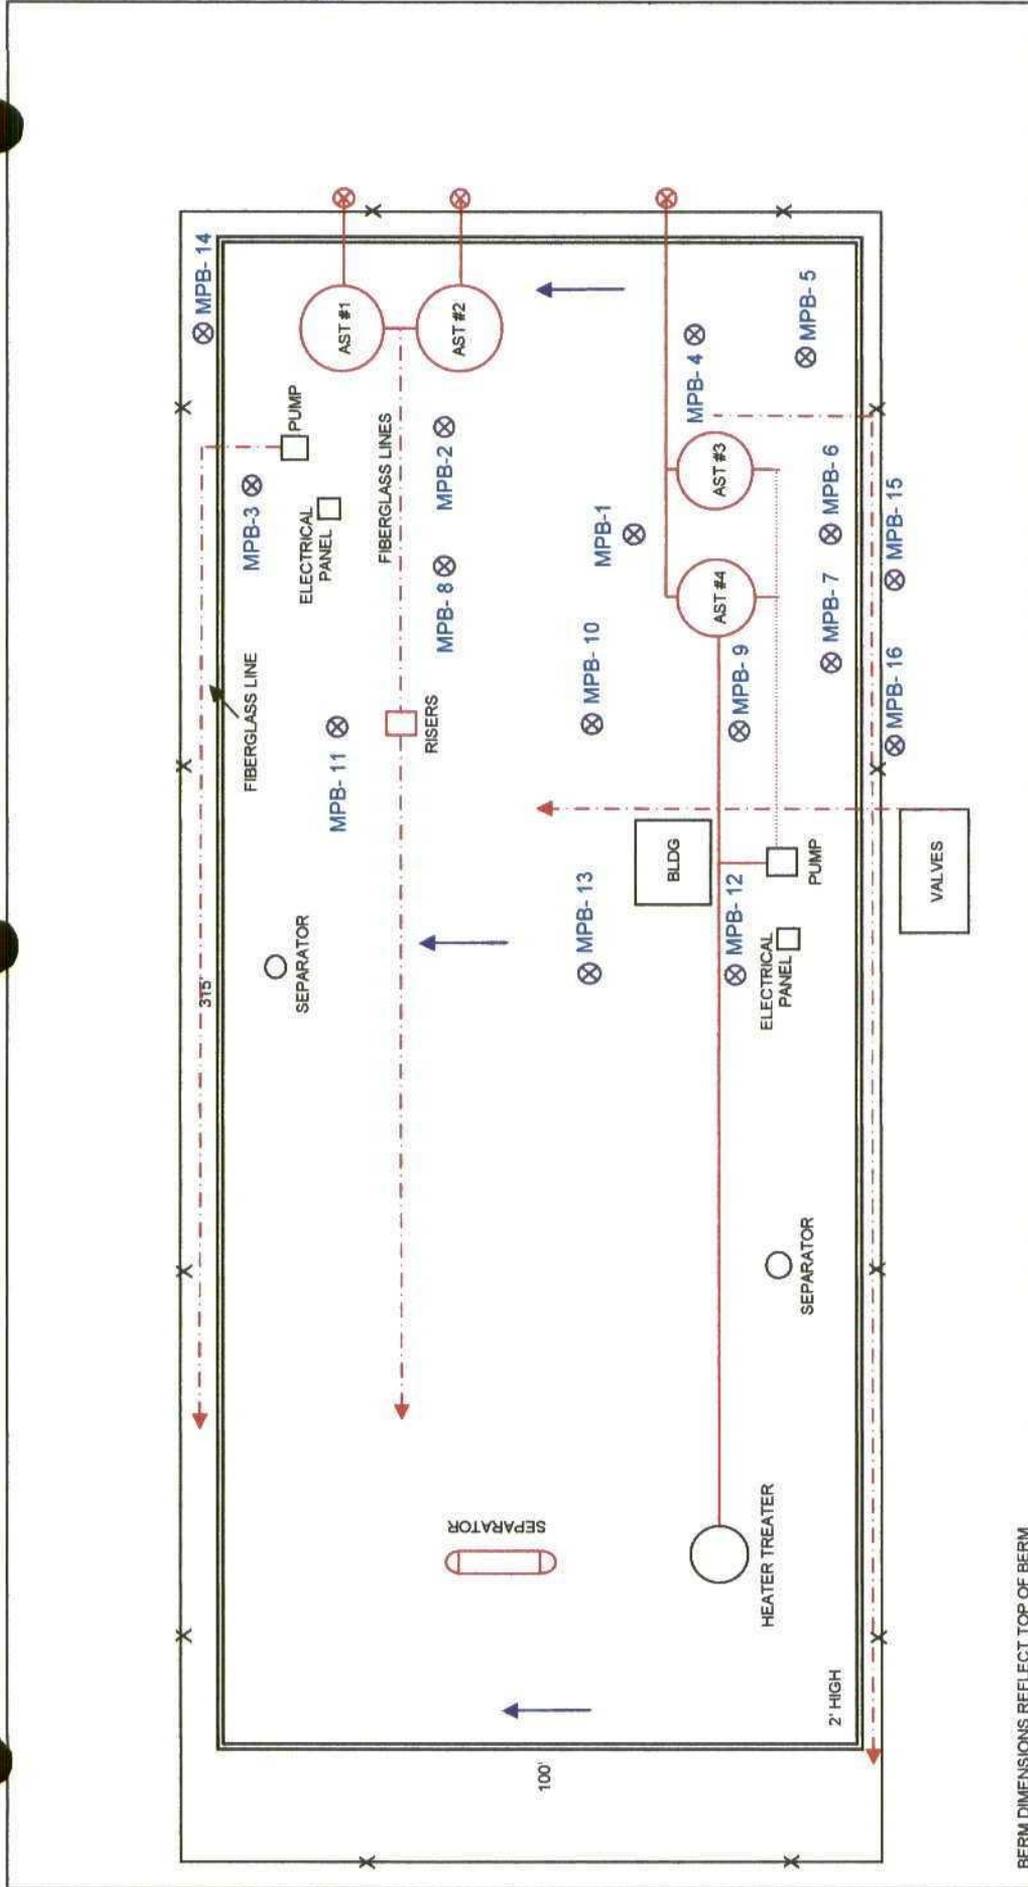
Figure 3
Mattie Price Battery Soil Boring Plot
 Lea County, New Mexico
 N 32° 52' 33" W 103° 10' 46.86"

Soil logs (**Table 1**) and field headspace readings (**Table 2**) were collected during boring, with headspace reading collected on each 2.5' sample interval using a photo-ionization detector (PID). Sample collection and headspace readings were conducted according to the procedures outlined in NMOCD's Guidelines for Remediation of Leaks, Spills and Releases. All maximum benzene and total BTEX (benzene, toluene, ethyl benzene and xylene) concentrations measured were below the NMOCD regulatory thresholds of 10 mg/kg for benzene and 50 mg/kg for BTEX. TPH concentrations exceeded the site specific 1000 mg/kg threshold in borings MPB-1, MPB-5, MPB-7, MPB-9, MPB-10 and MPB-12.

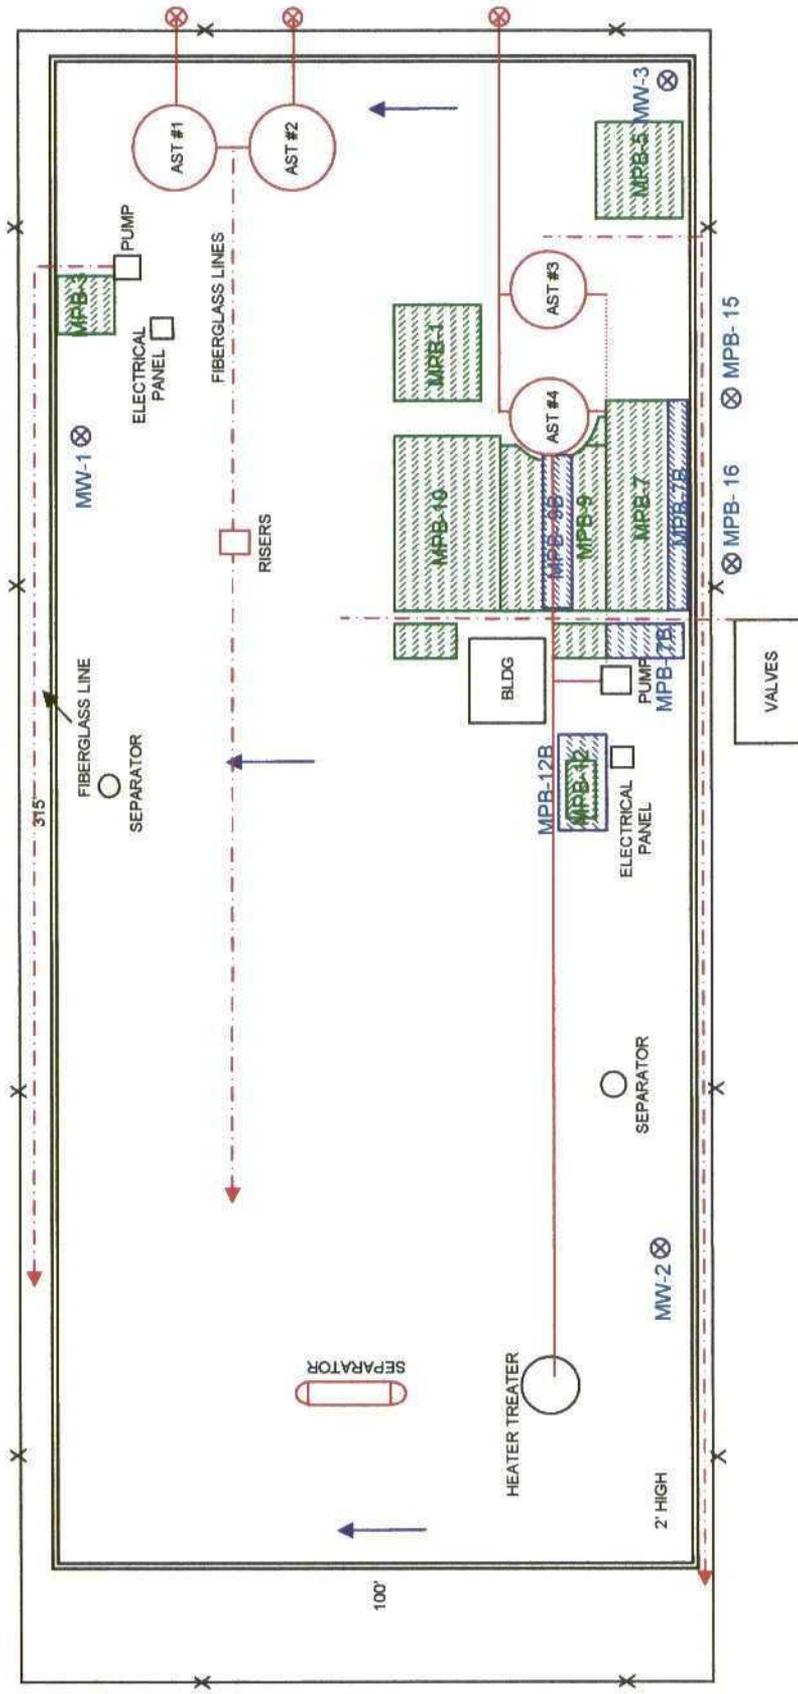
Figure 4
Mattie Price Battery Soil Excavation Plot

Excavation was initiated in the area represented by boring MPB-5 where site investigations indicated TPH levels of 2740 mg/kg in the 7.5-10' sample interval. An area 12' x 12' centered on MPB-5 was excavated to a depth of 9' where bedrock was encountered. Based on field headspace readings, the surface-5' soils were stockpiled for use as backfill soil. The 5-9' soils were stockpiled separately for disposal. An excavation floor sample (MPB-5 Floor 9') was collected using the backhoe to scrape the excavation floor and retrieve the loosened materials for subsequent sample collection. Each sidewall of the excavation was sampled using the backhoe to scrape the sidewall, catching the loosened materials in the backhoe bucket for subsequent sampling. MPB-5 Excavation Floor and sidewall samples indicated excavation of hydrocarbon contaminated soils in excess of the site specific TPH threshold was complete, with a maximum TPH concentration of 142 mg/kg remaining in the East Sidewall sample (MP5-ESW).
