1R - 448

# REPORTS

**Re: Final Pipeline Spill Remediation Report, Dynegy Midstream Services, L.P., Unit Letter C (NE/4, NW/4), Section 14, Township 22 South, Range 37 East, Lea County, New Mexico**

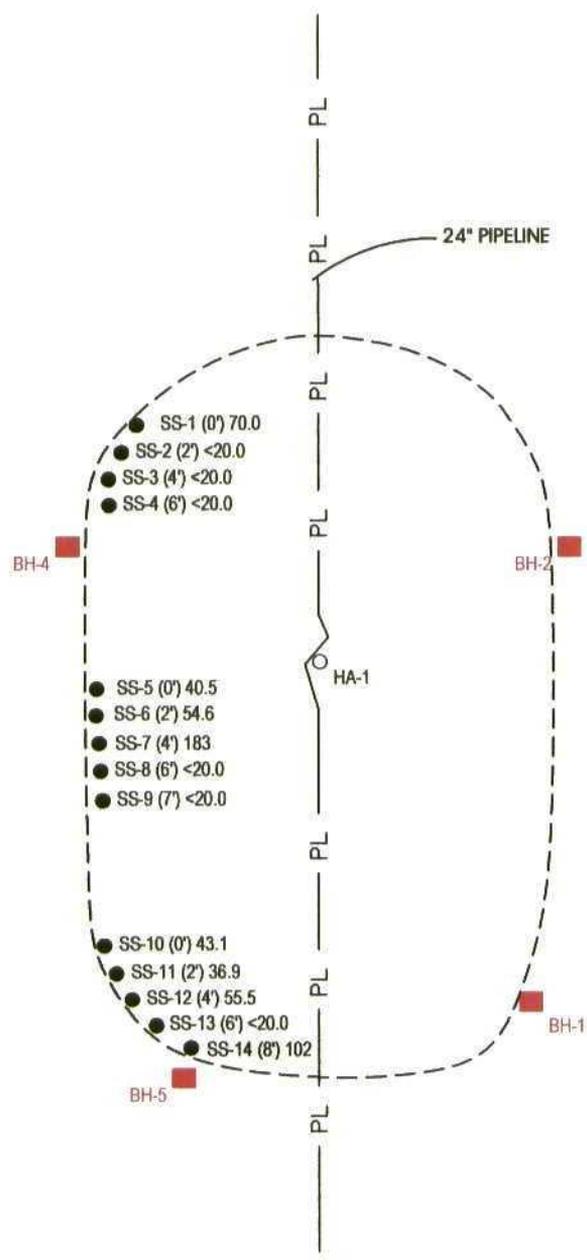
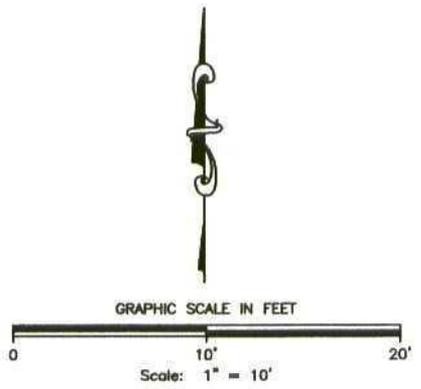
**FIGURE # 2**

- - - - - EXCAVATION BOUNDARY (2002)
- BH-1 - SOIL BORING LOCATION (8/14/02)
- HA-1 - HAND AUGER BORING LOCATION, (9/4/02)
- SS-10 (0') 43.1 - SOIL SAMPLE LOCATION, (1/29/03) WITH DEPTH (0') IN FEET AND TPH CONCENTRATION (MG/KG)

SITE DETAILS  
SITE # 20

BH-5. Figure 2 shows the locations of the soil borings. Appendix A presents the boring logs. Appendix B presents the laboratory analyses. Appendix C presents photographs.

On January 29, 2003, samples were collected from the west wall of the excavation at the surface, and depths of approximately 2, 4, 6, 7 and 8 feet bgs. Soil samples were placed in clean glass sample jars, labeled, chilled in an ice chest, and delivered under chain-of-custody control to ELOT. The samples were analyzed for TPH by EPA method SW-846-8015, including GRO and DRO, and for chloride by EPA method SW-846-9253. Table 2 presents a summary of the laboratory analyses of soil samples collected from the west side of the excavation. Figure 2 shows the sample locations. Appendix B presents the laboratory analyses.

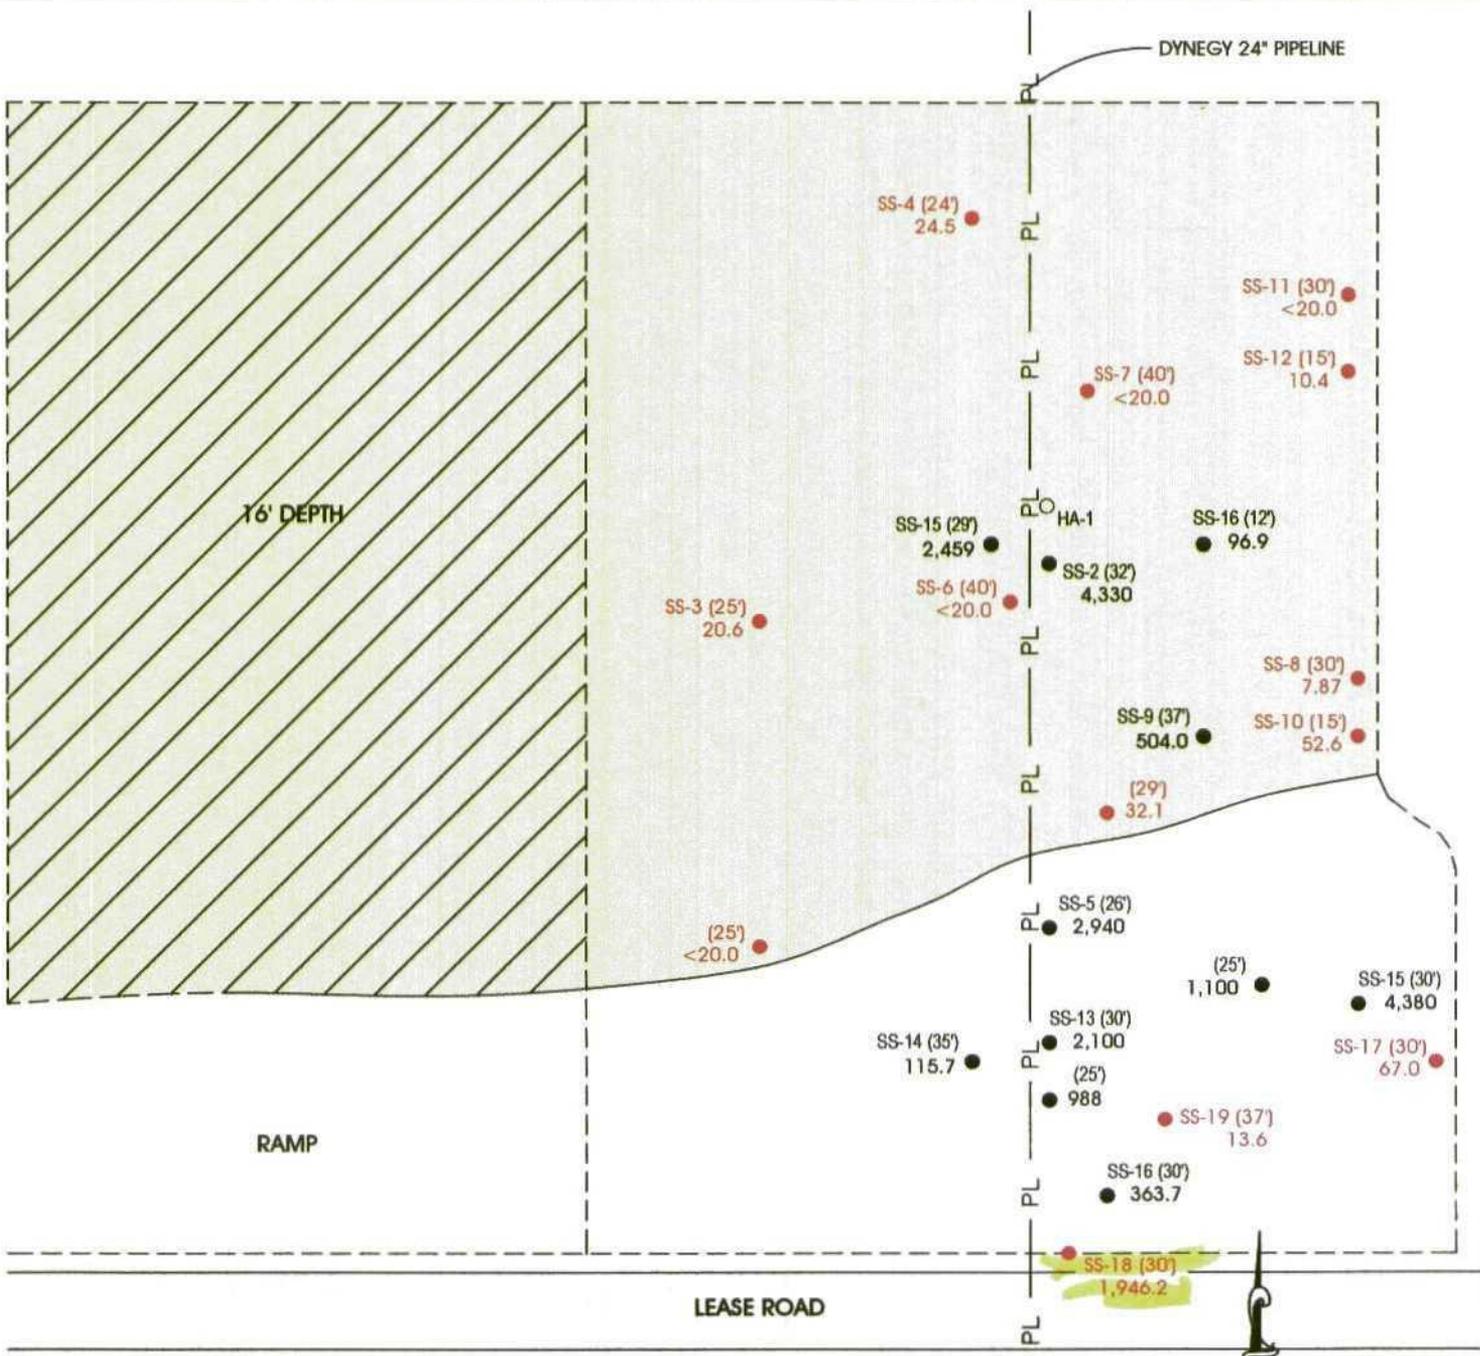
FIGURE #3

- - EXCAVATION BOUNDARY
- HA-1 - HAND AUGER LOCATION, (FOR REFERENCE)
- SS-15 (29) 2,459 - SOIL SAMPLE LOCATION, WITH DEPTH (FEET) AND TOTAL TPH CONCENTRATION (MG/KG)
- - BACKFILLED AREA (EXCAVATED TO 40' DEPTH)
- ▨ - EXCAVATED TO 16' DEPTH

EXCAVATION DETAILS

Soil from the excavation was placed adjacent to the hole, and periodically ~~blended~~ to reduce the TPH concentration below the RRAL. Soil with TPH concentrations in excess of the RRAL was hauled to an NMOCD approved landfarm. Soil that reported final TPH concentrations below the RRAL (Spoil-8, 17.7 mg/kg) was used to backfill the north portion of the hole in order to provide equipment access to continue excavating to the south. Figure 3 presents the backfilled area.

Excavation continued to the south until the lease road was encountered. Confirmation samples were collected on September 21, 2004. All samples reported concentrations of TPH below the RRAL, with the exception of sample SS-187(1) 946-2 mg/kg, collected from the south wall at a depth of approximately 30 feet bgs.

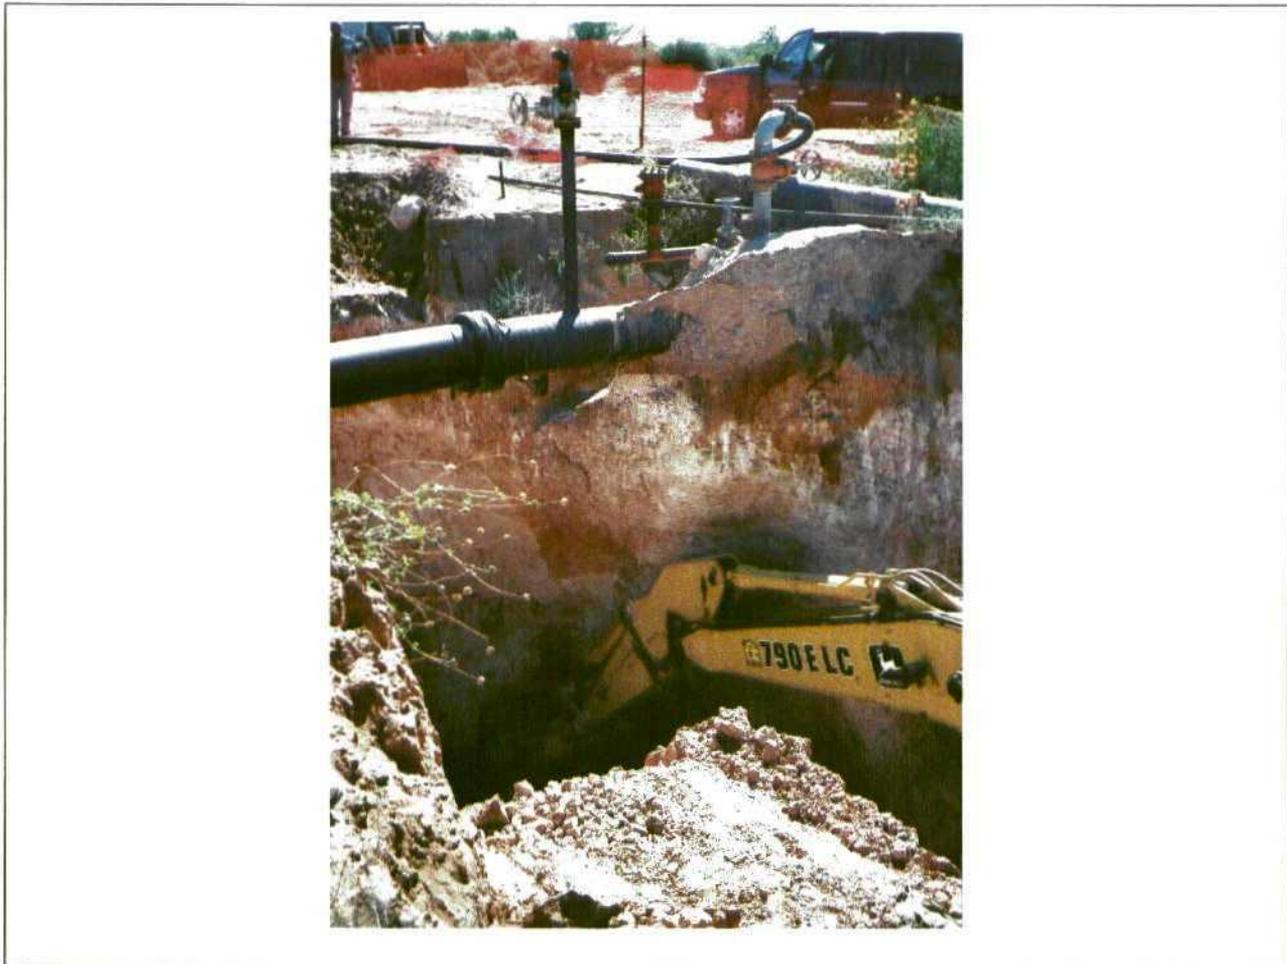
**1. View to southeast. Note lease road immediately to south. (5/10/04)**

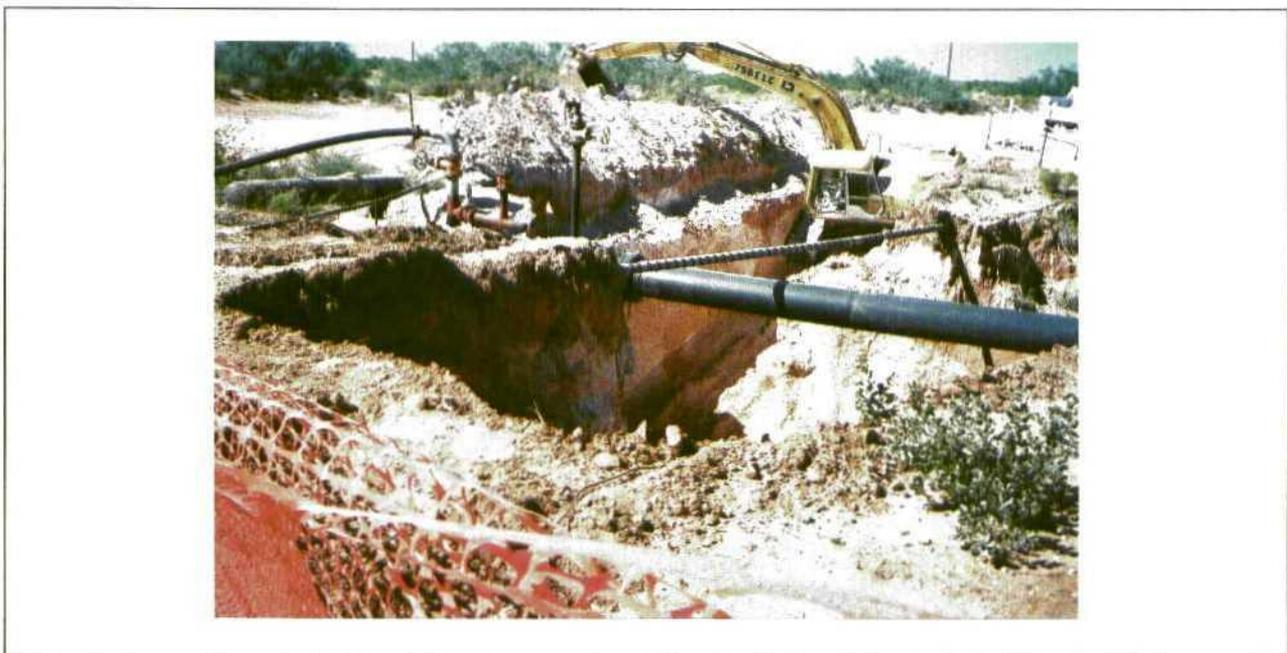
**2. View to southwest. Note road immediately to south. (9/10/04)**
