**STAGE 1 & 2
REPORTS**

**Closure of Service Pit and Flow
Through Process Tank
Brickland Refinery
Sunland Park, New Mexico**

**Prepared for
Rexene Corporation
Odessa, Texas 79760**

March 6, 1997

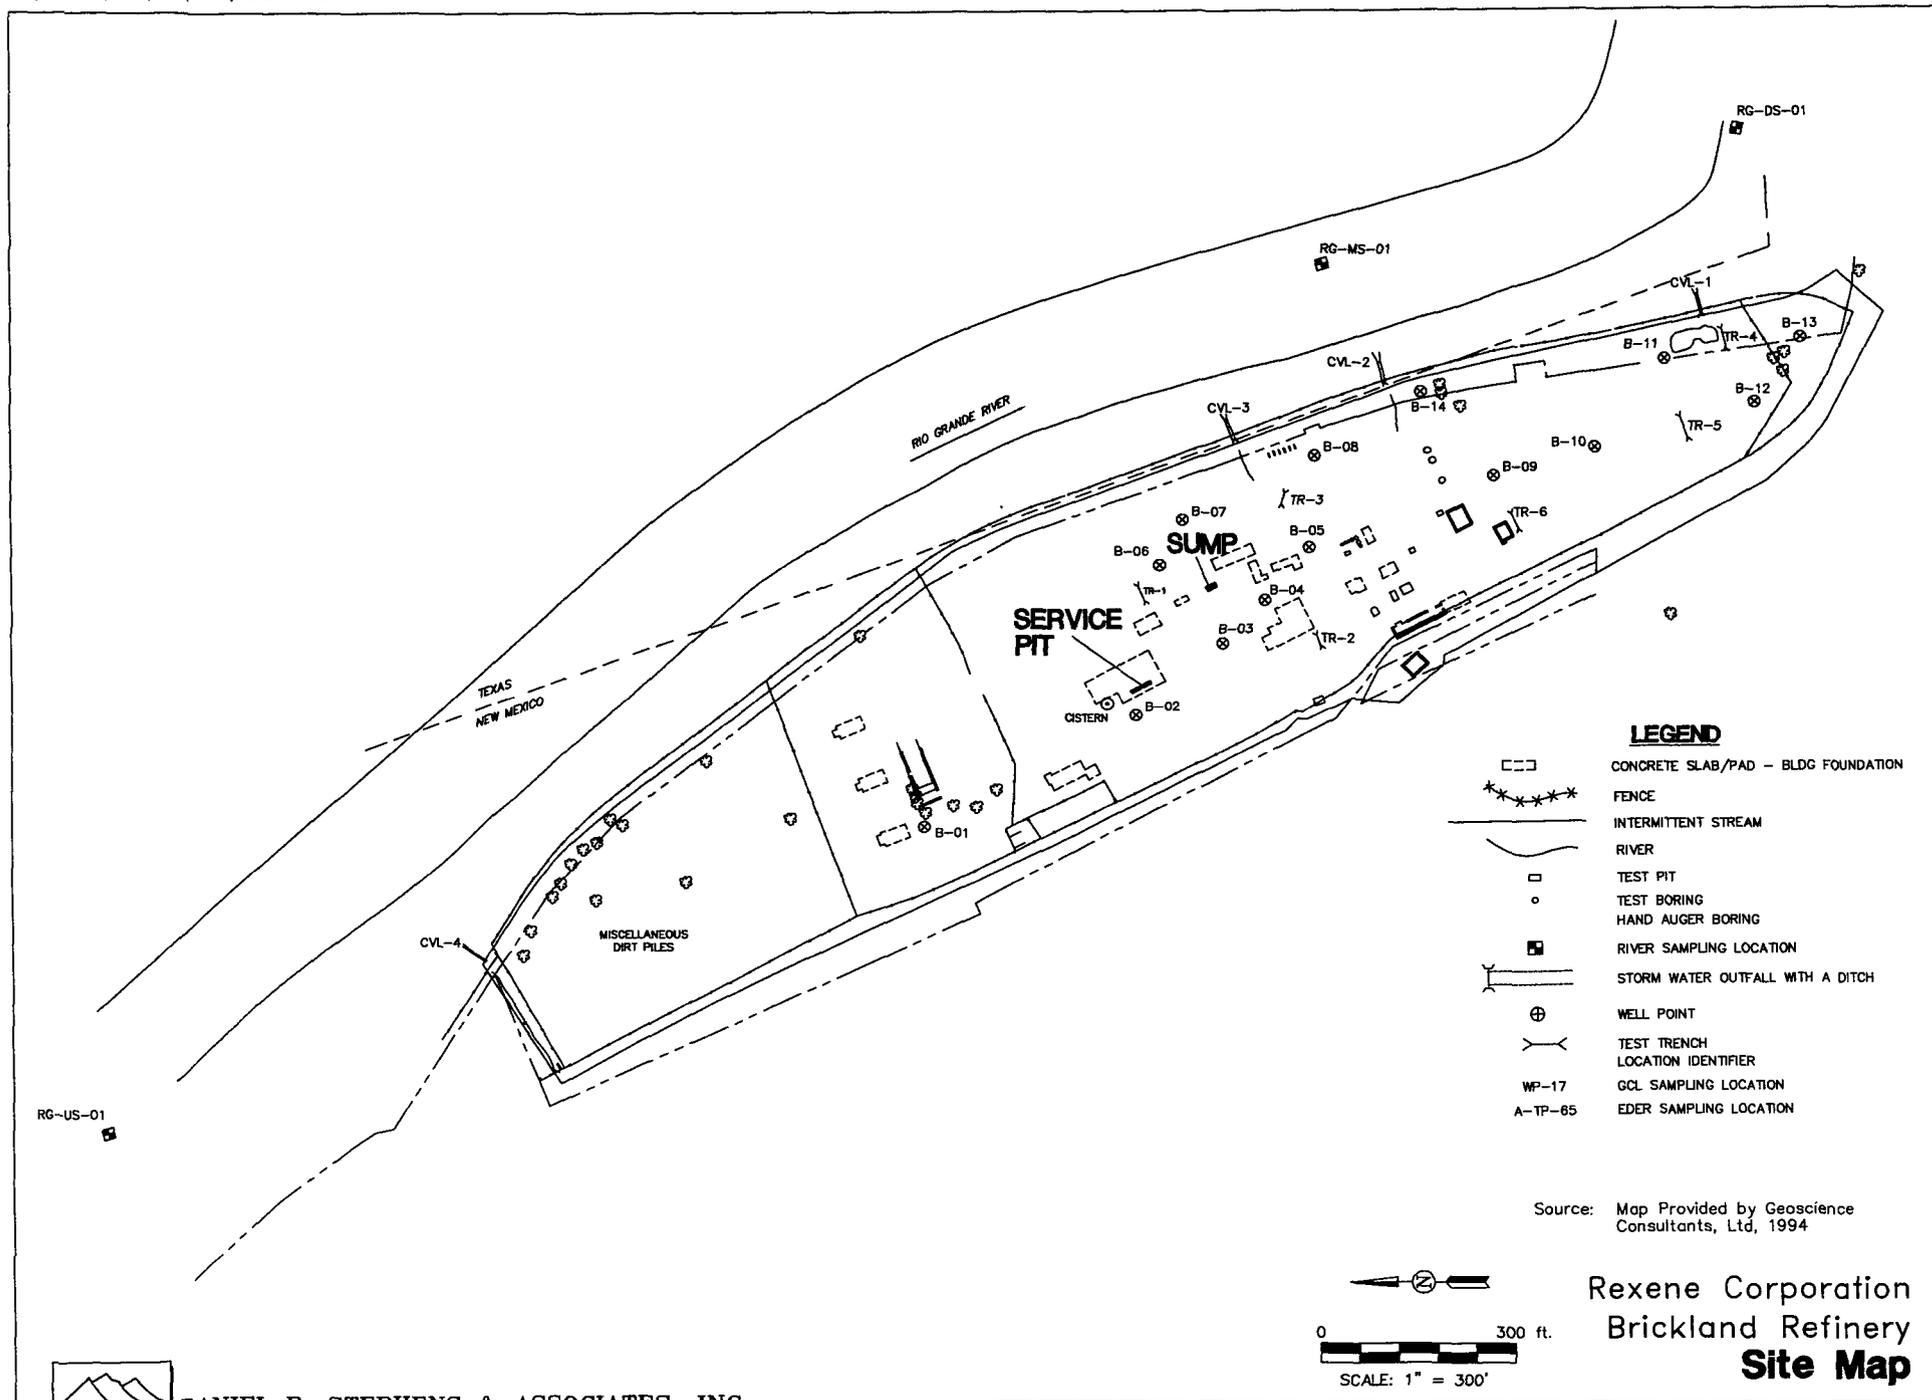
Figure 1

**Rexene Corporation
Brickland Refinery
Site Map**

A service pit for servicing trucks was located in the central portion of the property (Figure 1). The service pit is constructed of concrete and has approximate dimensions of three-feet by 30-feet by six-feet. The pit was clean and free of debris and wastes. In accordance with the approved work plan, the service pit was abandoned in place by backfilling with clean fill material on December 18, 1996. The fill was compacted by wheel rolling to finished grade (Appendix A, Pictures 1 and 2).

A flow-through process tank was located in the central portion of the Brickland facility (Figure 1). The tank is estimated to have had a capacity of approximately 1,000 gallons. This tank was originally used as a flow-through process tank during refinery operations. However, during the course of operational changes at the site, the tank was used to accumulate waste oil, oil filters, and debris. Based on the exposed portion of the sump, it was assumed that the tank was constructed of metal.

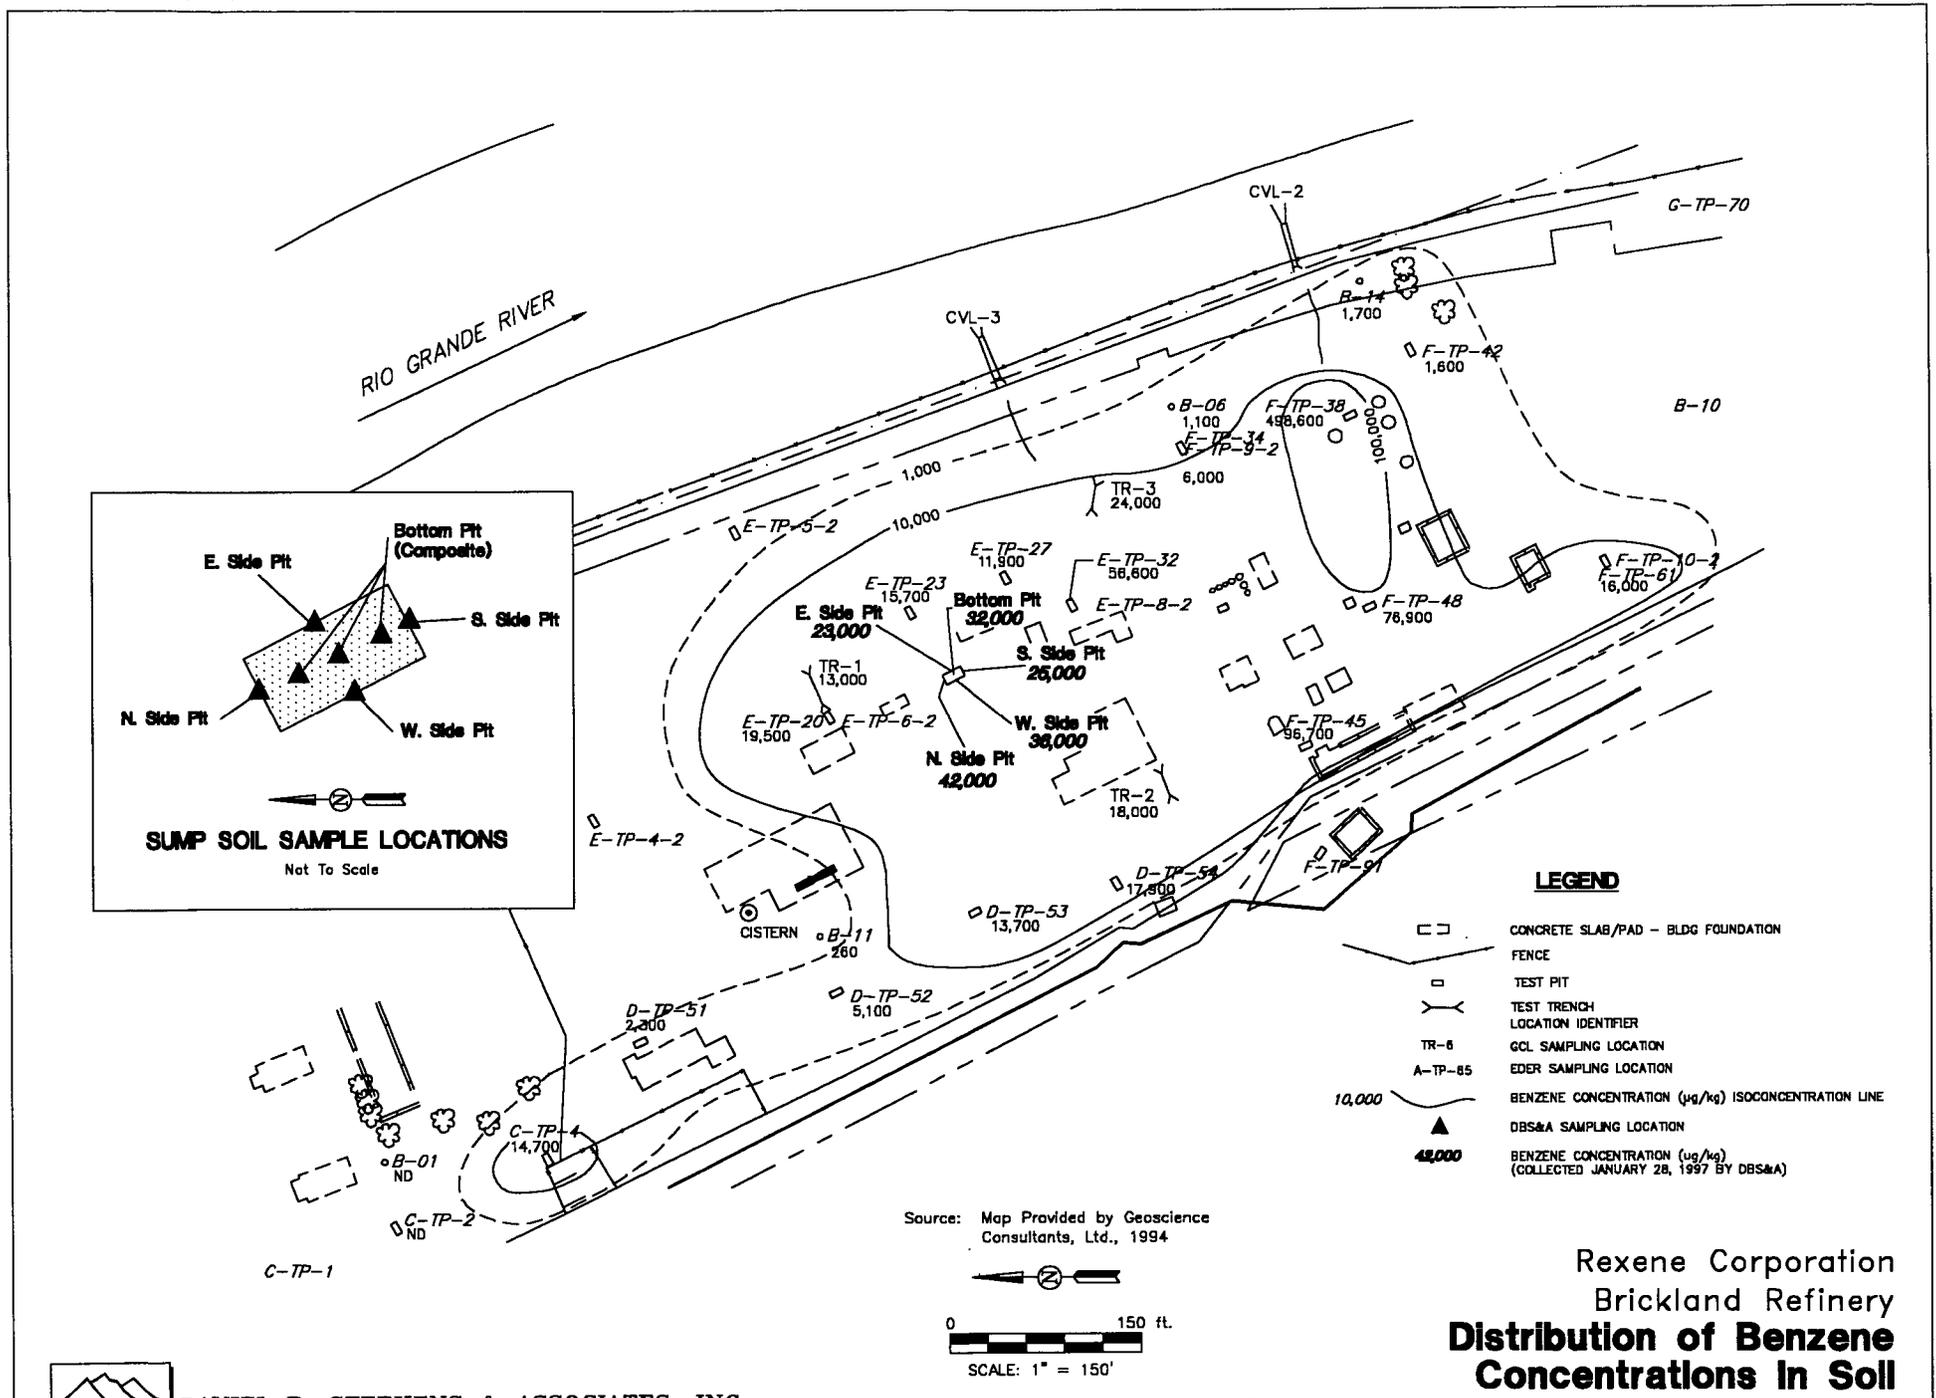
Figure 3

Rexene Corporation
 Brickland Refinery
**Distribution of Benzene
 Concentrations in Soil**

Analytical results from soil samples collected from the tankhold indicated total recoverable petroleum hydrocarbon (TRPH) concentrations ranging from 8,800 mg/Kg to 15,000 mg/Kg. Benzene concentrations ranged from 23 mg/Kg to 42 mg/Kg, ethylbenzene concentrations ranged from 1.5 mg/Kg to 11.0 mg/Kg, and total xylenes concentrations ranged from 4.3 mg/kg to 18.0 mg/kg. No other aromatic or halogenated organic compounds were present above detection limits.

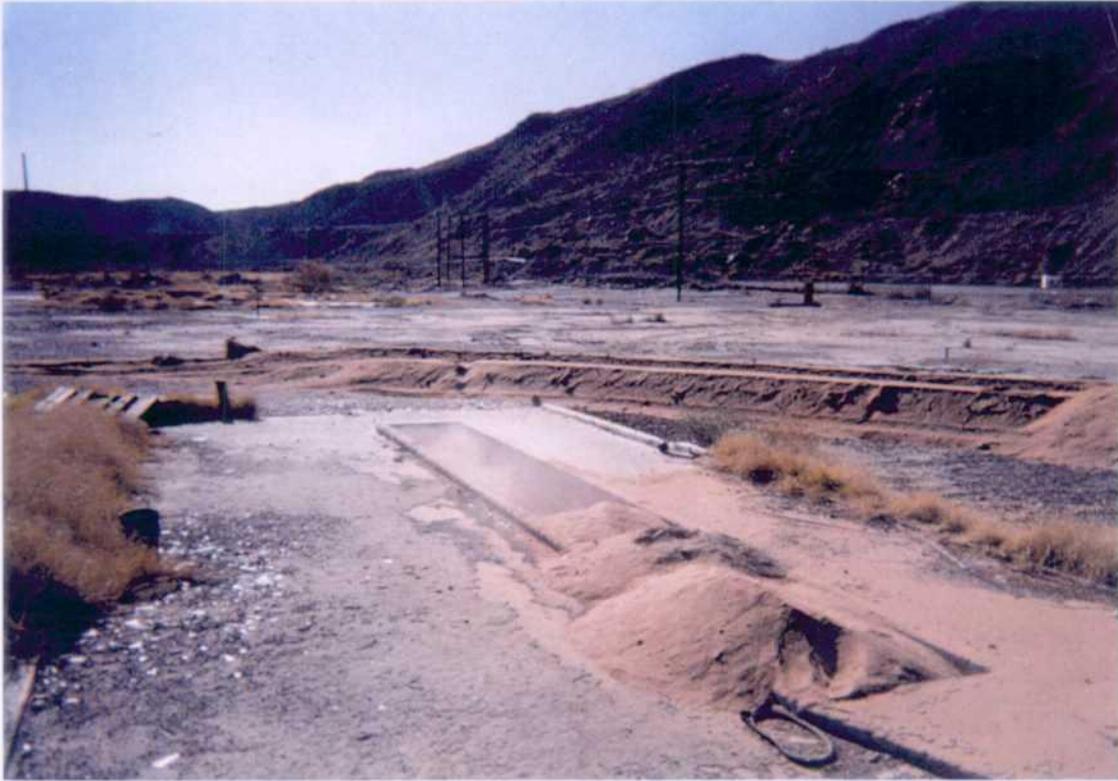
1: View looking south; backfilling service pit.

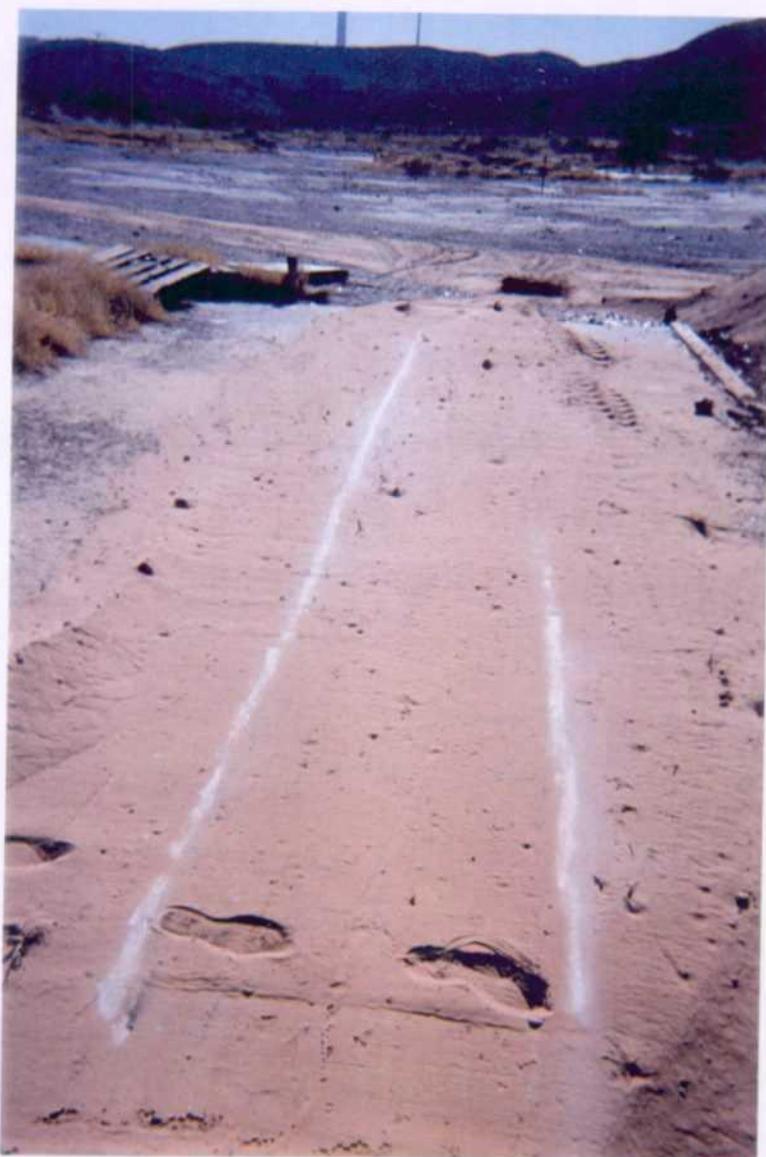
2: Service pit backfilled to finished grade

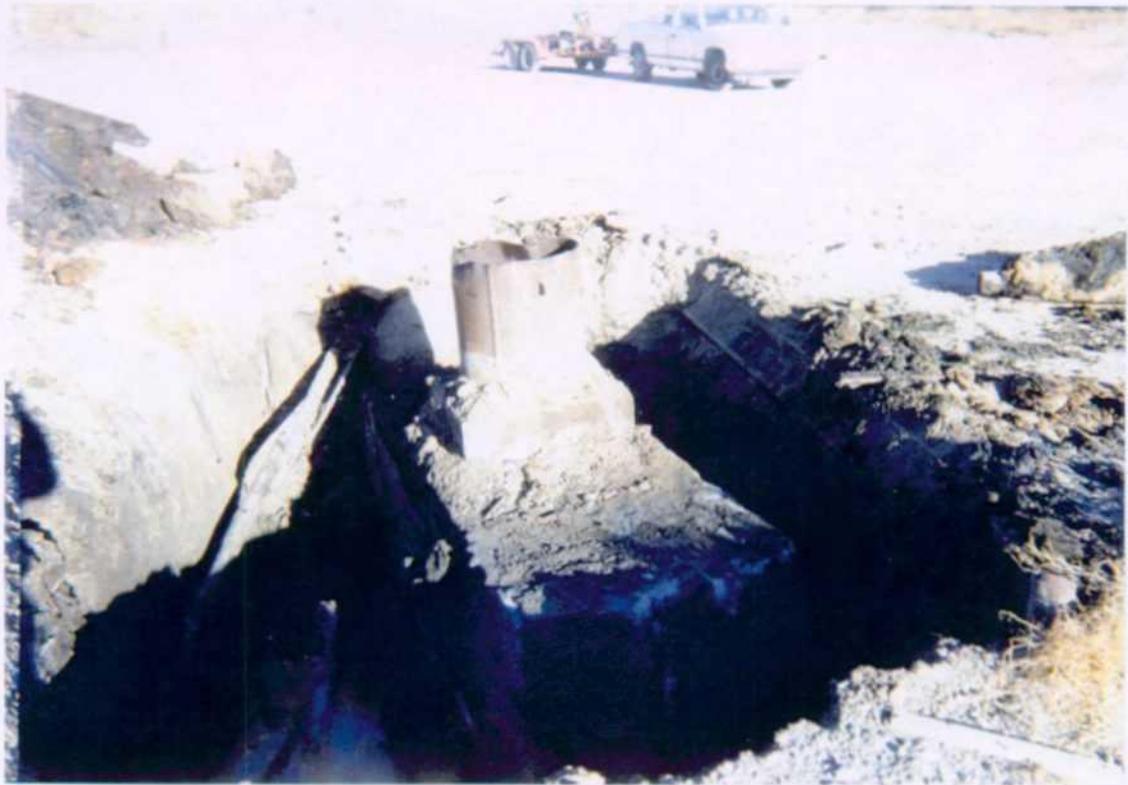
On December 26, 1996, the top and sidewalls of the tank were excavated, and it appeared that the tank was constructed of concrete (Picture 3). The exterior dimensions of the concrete sump were approximately 12-feet by four-feet by four-feet.

3: Excavated top and sidewalls revealing concrete sump.

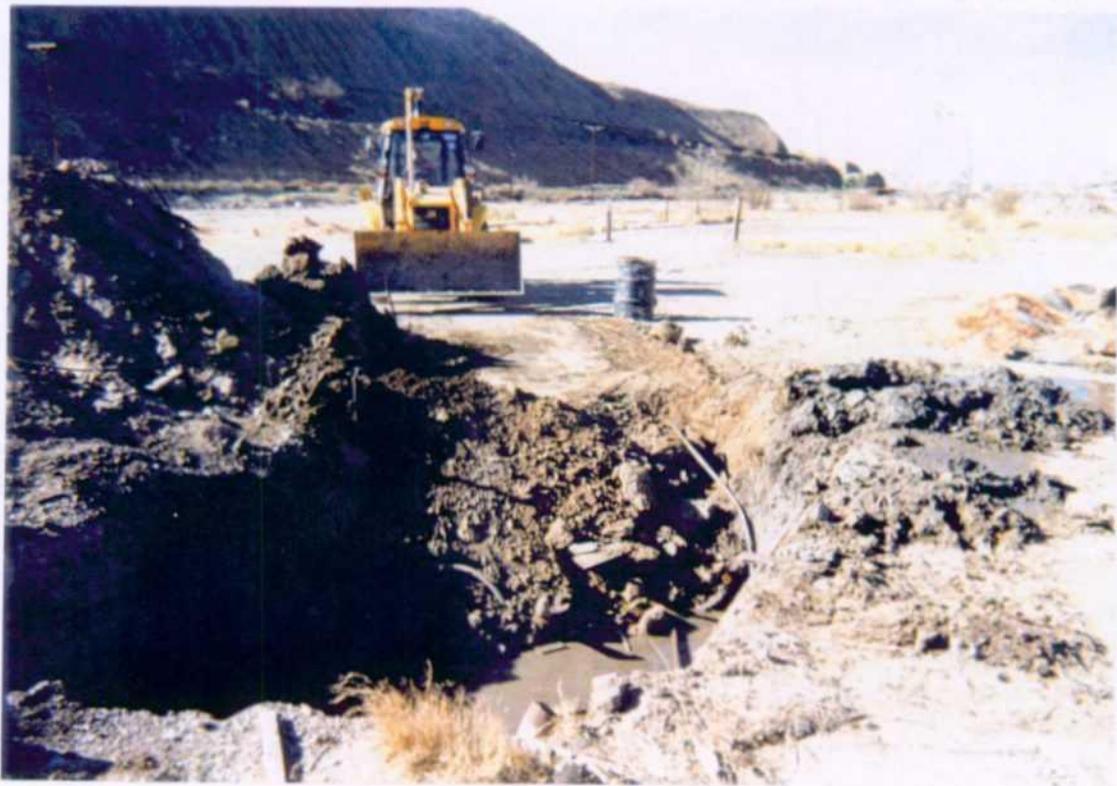
Groundwater was encountered in the tank pit approximately four-feet below the ground surface. This was anticipated due to the close proximity of the Rio Grande and observed water levels in site monitor wells. On December 26, 1996, visual inspection of the groundwater in the tankhold revealed a very slight sheen on the water table. However, on January 28, 1997, when the sump was removed from the tankhold, no visual product or sheen was observed (Picture 4).

4: View looking northwest at groundwater in tankhold.

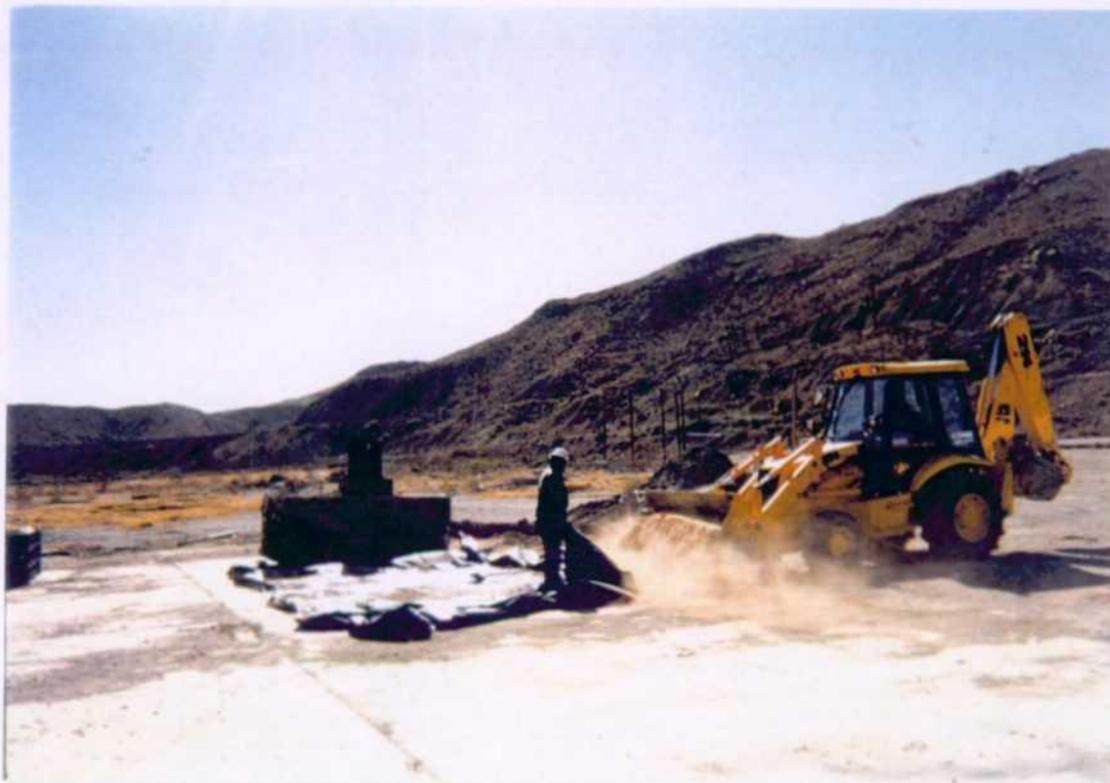
5: Constructing containment structure. Service pit located below backhoe.

Due to the potential for spillage, it was decided not to remove the oil filters and debris with the sump in-place. On January 28, 1997, a containment structure was constructed by placing a 30-mil high density polyethylene (HDPE) liner on the concrete pad adjacent to the sump. The four sides of the containment structure were bermed (Picture 5). A chain was carefully placed under the base of the sump and a backhoe was used to lift the sump from the excavation (Pictures 6 and 7). The sump was then carefully placed within the containment structure (Picture 8).

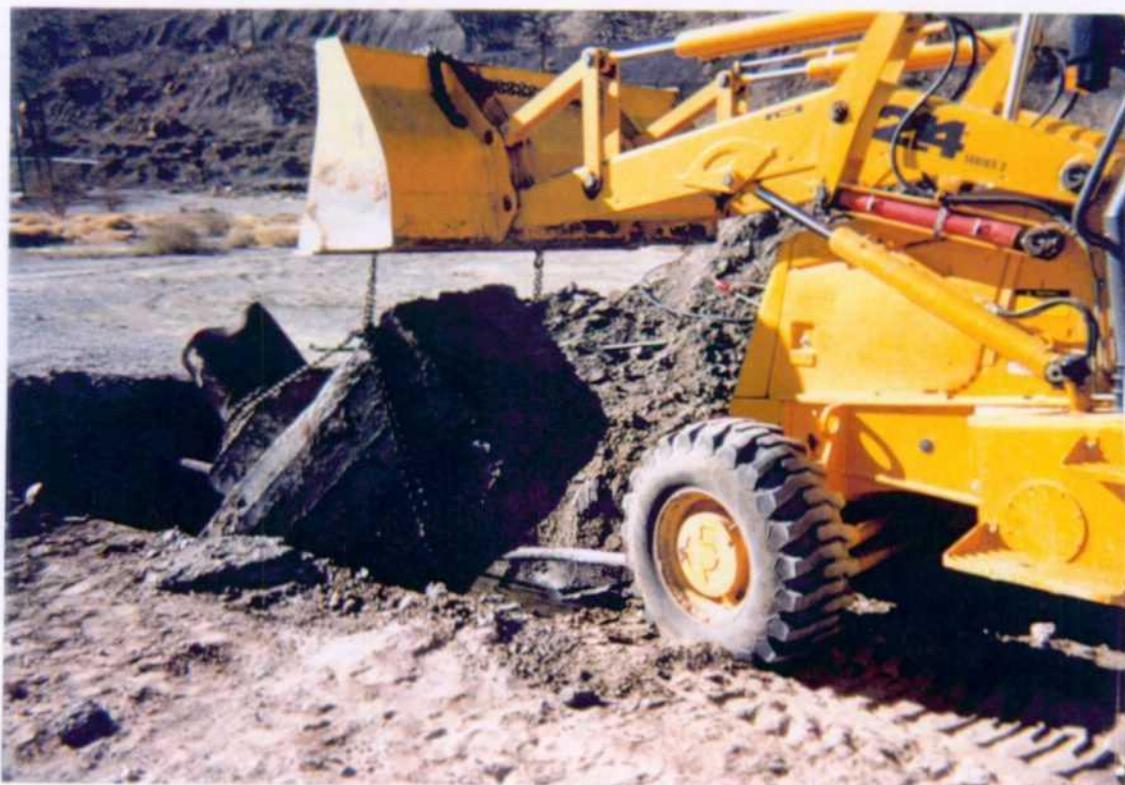
6: View looking southwest; lifting sump from tankhold.

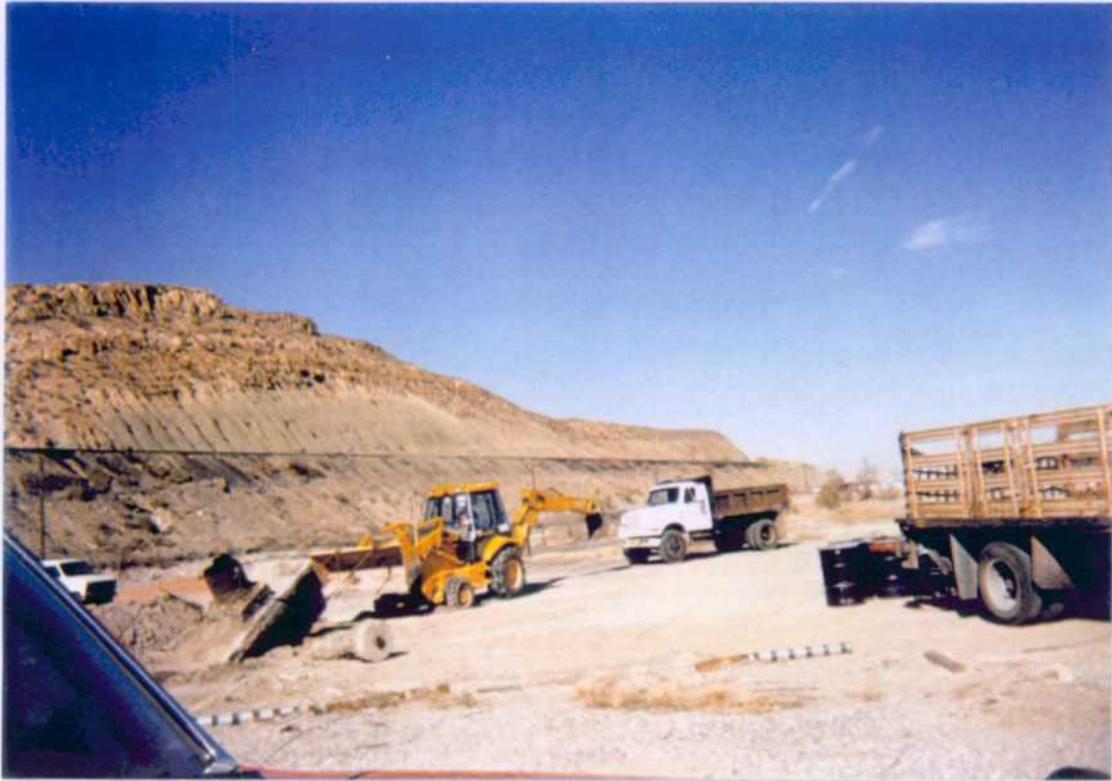
7: View looking northwest; sump removed from tankhold.

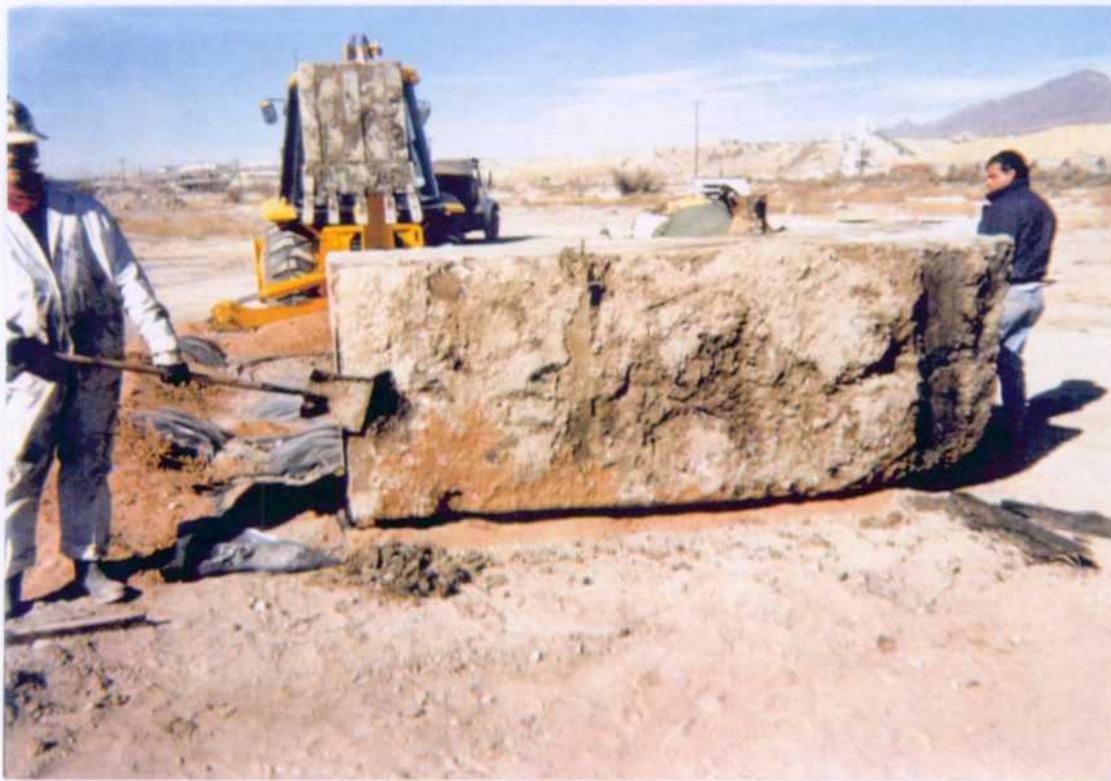
8: Sump placed in containment structure. View looking at base of sump.

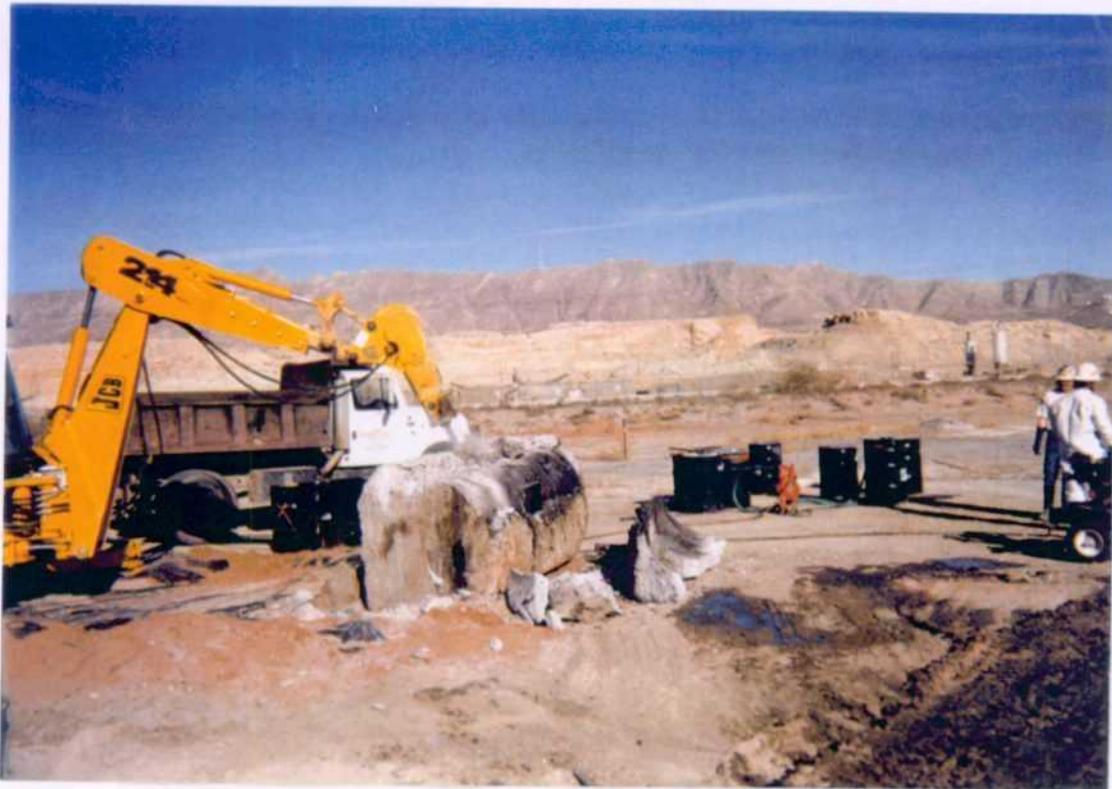
9: Jackhammer on backhoe used to remove concrete from metal tank.

An attempt was made to remove the lid of the tank in order to evacuate the debris. However, while jack-hammering the lid of the sump, the concrete crumbled away to reveal a steel tank (Picture 9). It was later determined that due to the presence of the high water table, it was necessary to entomb the steel tank in concrete in order to prevent the tank from floating. The concrete which surrounded the tank was clean and free from any hydrocarbon contamination.

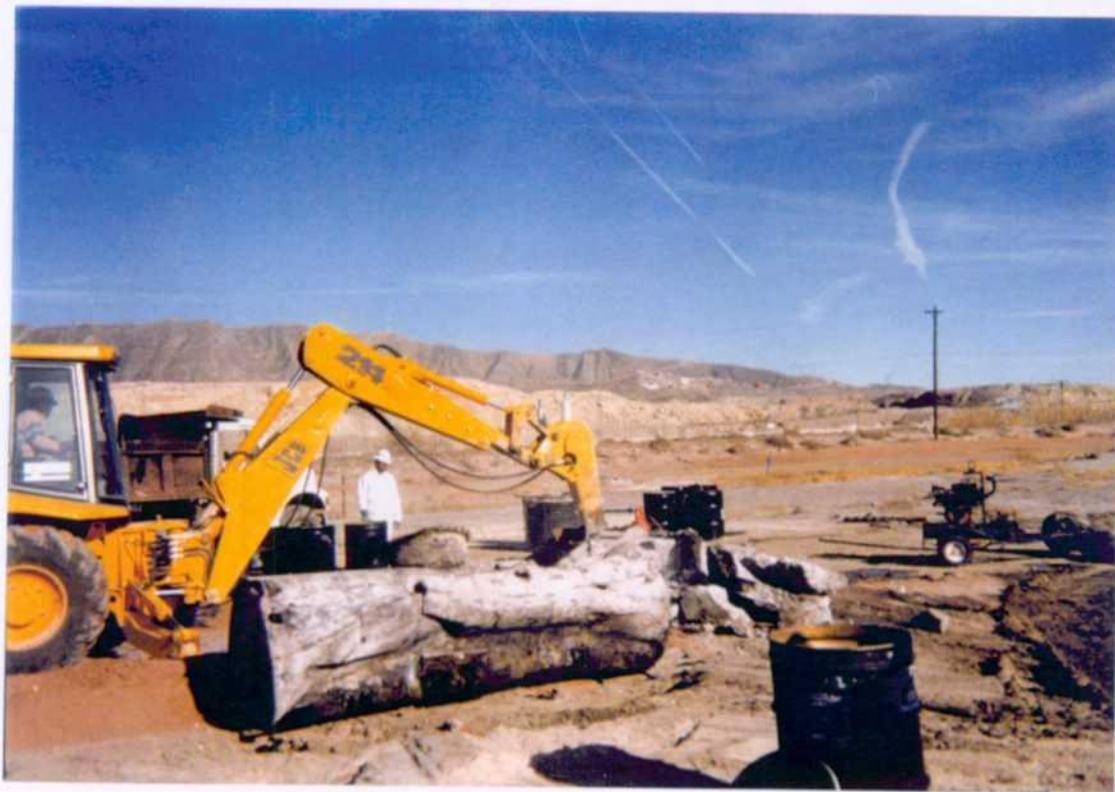
10: Concrete from sump is segregated to prevent coming in contact with the tank contents.

Therefore, the concrete was removed and segregated in order to prevent it from coming in contact with the tank contents (Picture 10).

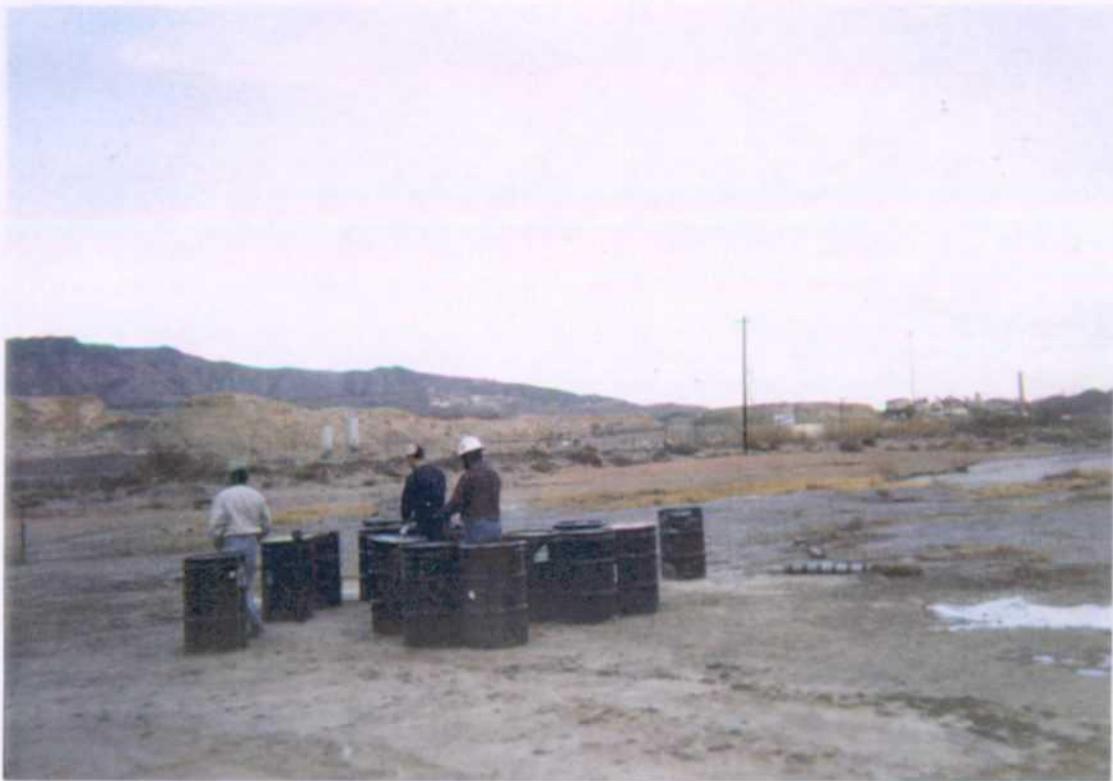
11: Waste is placed in DOT approved drums and sealed for transportation.

The oil filters and debris were then removed from the tank and placed in Department of Transportation (DOT) approved drums (Picture 11). A total of 220 gallons of waste oil was collected and drummed for recycling. A small amount of waste oil was spilled while removing the tank from the excavation, transporting it to the containment structure, and removing the remaining contents. The affected soil was removed with the backhoe and placed in DOT approved drums. Additionally, the HDPE used for the containment structure was drummed. In total, four drums of waste oil, five drums of debris, oil filters, and HDPE and one drum of soil were generated in association with the sump removal.

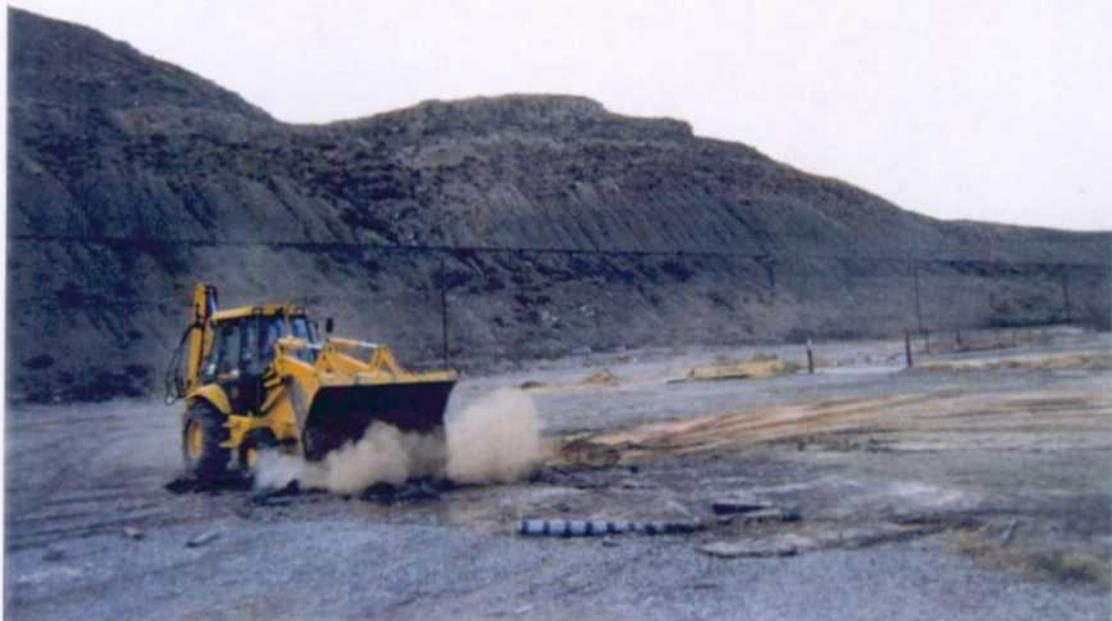
12: Sump tankhold is backfilled and wheel rolled.

Following soil sample collection, (discussed below), the excavation was backfilled by placing the excavated soil and approximately seven-yards of clean fill material in the excavation. The backfill was then wheel rolled and soil was left mounded in anticipation of the soil settling (Picture 12).

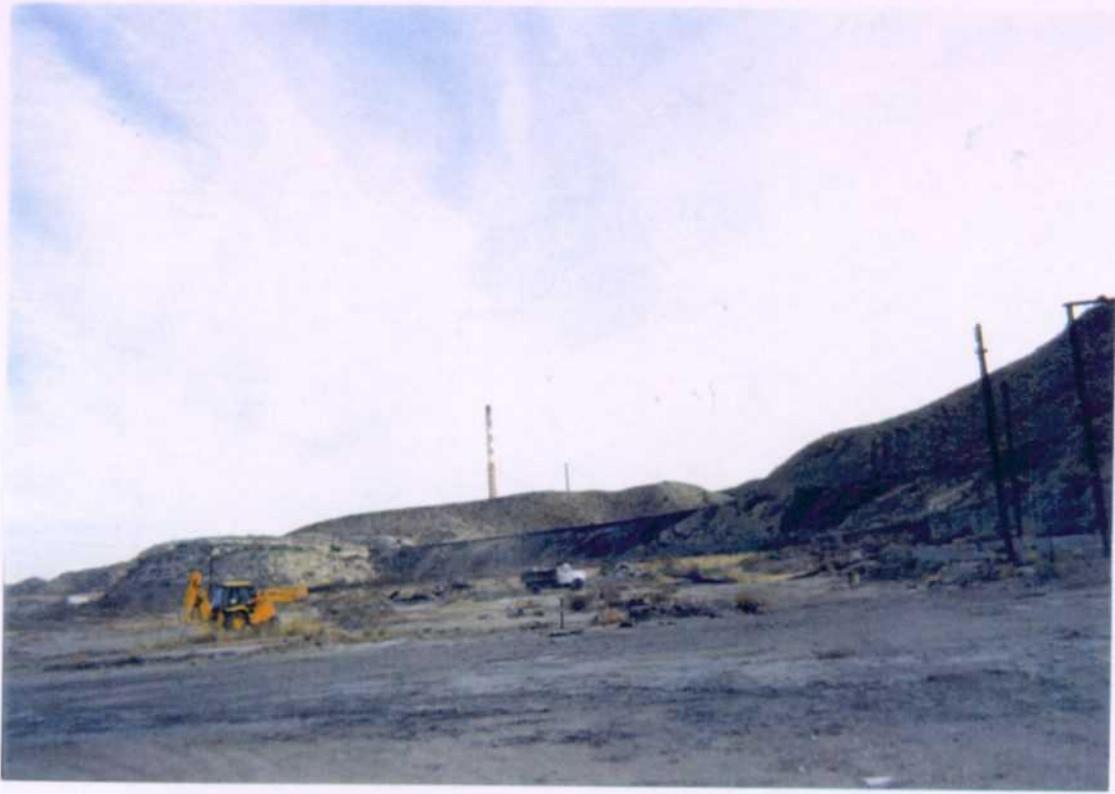
13: Concrete from sump is placed with existing construction stockpile.
