**STAGE 1 & 2
WORKPLANS**

ABATEMENT PLAN AP-20

CLOSURE

RE: MNA Enterprise, Ltd.
Stage 1 Abatement Plan (AP-20) Closure
W.F. Hanagan SWD Line Leak

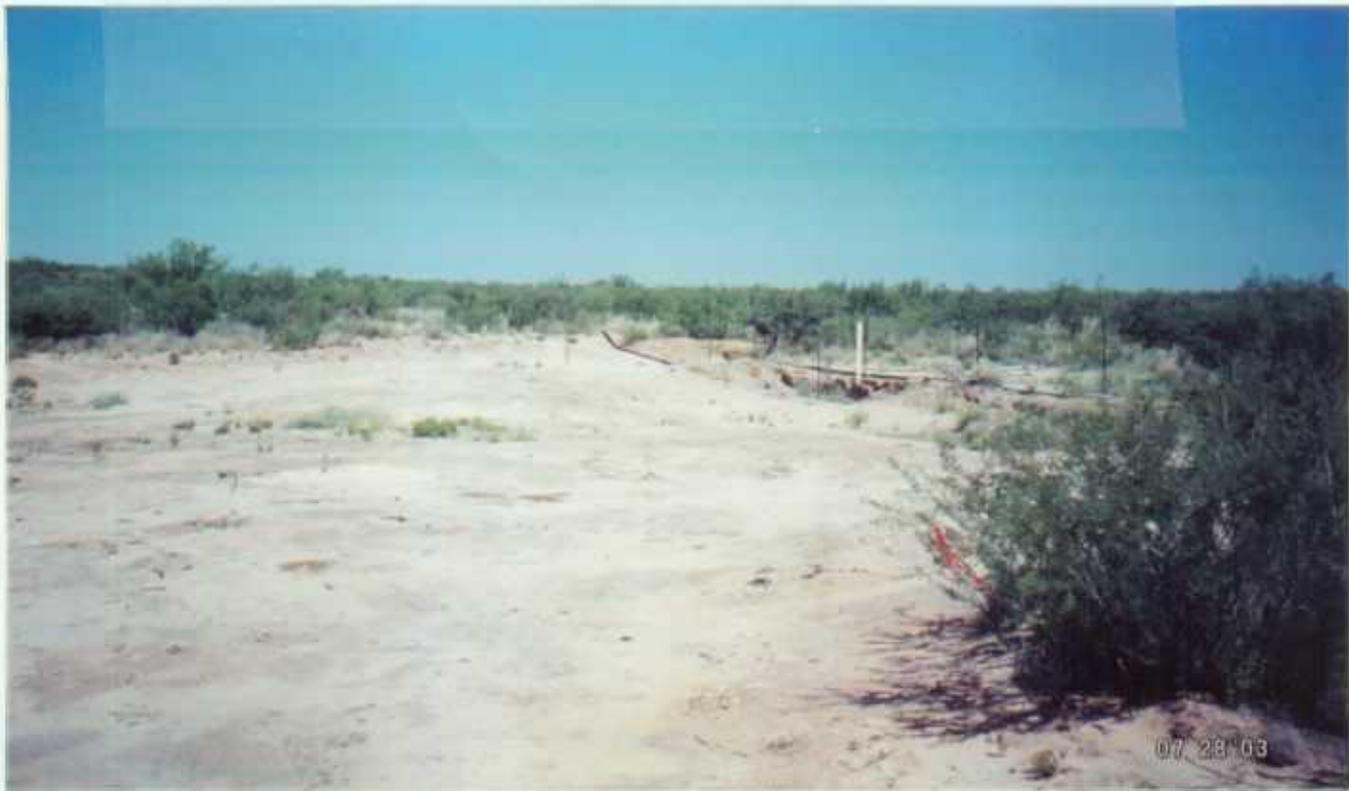
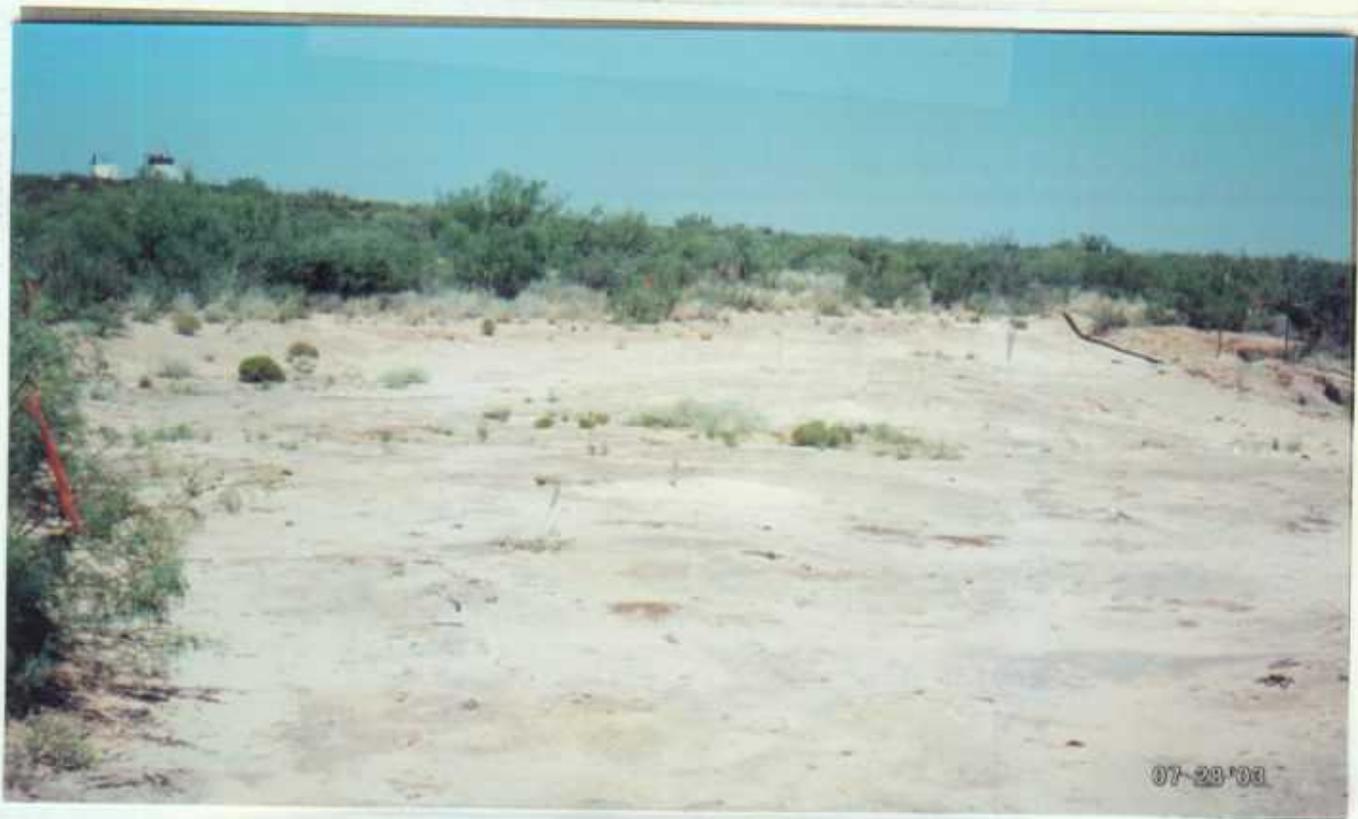
Before excavating

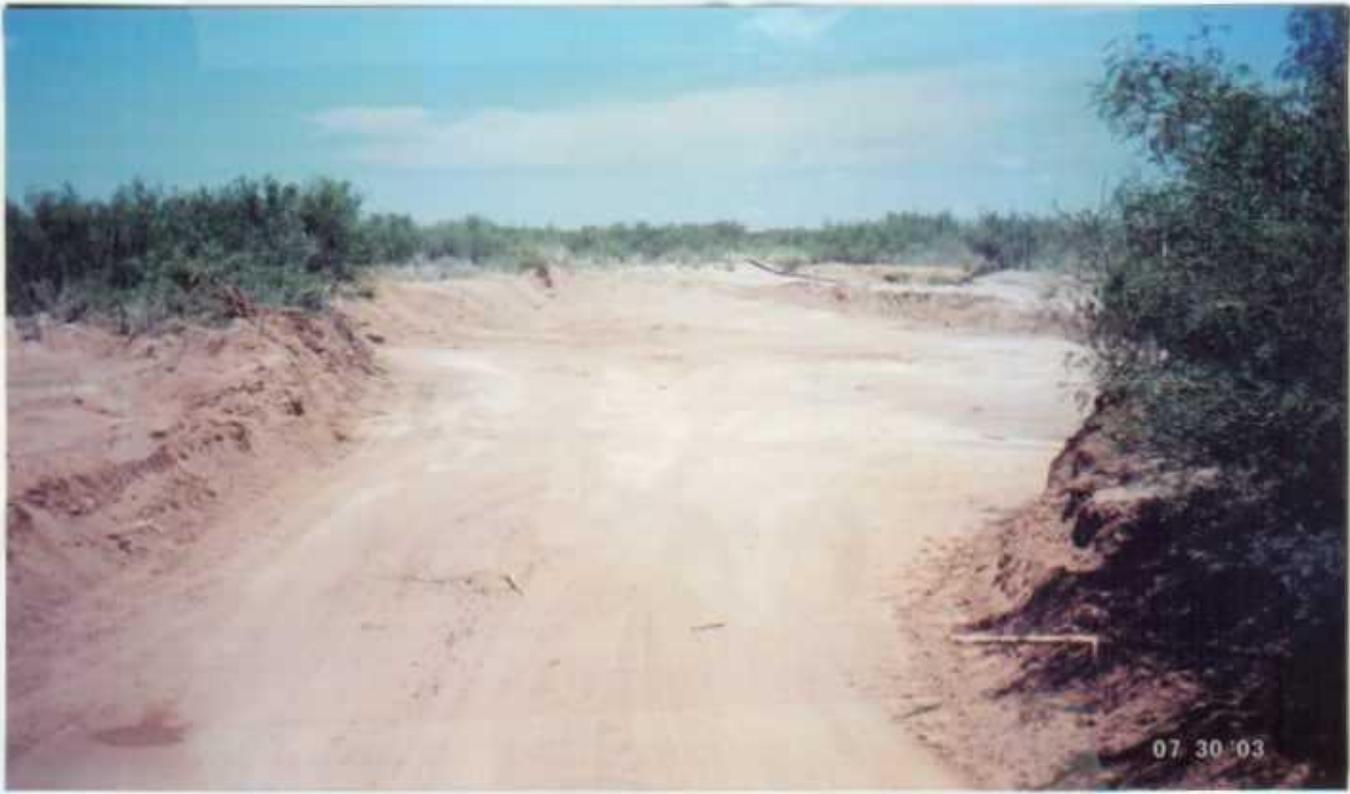
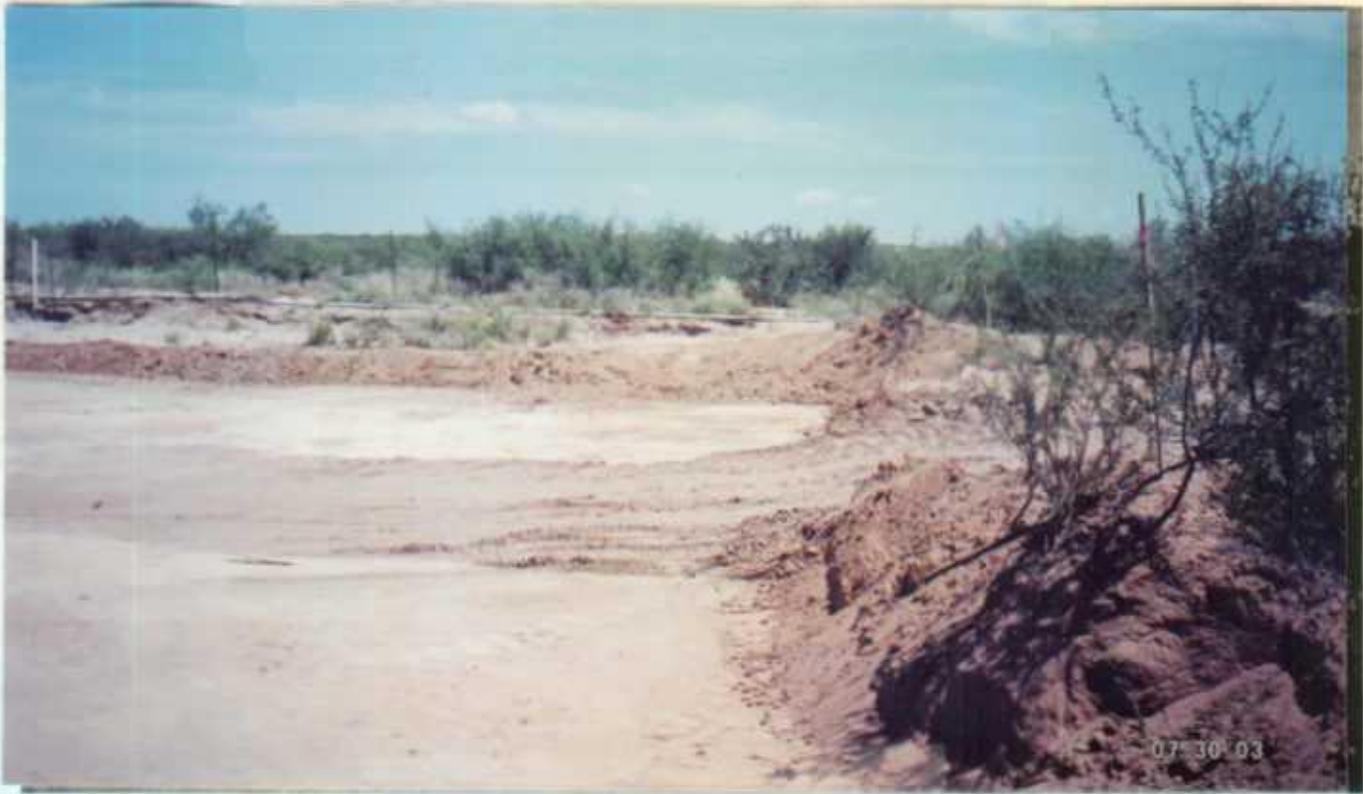
Work in progress

With the Aid of Phoenix Environmental as contractor, 660 cu. yds. of soil was hauled off of the MNA site. When the leak was originally discovered and approved, Donna Williams had MNA haul approximately two feet of soil from the spill site. Our approval was to remove an additional two feet and backfill with clean soil from Mr. Osborn's stock pile.

- 1) Phoenix removed 660 cu. yds. of contaminated soil and was disposed of at Doom Landfarm, Jal, NM, Permit #NM-01-0033.
- 2) Samples were taken from the site, a composite of the bottom and sidewalls and the clean soil used as backfill. A total of 816 cu. yds. of clean soil was used to backfill and crown.
- 3) Photos of all activities within.
- 4) Analytical within.
- 5) Maps and drawing within.

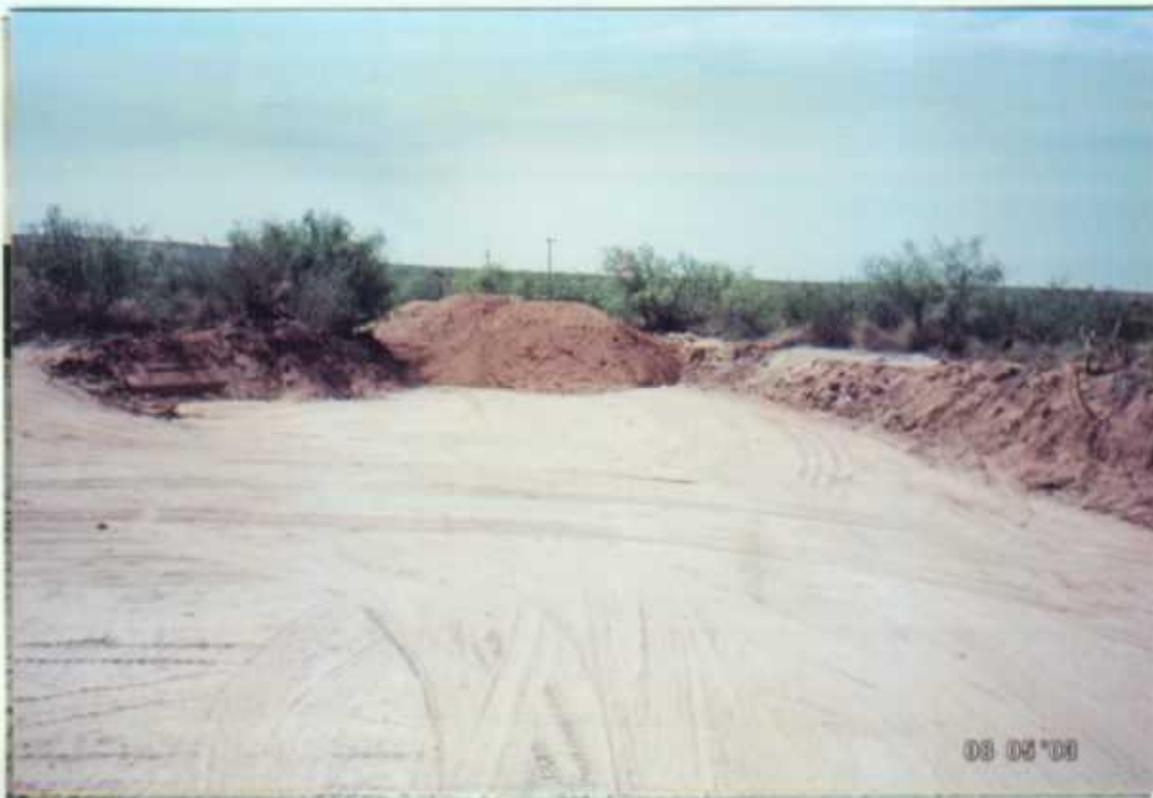
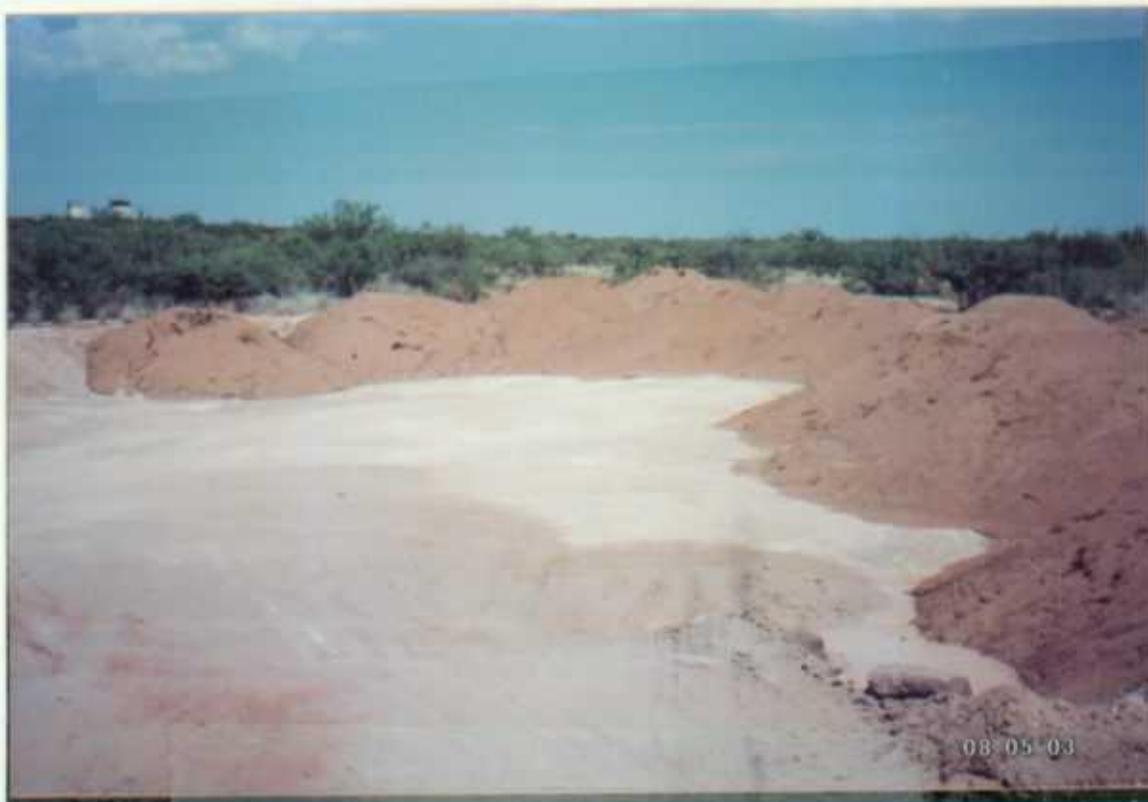
Backfill and closure

Whenever we receive moisture in the area, Phoenix has been designated to reseed the site with grasses native to the area.
