~~ANNUAL~~  
**MONITORING REPORT**

**MARALO SITE**

**SECTION 36, TWS. 25 S., RNG. 36 E.**

**JAL, NM**

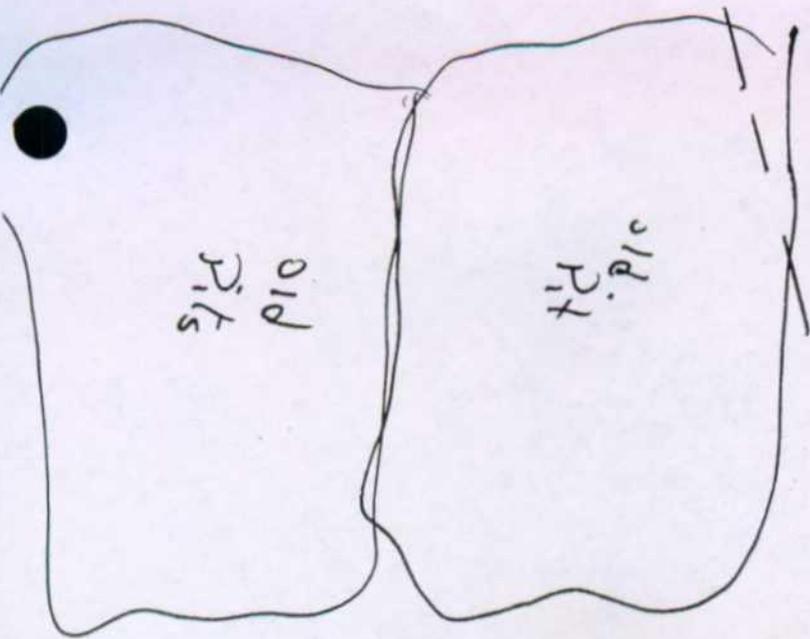
lease Road

TNMP - Koth Pipeline

Tank Battery Area

MA#2

MA#1

water well

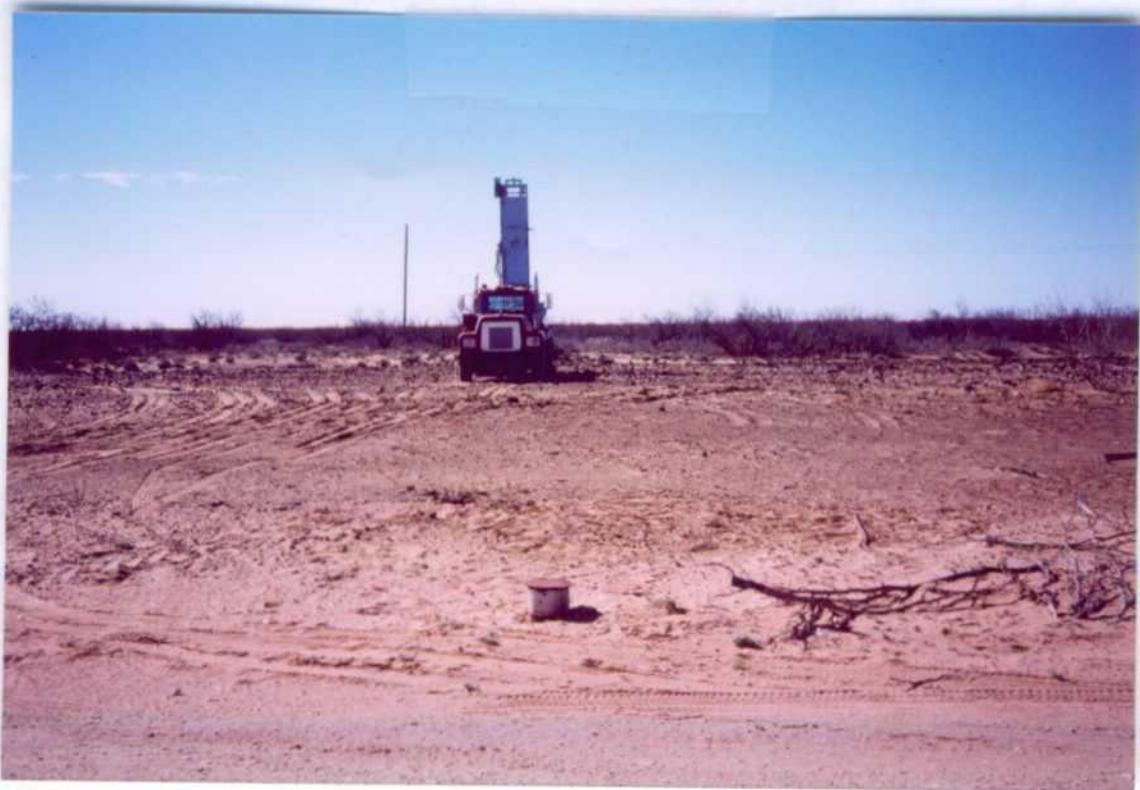
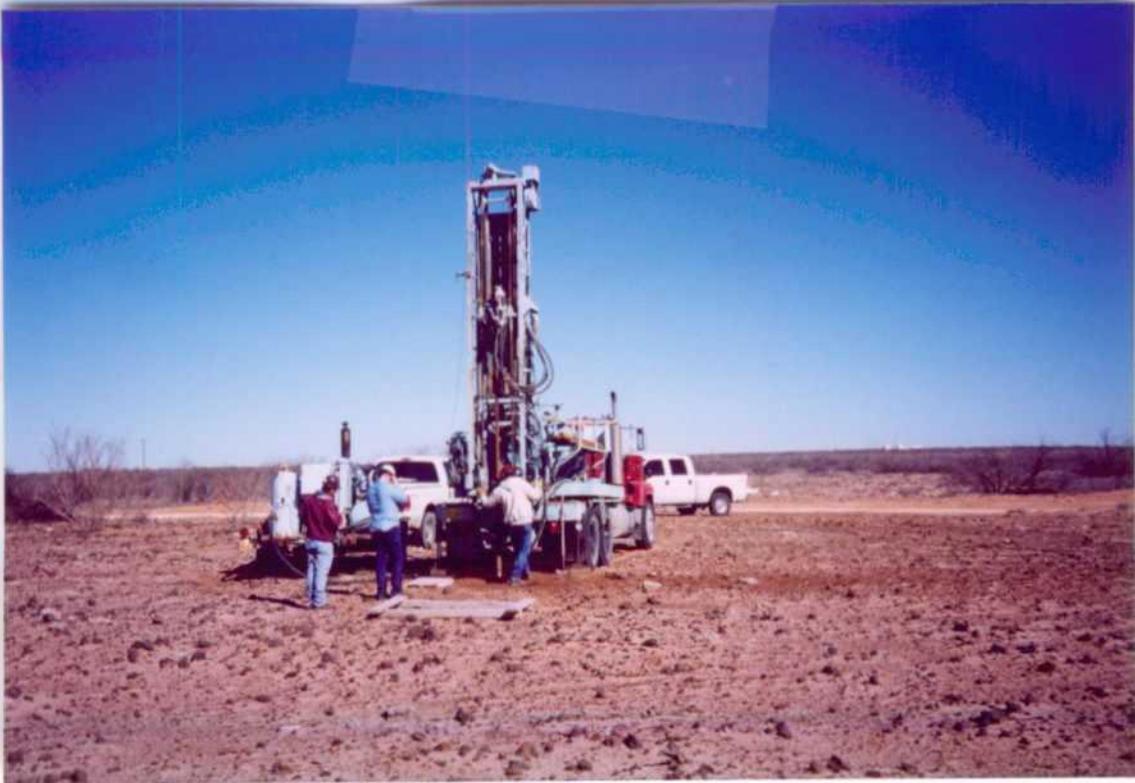
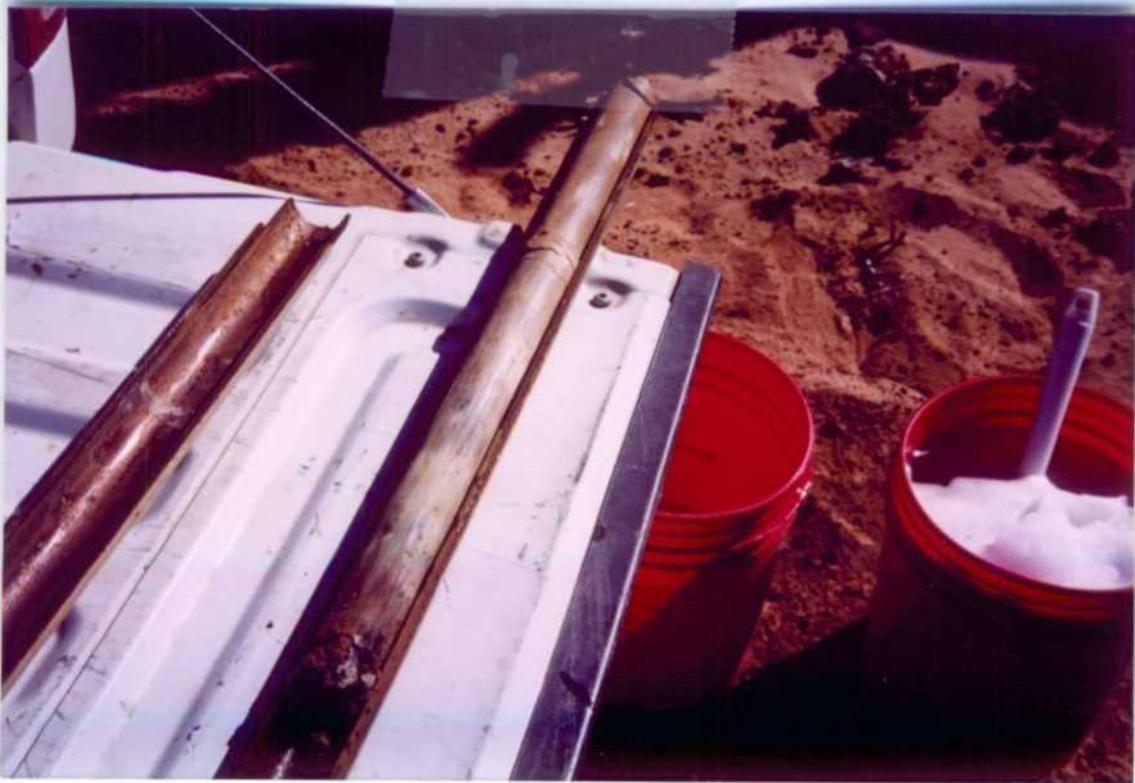
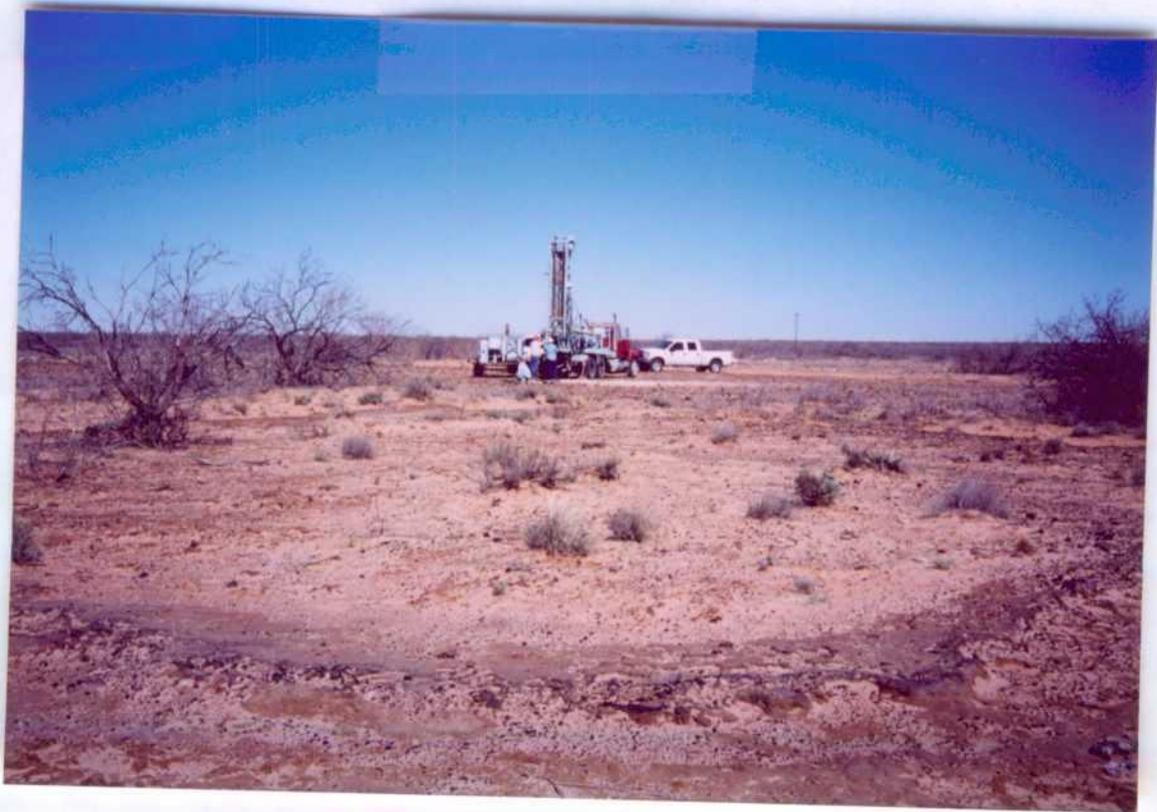
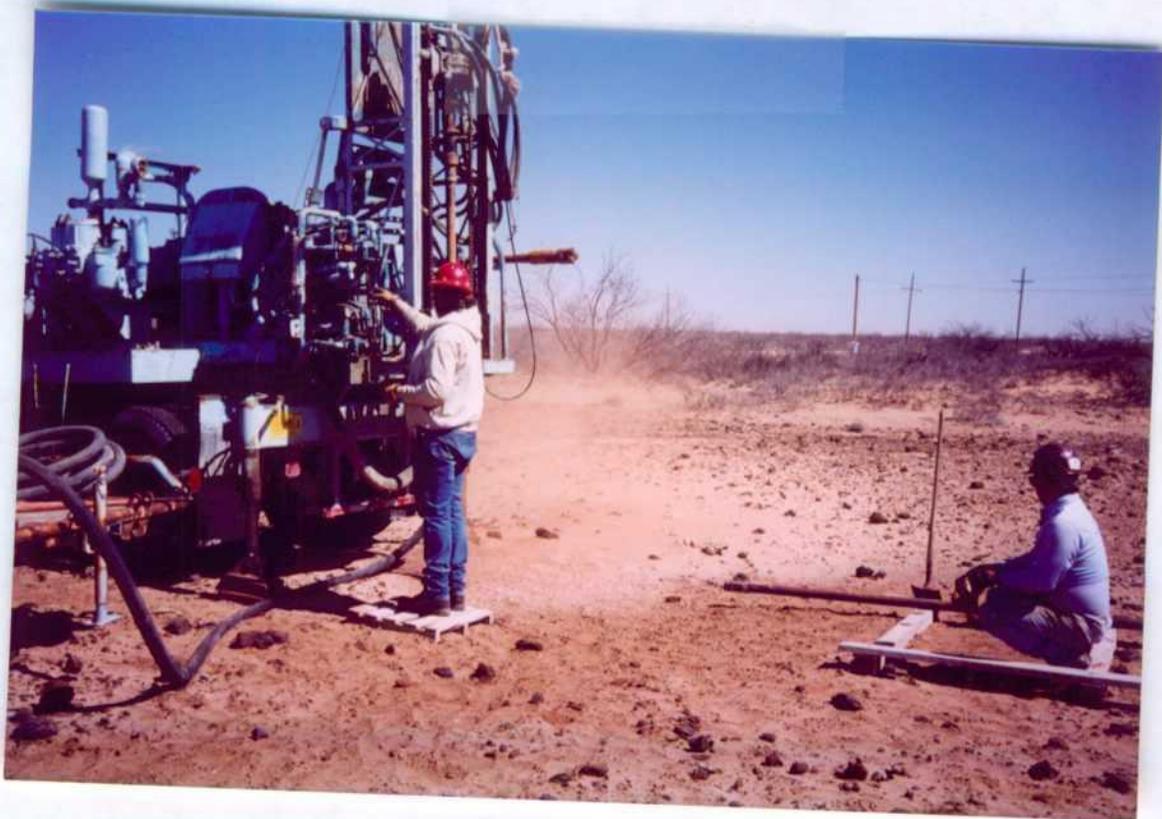
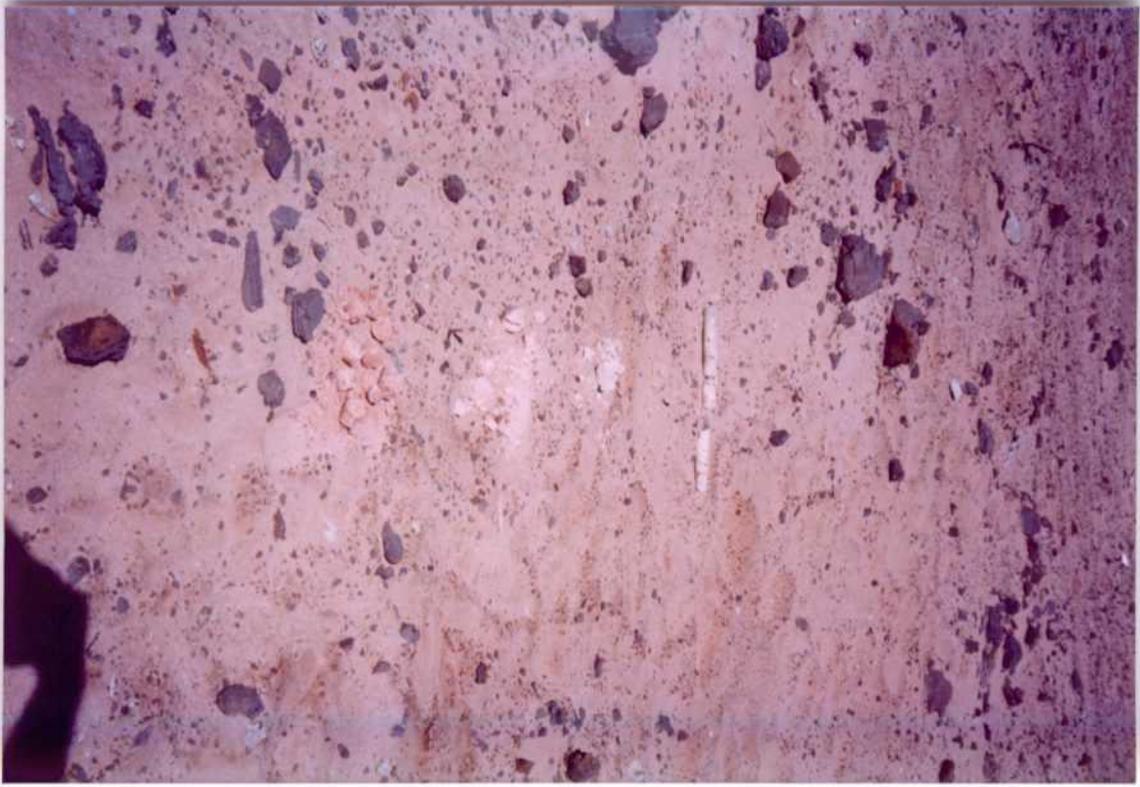
MA # 1

MA 1-1	8 to 10 ft. oily strong odor
MA 1-2	20 ft. oily strong odor
MA 1-3	40 ft. strong odor, discolored caliche
MA 1-4	60 ft. slight odor, staining
MA 1-5	80 ft. slight odor

0'-10' top soil rock, very oily  
10'-35' sand, rock, oily  
35'-50' caliche, rock, oil stained  
50'-65' sand, small gravel  
65'-80' sand, clay

From the analytical data provided on the soil borings, it is obvious that an extensive investigation and remediation plan needs to be undertaken by the responsible party. The analytical exceeds the guidelines set forth by the NMOCD for cleanup and remediation. Given the depth of contamination in the soil borings, it will just be a matter of time before we have major impact to the groundwater.

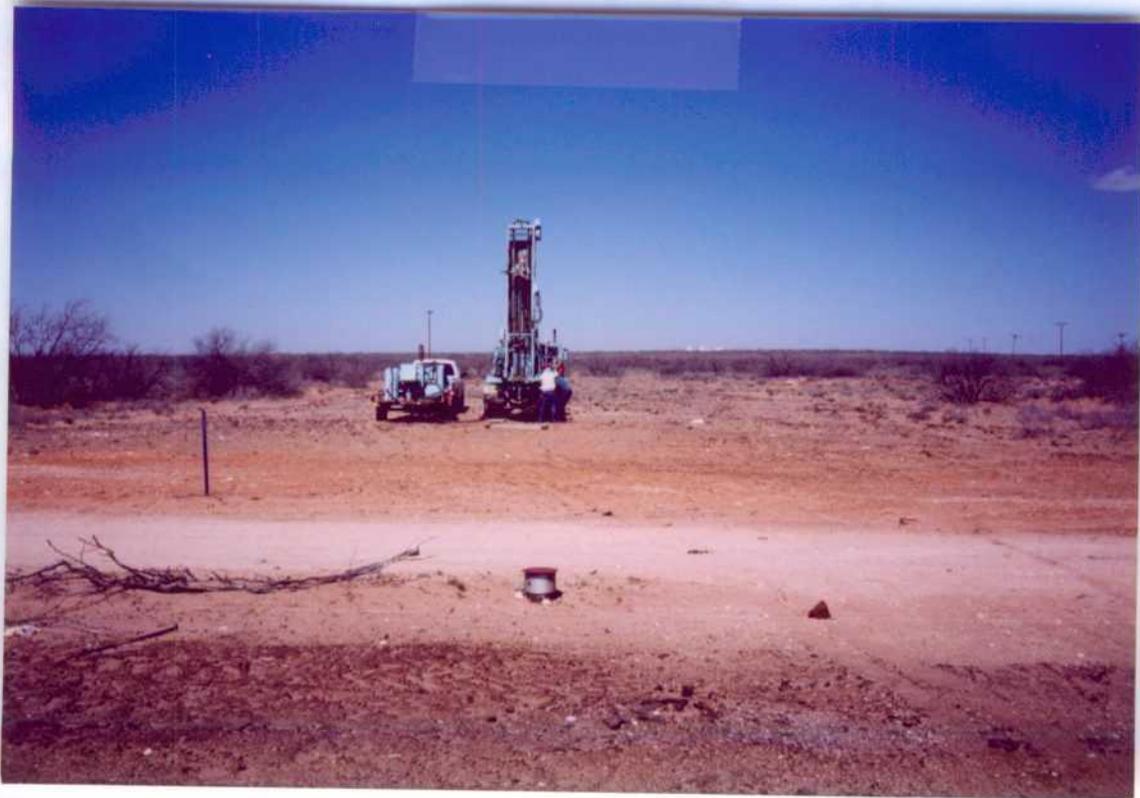
MA #2

MA 2-1	8' to 10' black oily, strong odor
MA 2-2	20' oily, strong odor
MA 2-3	40' stained caliche, slight odor
MA 2-4	60' slight odor
MA 2-5	80' slight odor

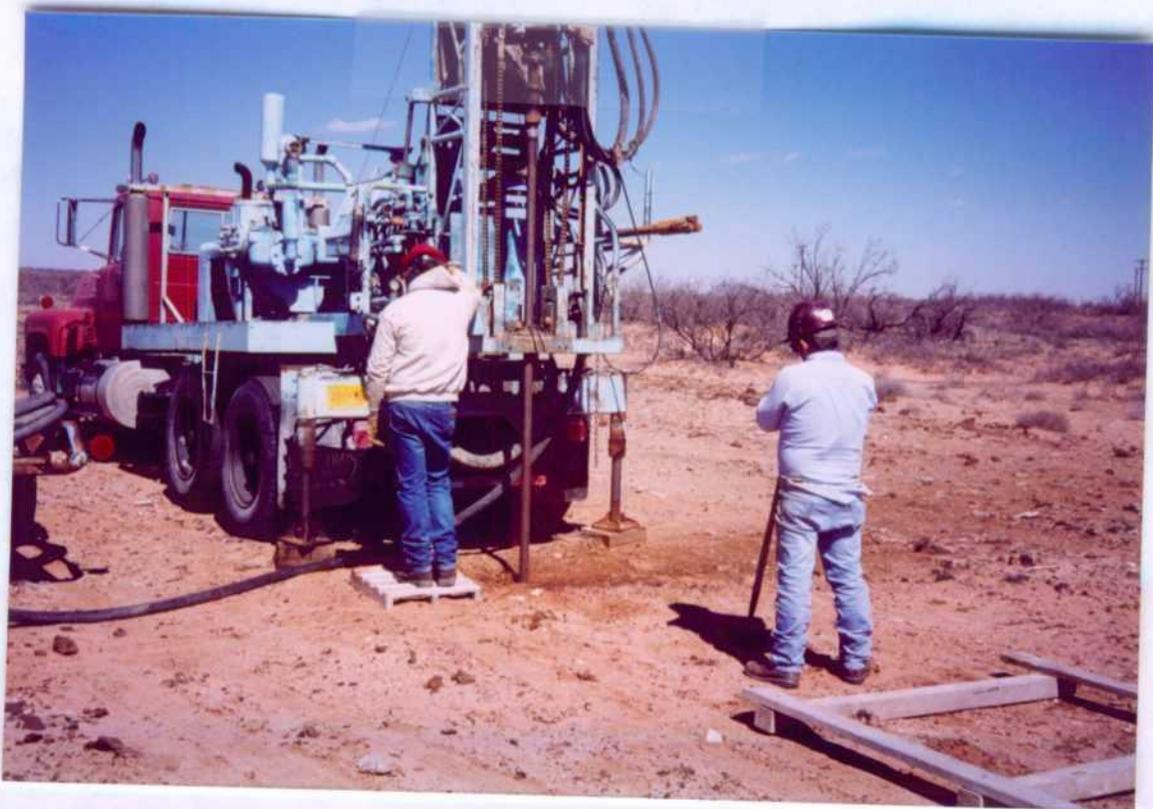
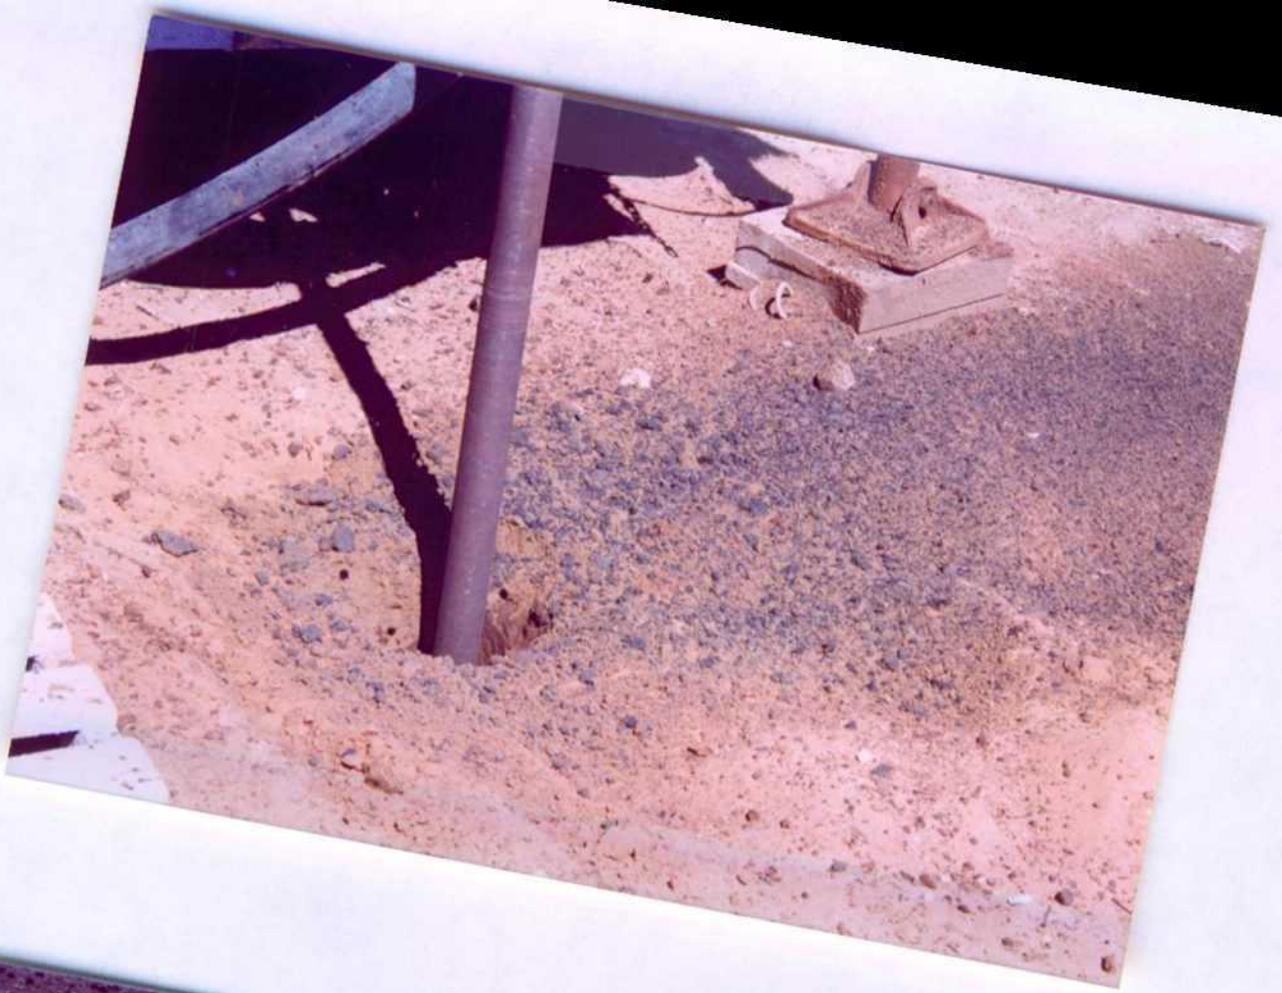
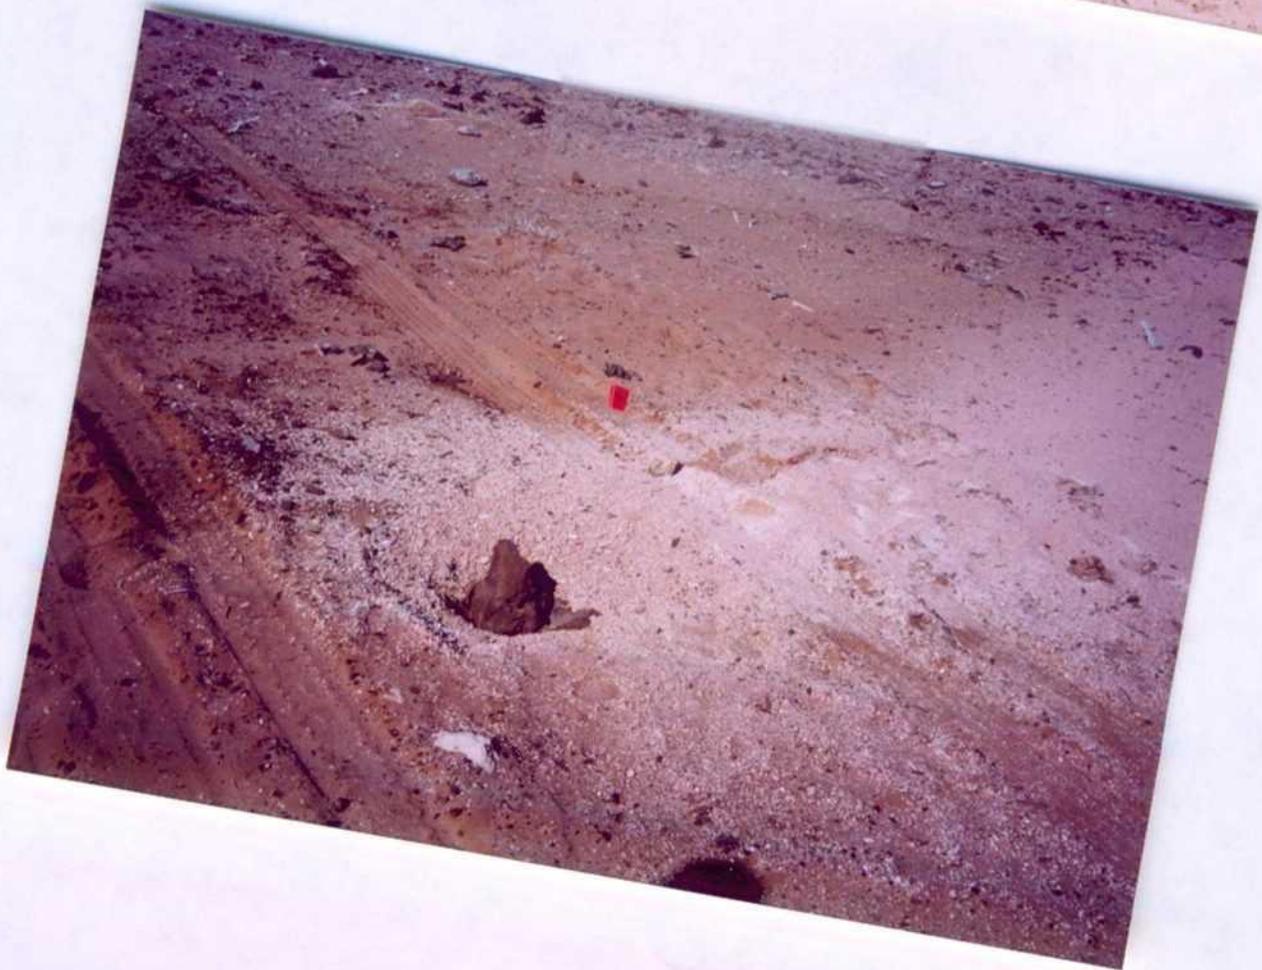
0'-15' black very oily top soil  
15'-26' sand, rock, oily, strong odor  
26'-32' caliche, charcoal gray, strong odor  
32'-38' caliche white in color, odor  
38'-48' caliche, sand, rock, odor  
48'-57' sand, caliche, rock  
57'-80' sand, clay, rock  
TD 80 ft.
