**RE: Investigation & Characterization Plan: Santa Rita EOL Release Site
T22S - R37E – Section 27 – Unit Letter A**

INVESTIGATION & CHARACTERIZATION PLAN

BD Santa Rita EOL Release Site
T22S, R37E, Section 27, Unit Letter A
Lea County, New Mexico

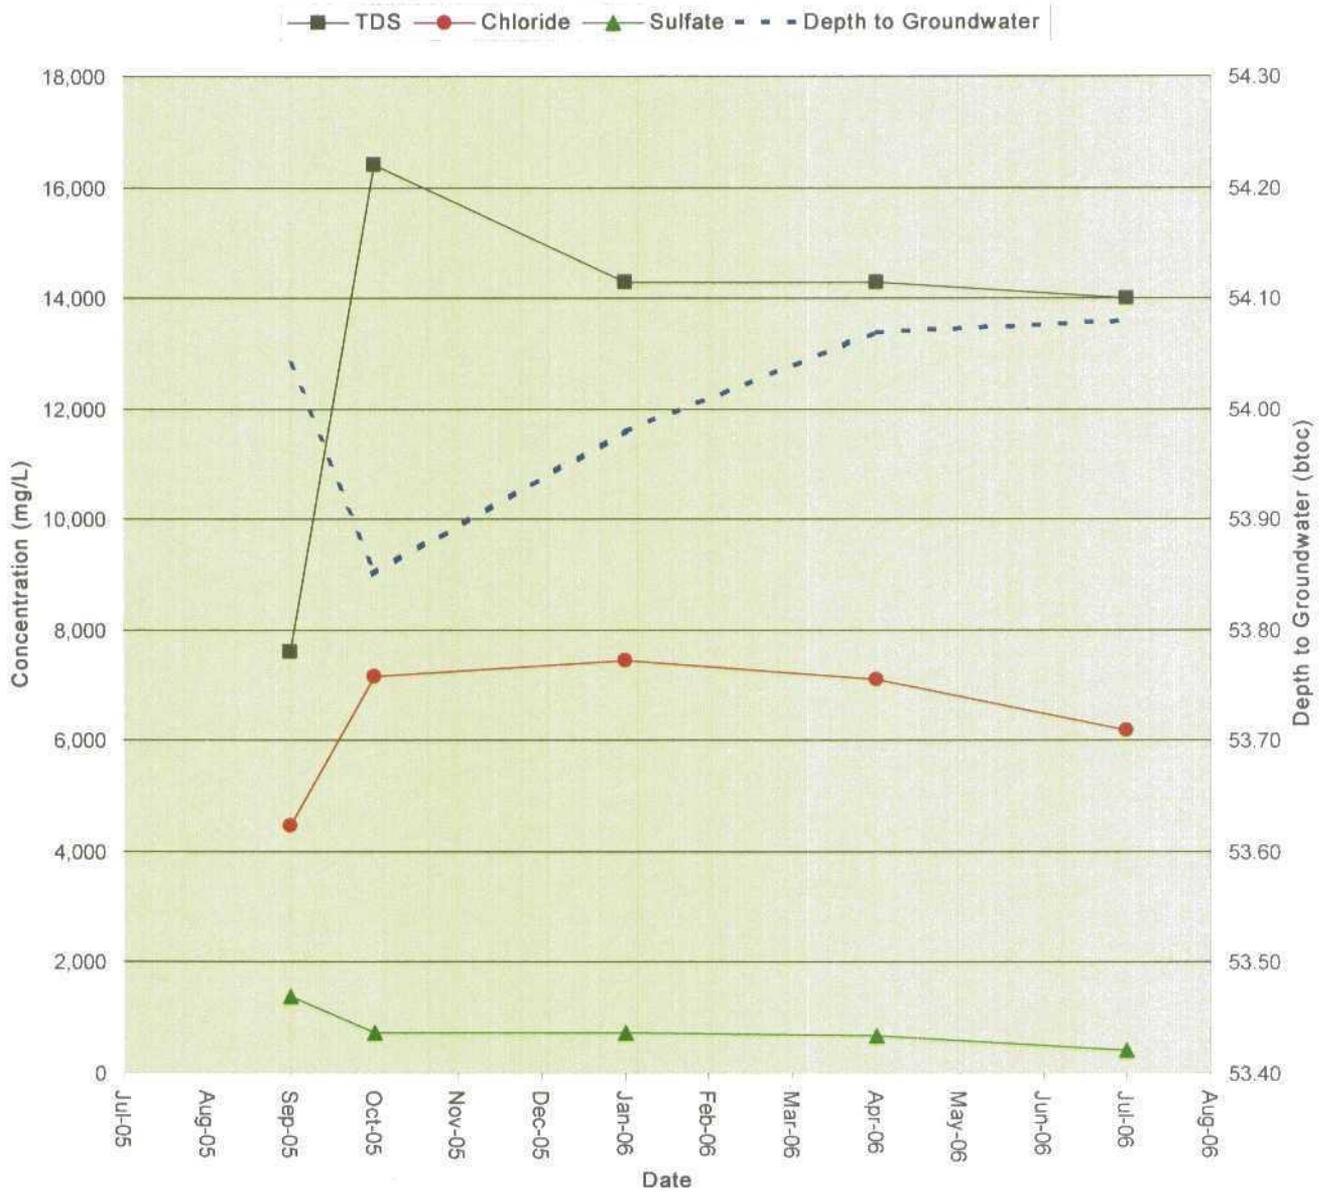
MW-1
 Chloride, TDS Concentrations, and Water Table Elevation Versus Time Graph
 Santa Rita EOL Site

Background and ambient concentrations of these compounds have not been established at this time. Chloride, sulfate, and TDS concentrations in MW-1 have consistently decreased since the initial sampling event. No correlations between chloride/sulfate/TDS concentrations and changes in ground water levels are evident.

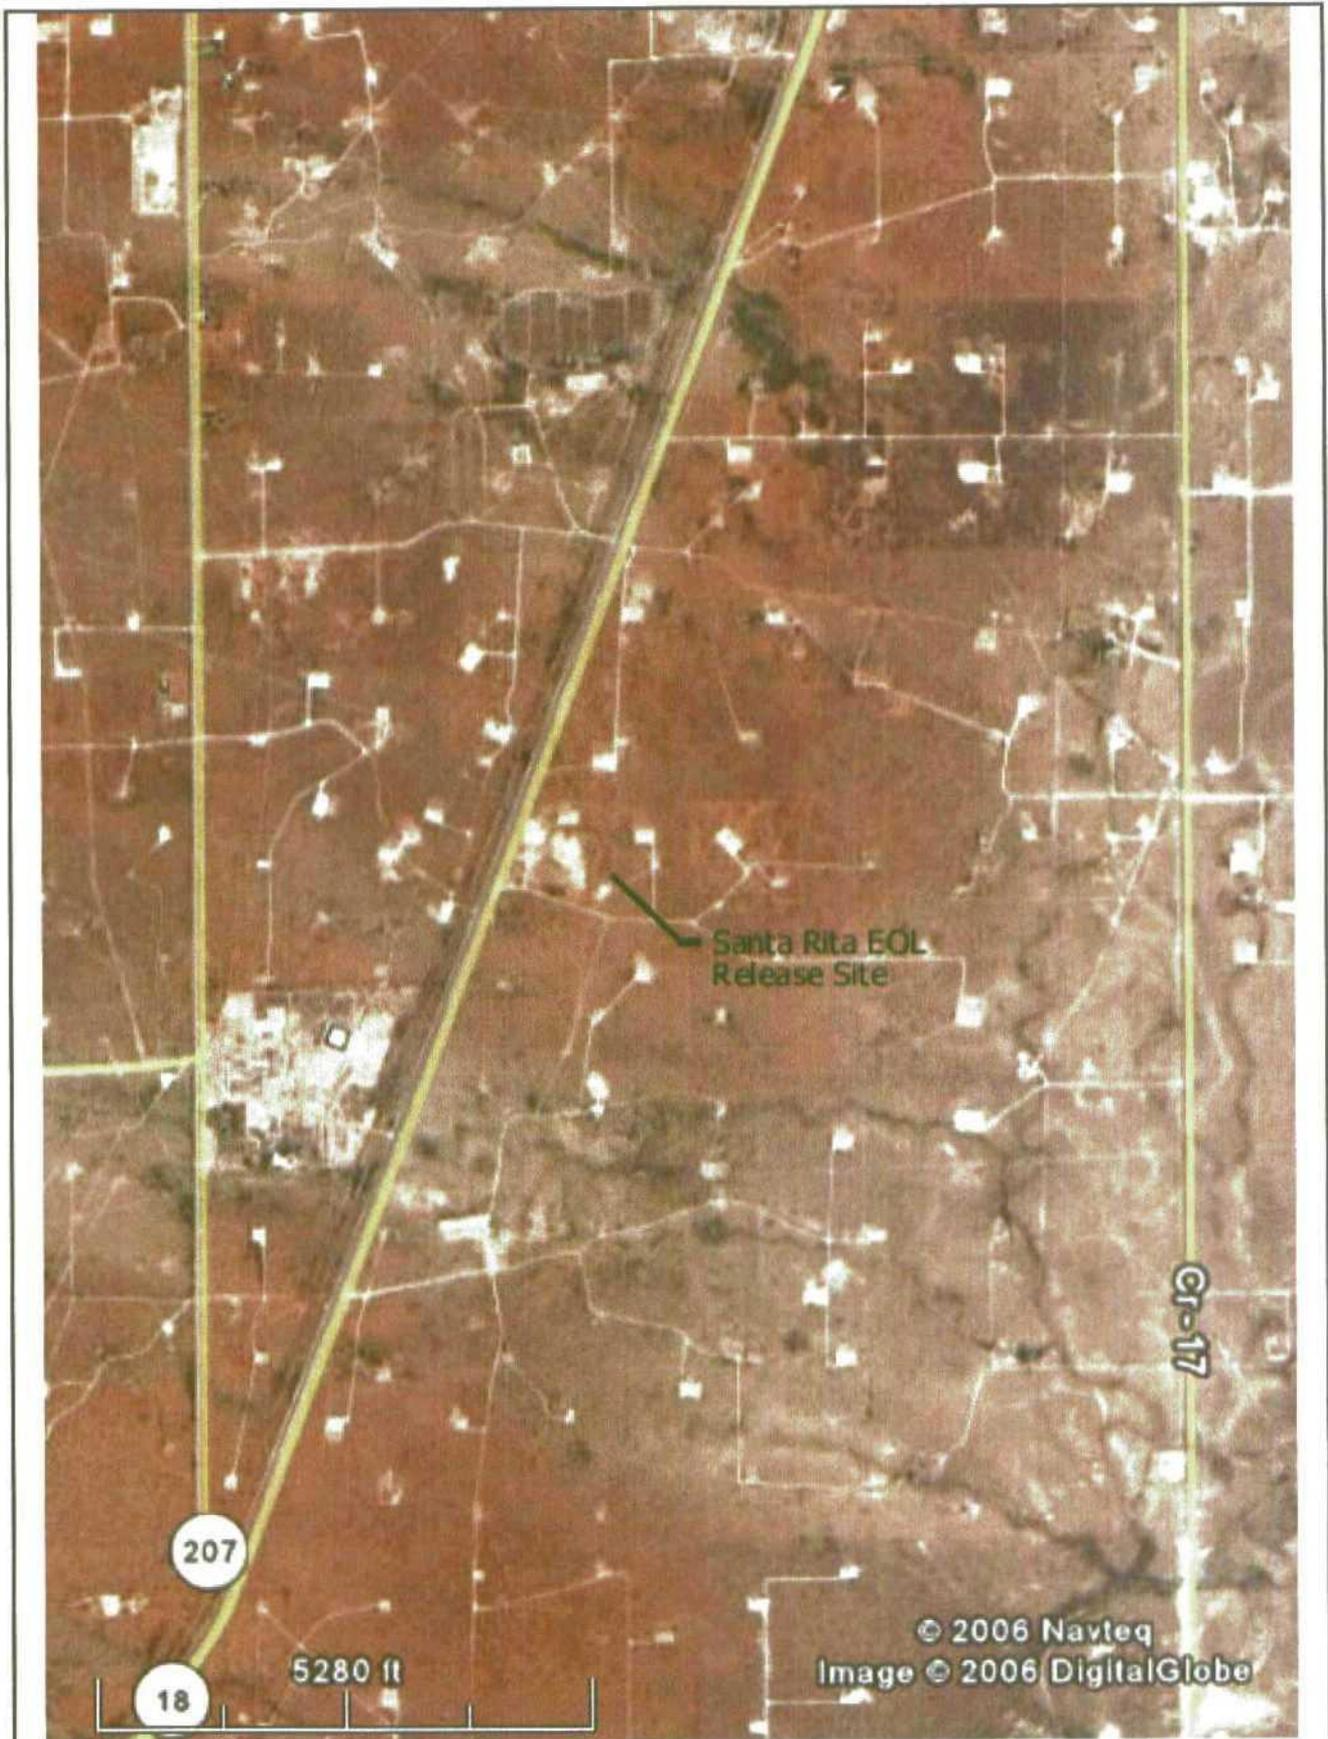
Plate 1
 August 2006

SITE LOCATION MAP
 Santa Rita EOL Release Site
 RICE Operating Company

The Santa Rita EOL Release site and release is located on land owner by Irwin Boyd in Township 22 South, Range 37 East, Section 27, unit letter A approximately 4.5 miles southeast of Eunice, NM as shown on the attached Site Location Map (Plate 1). Produced water gathered by the BD SWD System in the site area is sent to the H-35 SWD well, which is located approximately 1.6 miles southeast of the Santa Rita EOL Release site. Land in the site area is primarily utilized for crude oil, gas production, and cattle ranching. Plate 2 is a recent aerial photograph at the same scale as Plate 1 showing the land use.

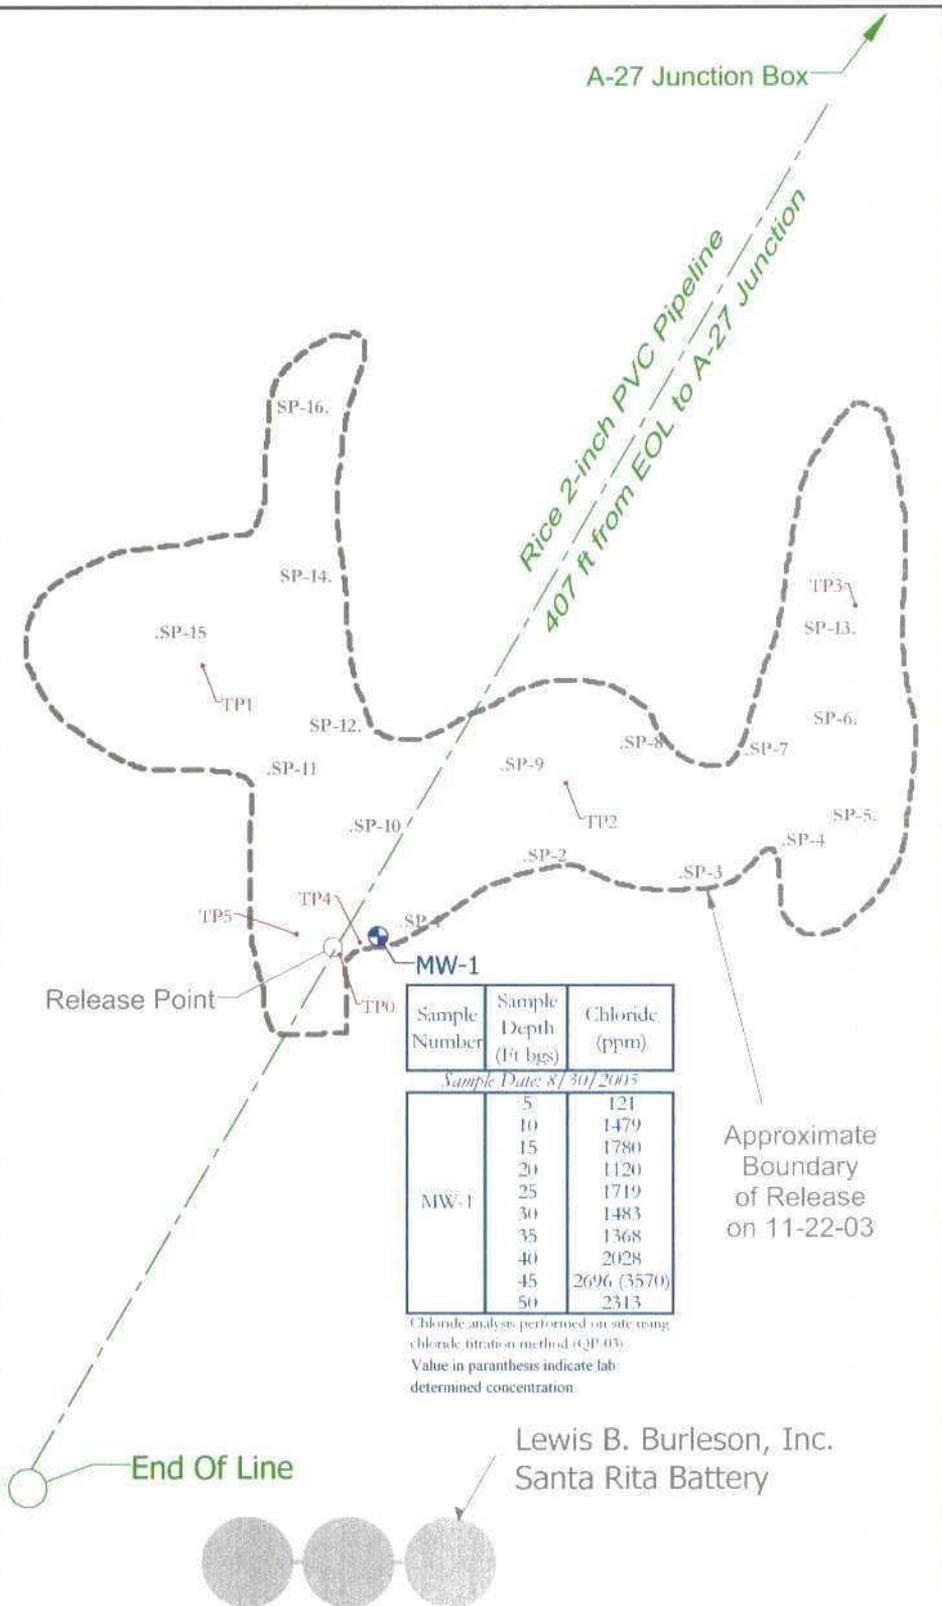
PLATE 3
PRELIMINARY SOIL
SAMPLE RESULTS

Site: BD Santa Rita EOL Release Site
Date: January 30, 2006
Sampled By: Rice Operating Company
Approximate Scale: 1 inch = 30 feet

A delineation soil bore was initiated near the pipeline break on August 30, 2005 where groundwater was encountered at approximately 51 feet below ground surface and a 2-inch monitoring well was installed to a depth of approximately 61 feet as chloride impact was indicated by field tests. The investigations indicated chloride impact to the vadose zone and groundwater, however no indication of hydrocarbon impact was evident based on field screening with a photoionization detector (all readings were less than 0.1 ppm). Soil sample results are depicted in Plate 3.

ROC conducted initial upper vadose zone delineation field activities on November 26 and December 19, 2003. Investigation activities were conducted with a backhoe by trenching to 12-feet below ground surface (bgs) at 6 locations immediately adjacent to the source of the leak and in areas where pooling was observed (Plate 3). Soil samples were analyzed in the field for chlorides using field-adapted Method 9253 (QP-03). Field chlorides ranged from a concentration of 1128 parts per million (ppm) at sample point TP-2 located 50 feet northwest of the release point and 2 feet deep to 5,530 ppm at the surface of sample point TP-1 located 45 feet northeast of the release point (Plate 3).

On August 9, 2005, soil samples were collected by ROC with a hand auger at 16 locations within a 25-foot grid spacing that encompassed the area where the spill had encroached. The hand augered borings did not go further than 4 feet below ground surface due to encountering a hard caliche layer. Soil samples were analyzed in the field for chlorides using field-adapted Method 9253 (QP-03). Field chlorides ranged from a concentration of 41 ppm at sample point SP-3 located about 55 feet east of the release point and 3 feet deep to 851 ppm at the surface of sample point SP-5 located 85 feet east of the release point along the lease road (Plate 3).

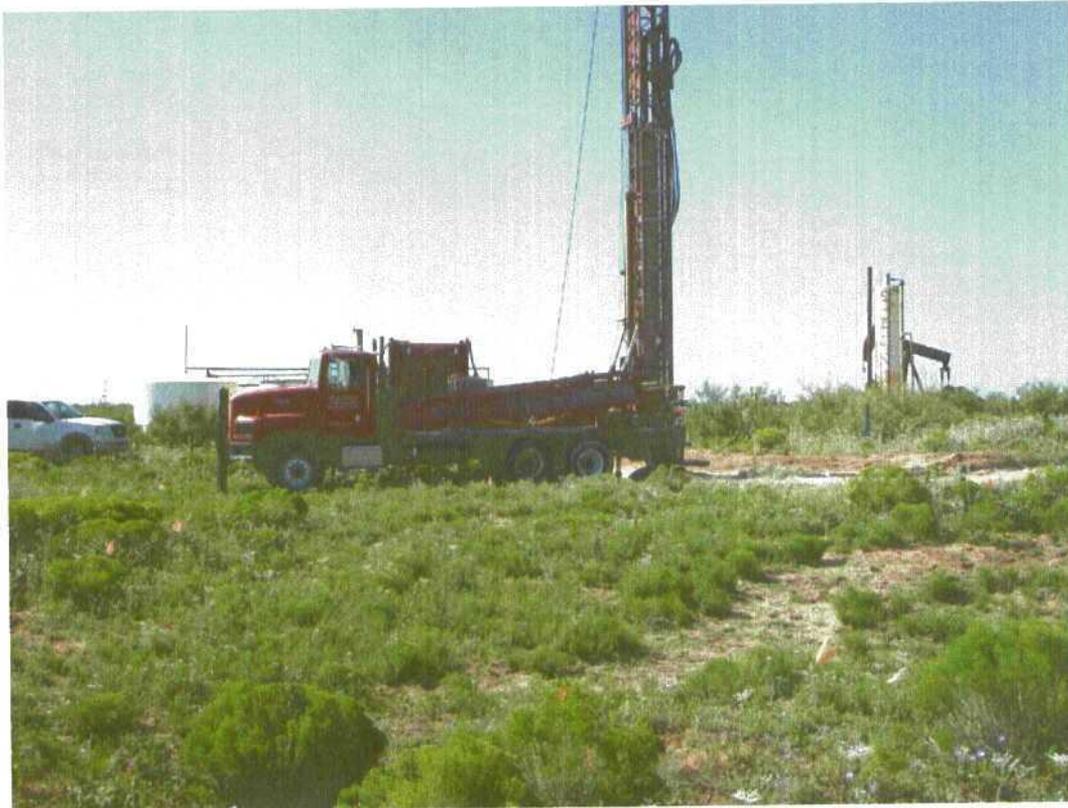
View facing southwest showing drilling of monitoring well MW-1 located adjacent to release point at the Santa Rita EOL Site. (08-30-06)

To further delineate depth of impact in the vadose zone and to assess ground water quality, a monitoring well (MW-1) was installed immediately adjacent to the release point on August 30, 2005, to a depth of 61-feet bgs. Chloride concentrations in the boring samples ranged from 121 ppm at 5 feet bgs to 2,696 ppm at 45 feet bgs, and then decreasing to 2,313 ppm at 50 feet bgs immediately above the water table. A duplicate of the sample collected at 45 feet bgs was submitted to the laboratory which indicated a chloride concentration of 3,570 mg/kg. A more detailed description of the lithology, field chloride tests, and well construction is shown on the boring log in Appendix B.

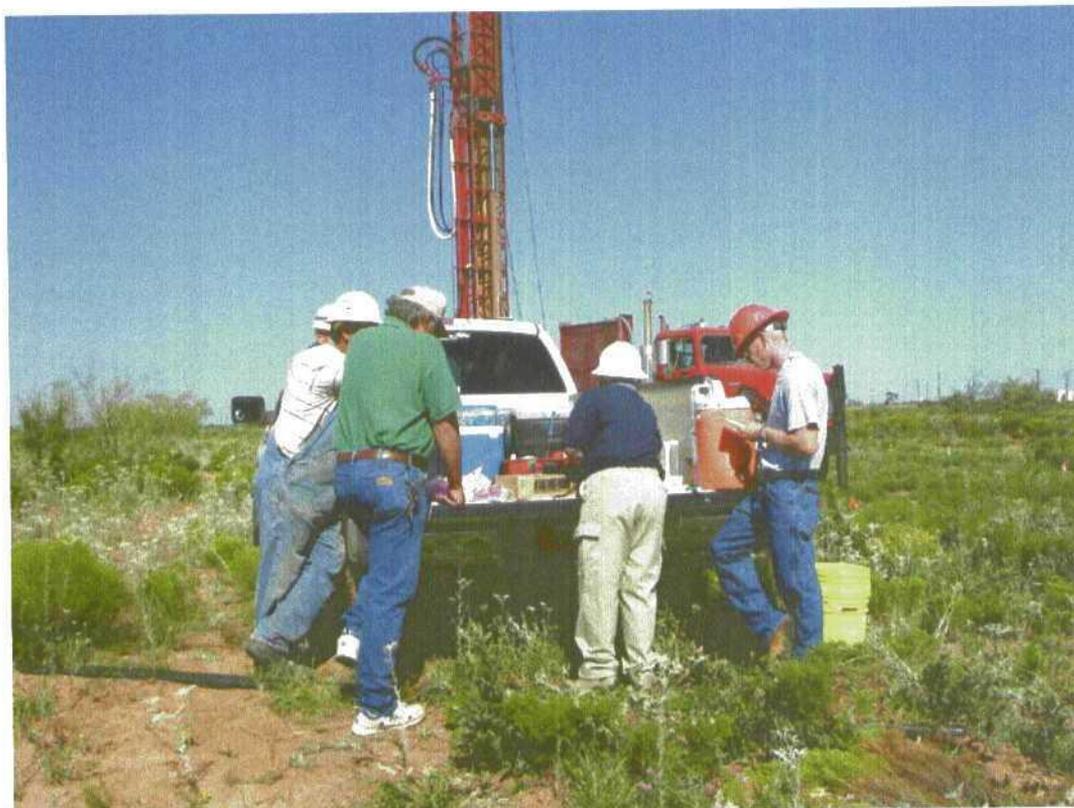
View facing west showing chloride screening activities for soil samples obtained from monitoring well MW-1 at the Santa Rita EOL site (08-30-06)

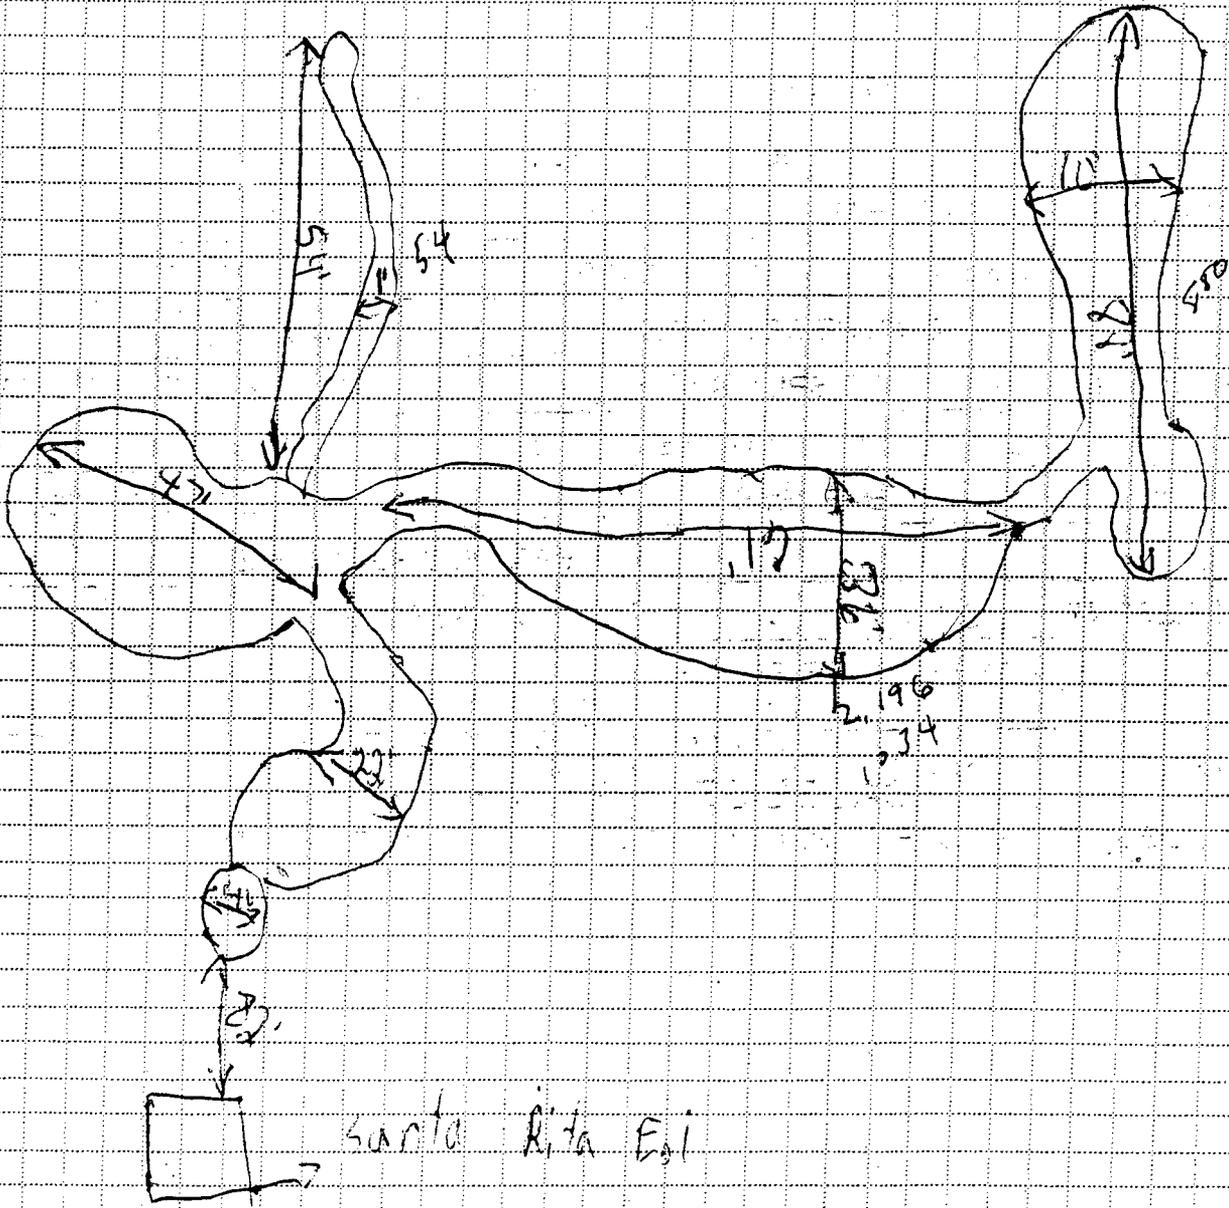
DRAW SKETCH OF AFFECTED AREA

TEST POINT NO. <i>Origin of Leak</i>				
DEPTH	TPH	CF	Soil	H ₂ O
5' bgs		2343		
6' bgs		2761		
7' bgs
